# Handover Inspection Report

Rosedale South, Qld, 4123

**Date of Inspection:** 19/07/2017

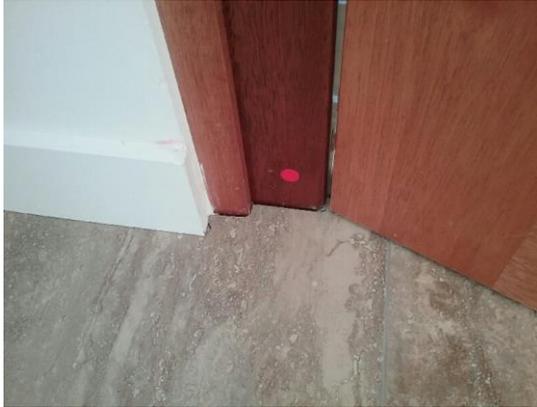
Kitchen- sealant missing around door frame, make good

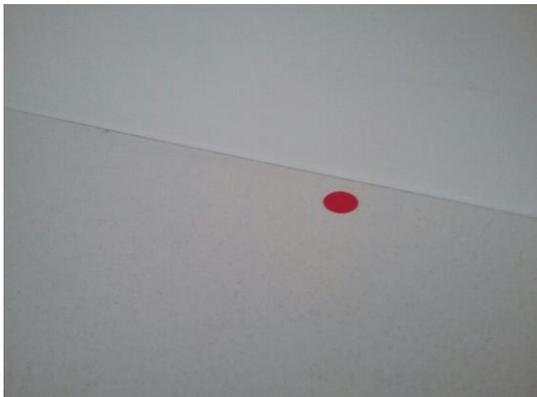
Kitchen- make good visible edge of caeser stone bench top

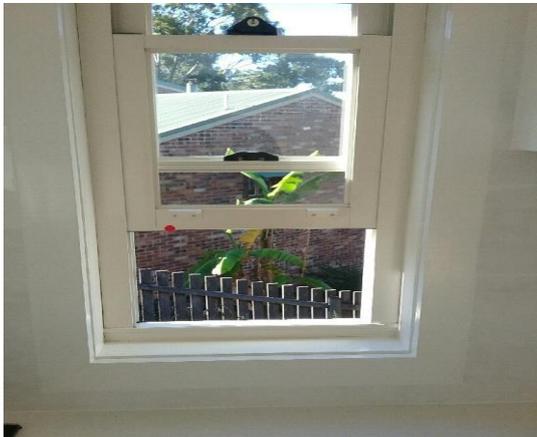
Kitchen- the 2 windows at bench height recommended to be restricted to open a maximum of 125mm or fitted with a suitable security screen as there is more than two (2) metres to the external ground level, to prevent small children falling through opening.

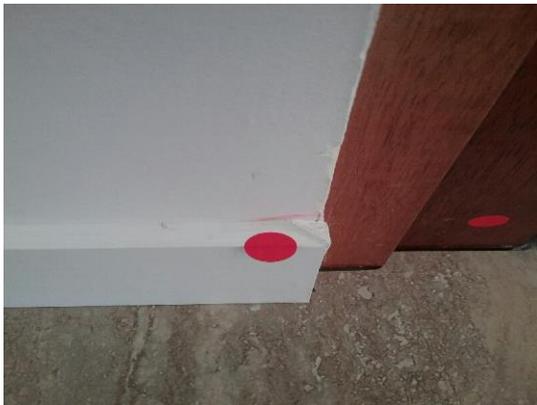
Kitchen- make good blemish and lump to skirting LHS

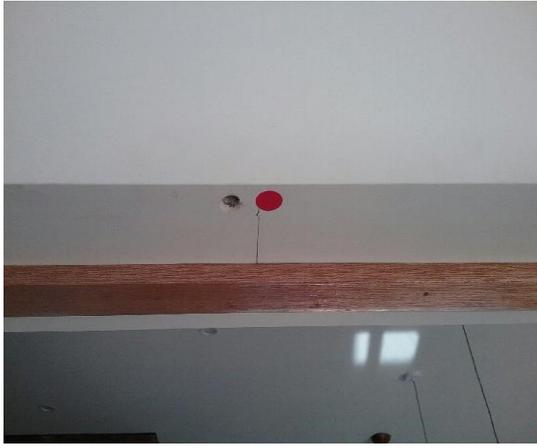
Kitchen- install metal escutcheon plate to double door top drop bolt

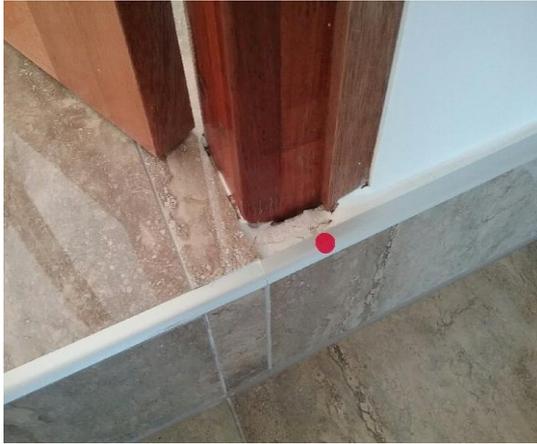
Dining- sealant missing (incomplete) around door frame, make good

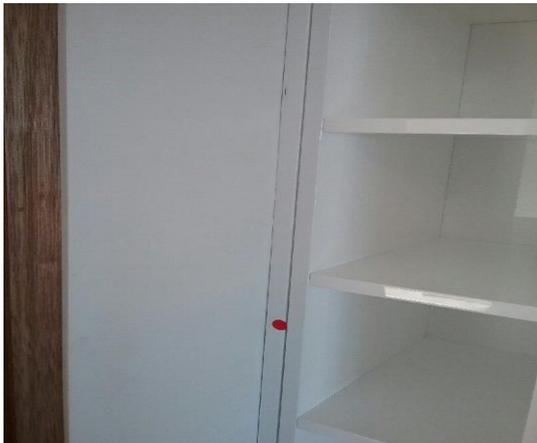
Dining- gap seal panel to wall

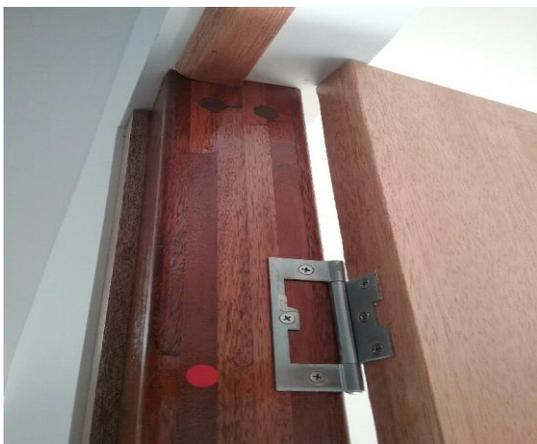
Kitchen- door stop missing both sides of double door

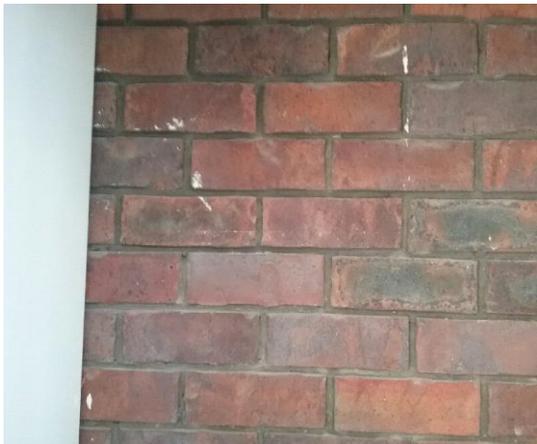
Dining- clean down plaster droppings from face brick

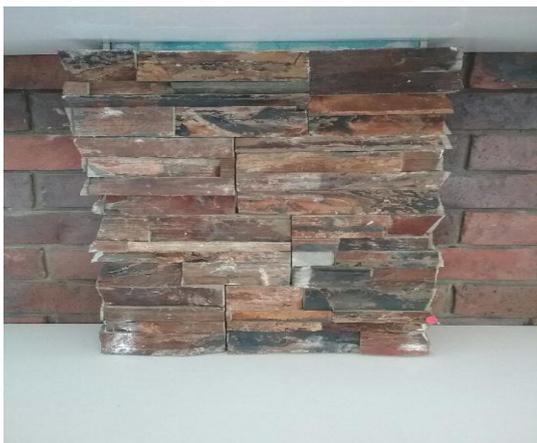
Dining- sharp edges to corners of tiles. Recommend removing sharp edges in the vicinity of the working bench area

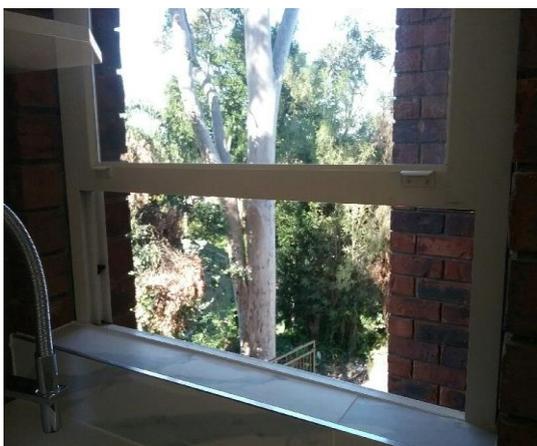
Dining- window at bench height is recommended to be restricted to open a maximum of 125mm or fitted with a suitable security screen as there is more than two (2) metres to the external ground level, to prevent small children falling through opening.

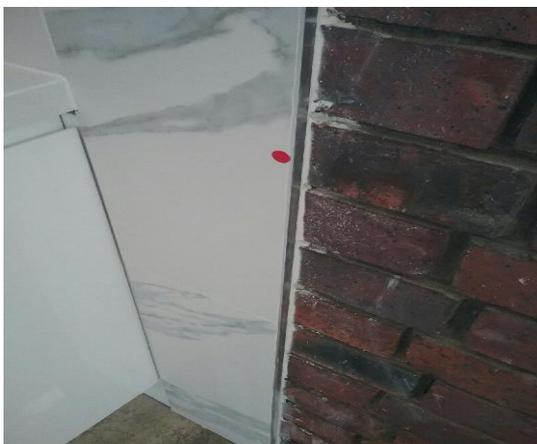
Dining- make good (clean up) untidy finish on brickwork/tile edge.

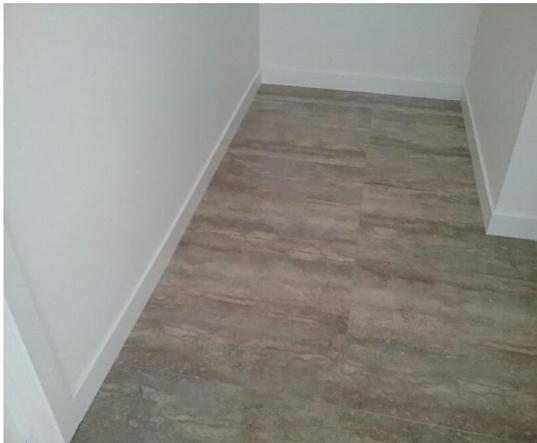
New Stairs- recommend applying sealant to tile/skirting junction to assist in protecting the skirting from moisture damage

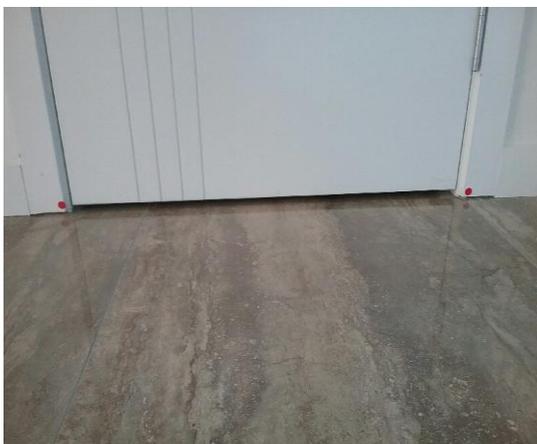
New Stairs- make good short architraves either side of door leading into storage room

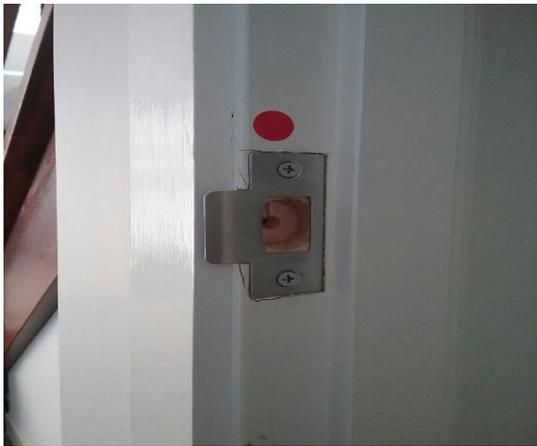
New Stairs- make good around striker plate leading into storage area under stairs

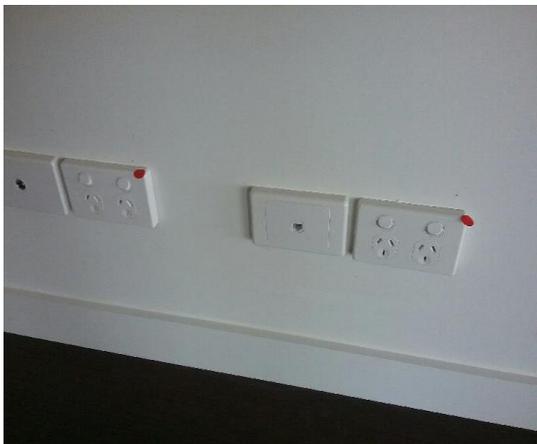
Family- make good loose GPOs

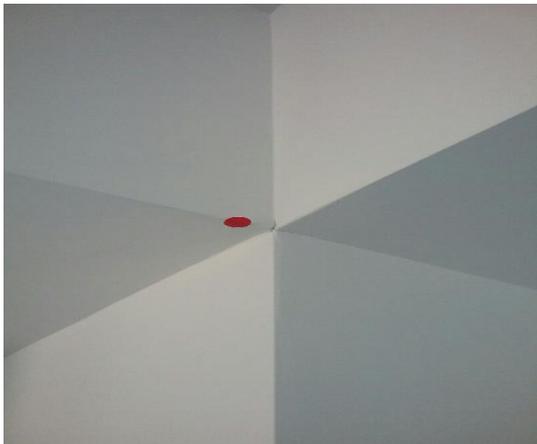
Family- make good plaster blemish to bulkhead, right in the corner

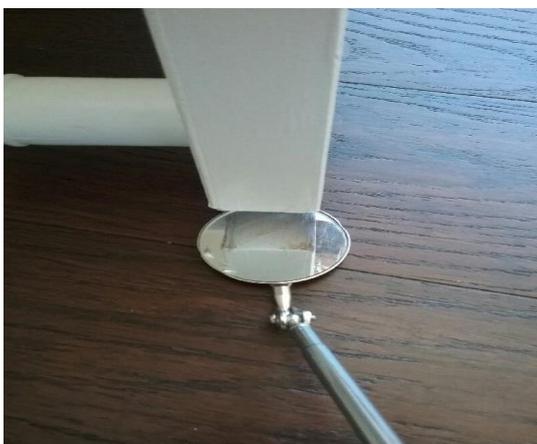
Passage- inadequate paint coverage top & bottom of ext. x 2 doors, make good

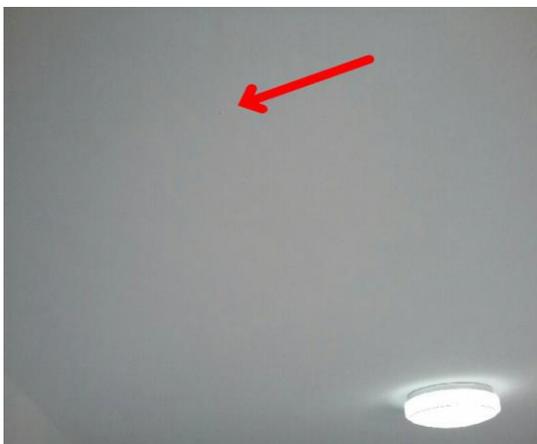
Bed 4- make good plaster blemish on ceiling

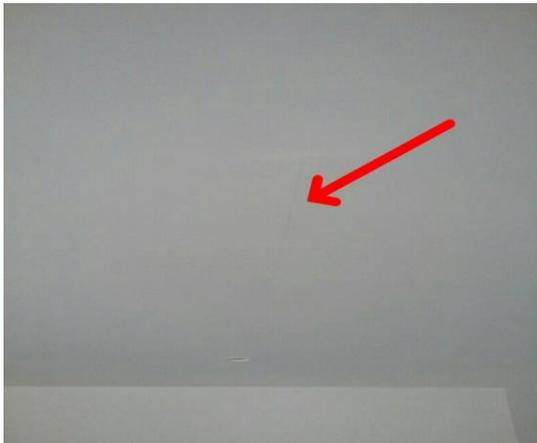
Bed 4- make good crack in ceiling

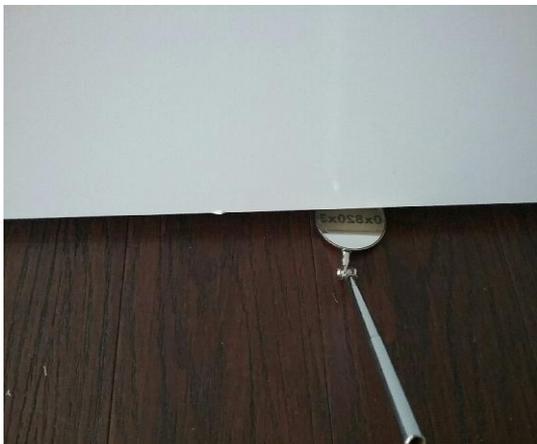
Walk in robe- paint top and bottom of door as required, review all and make good to ALL

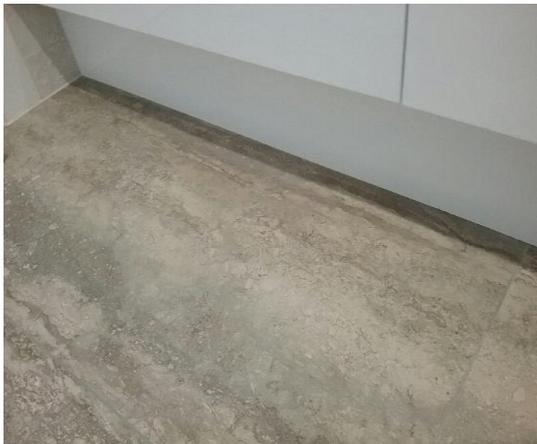
Ensuite 4- apply sealant to protect kickboard face of moisture

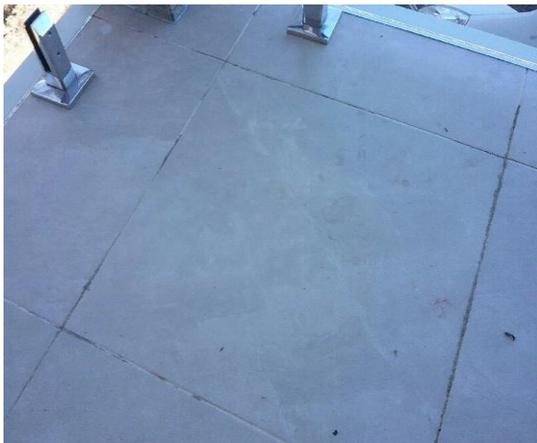
Balcony- grout not consistent and stained in places which may suggest moisture being retained underneath. Make good

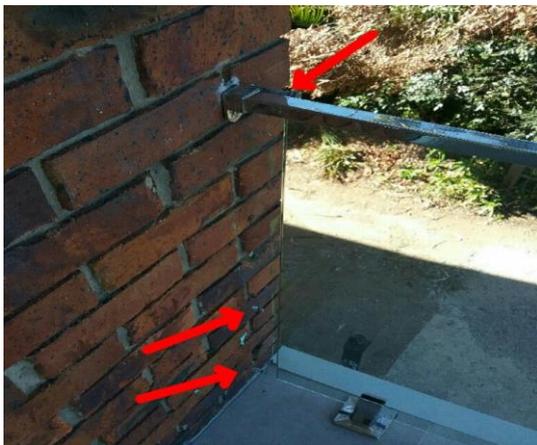
Balcony- remove bolts from wall

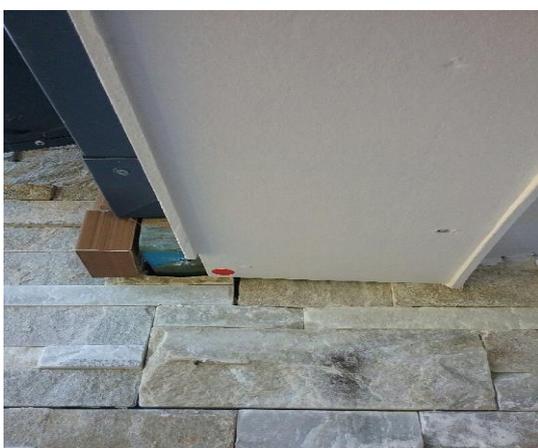
Balcony- make good finish and detail at end of bulkhead.

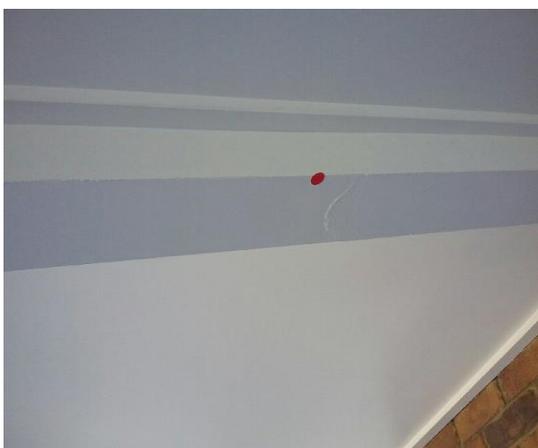
Balcony- finish to ext. bulkheads and ceilings are not finished off in a tradesman like manner. Areas are lumpy and have not been sanded prior to painting. Make good to all

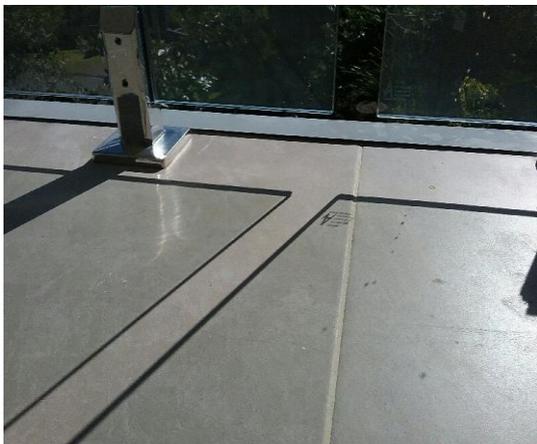
Balcony- metal capping to front edge of tiles is untidy and in particular where they overlap. Make good to all. Unknown if capping is sealed correctly to tiles and will not present moisture issues downstairs in the future. Consult with Builder for clarification and warranties

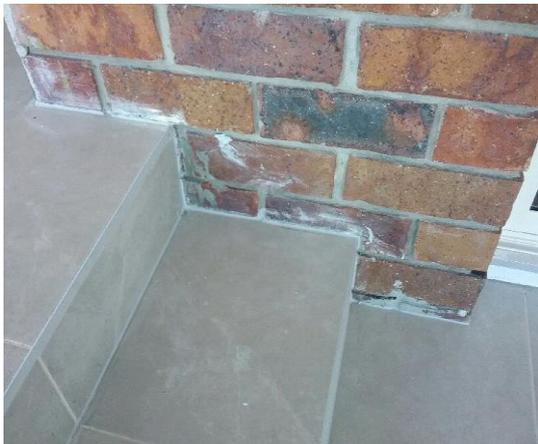
Balcony- make good glue and mortar splatter on face brickwork

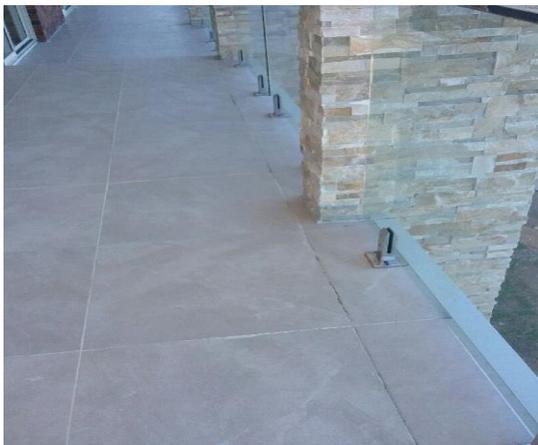
Balcony- grout not consistent and stained in places. Make good

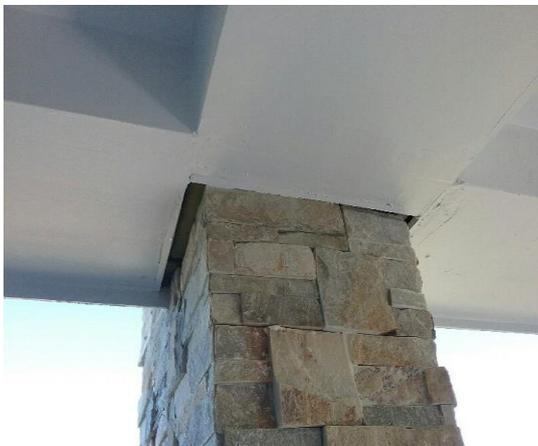
Balcony- finish to ext. bulkheads and ceilings are not finished in a tradesman like manner. Areas are lumpy and have gaps that require filling or trimming prior to painting. Make good to all

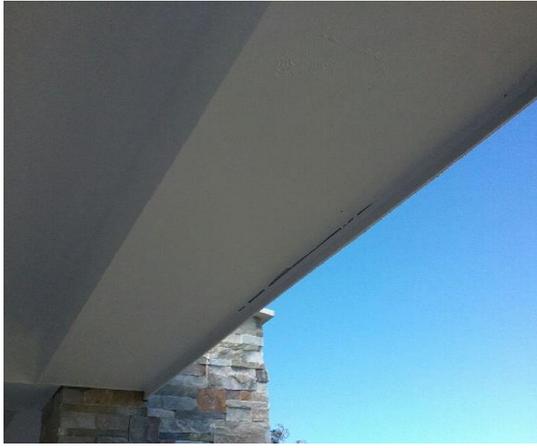
Balcony- finish to ext. bulkheads and ceilings are not finished in a tradesman like manner. Areas are lumpy and have gaps that require filling or trimming prior to painting. Make good to all

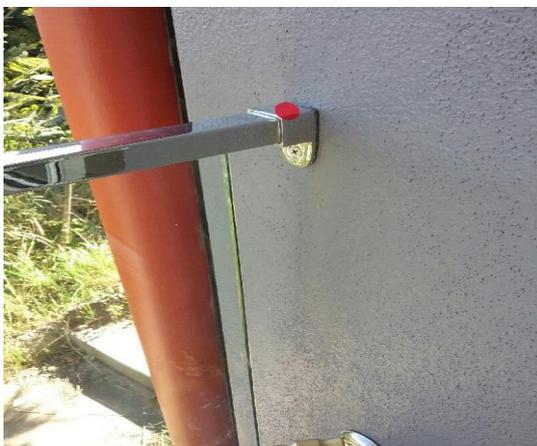
Balcony- make good loose top rail

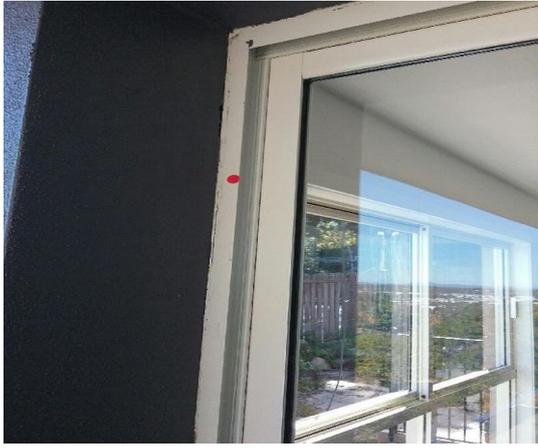
Balcony- make good along aluminium that is against render

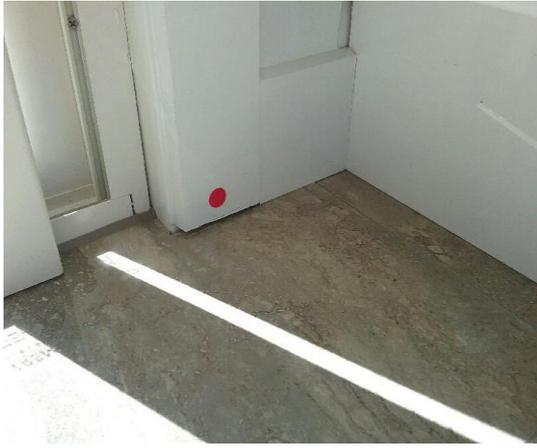
Rear entry- make good short architrave to sliding door

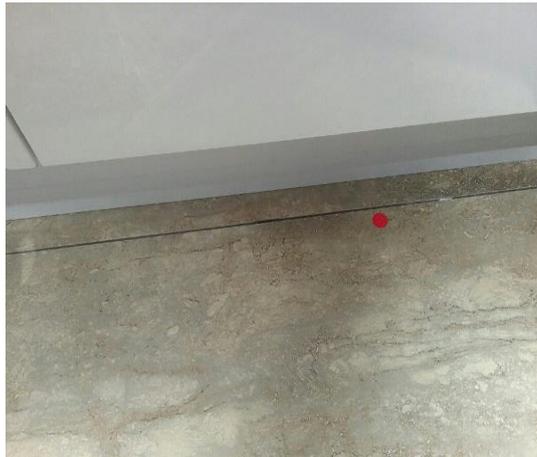
Rear entry- make good missing grout for floor in front of joinery unit

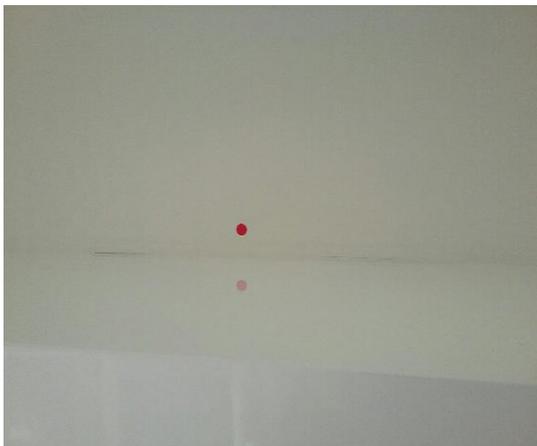
Rear entry- make good untidy finish

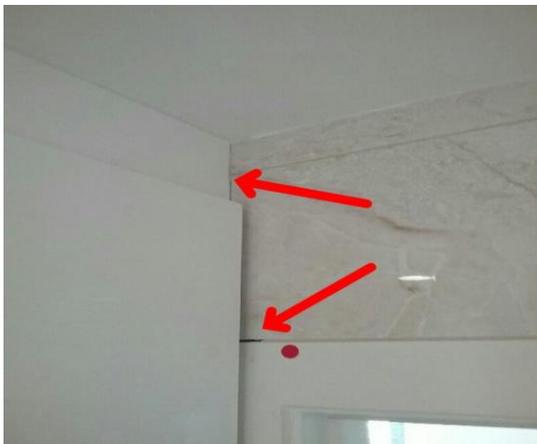
Laundry- make good missing grout above door architrave and internal corner

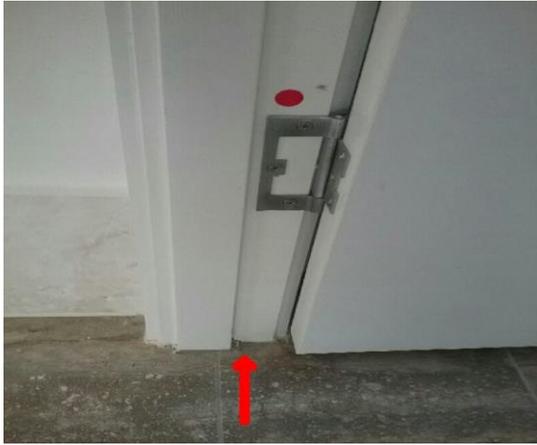
Laundry- missing sealant around door frame and blemish on door jamb, make good

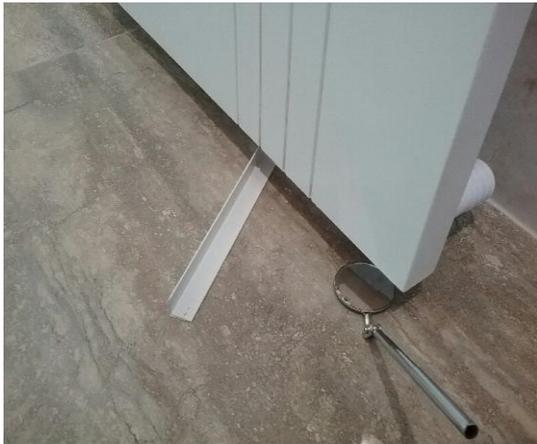
Laundry- excessive gap (>20mm) under door and top and bottom of door not painted, make good to all

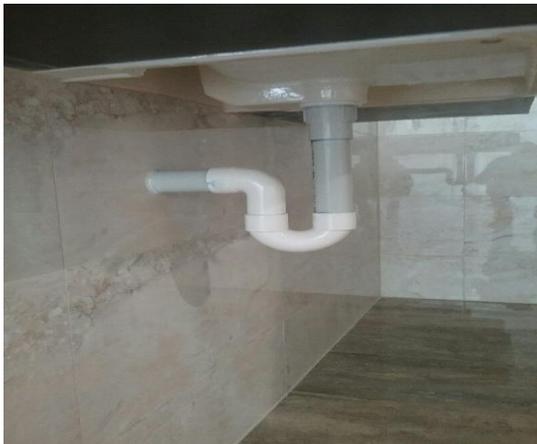
Powder Room- recommend painting exposed waste pipe under vanity one colour

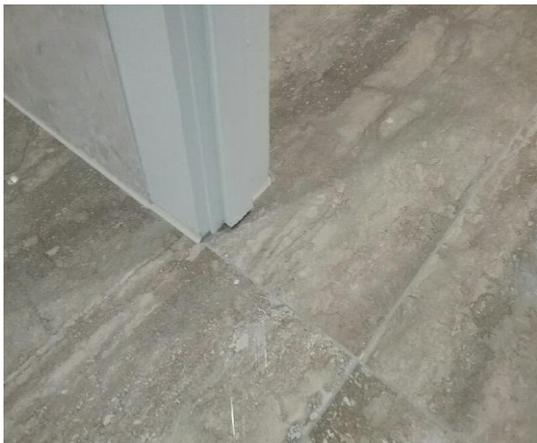
Powder Room- missing sealant around door frame, make good

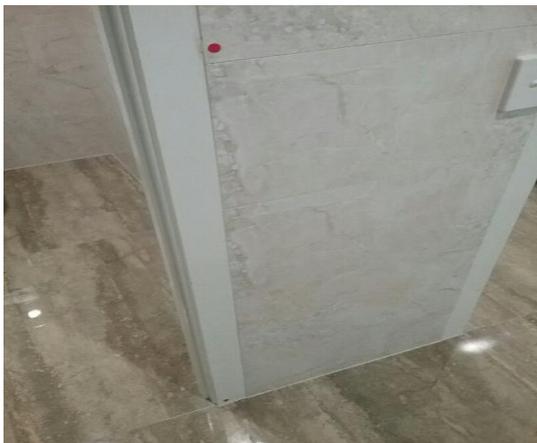
Powder room- make good crack in grout along architrave and clean off excessive grout from surfaces

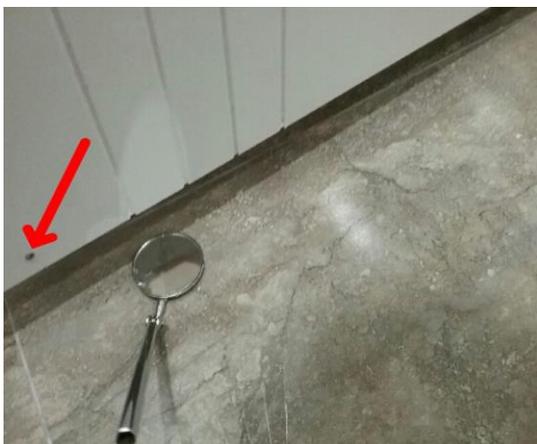
WC- Urinal- excessive gap (>20mm) under door, top and bottom of door not painted and hole in face of door, make good to all

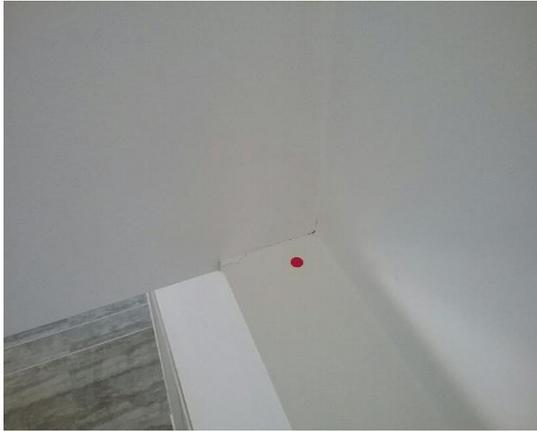
New stairs- make good crack in plaster

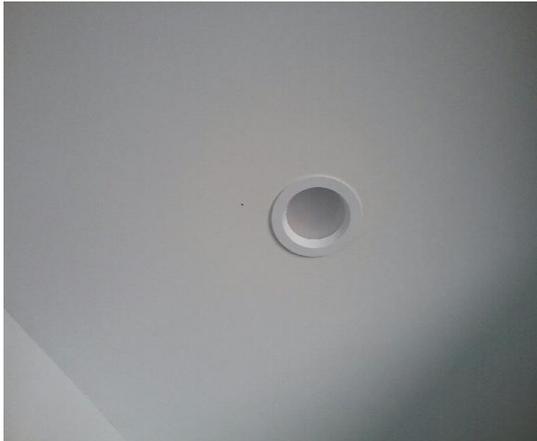
New stairs- make good hole on ceiling next to light fitting

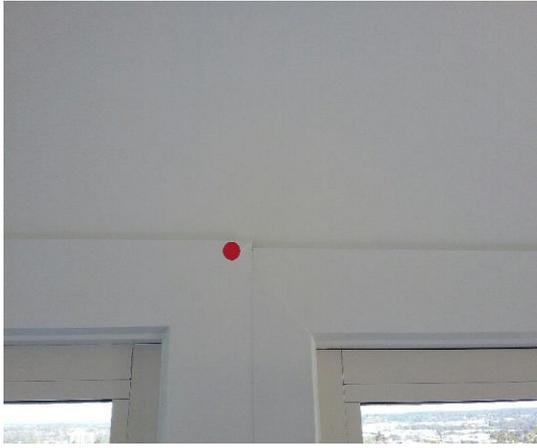
Mezzanine- make good misaligned architrave along the southern wall

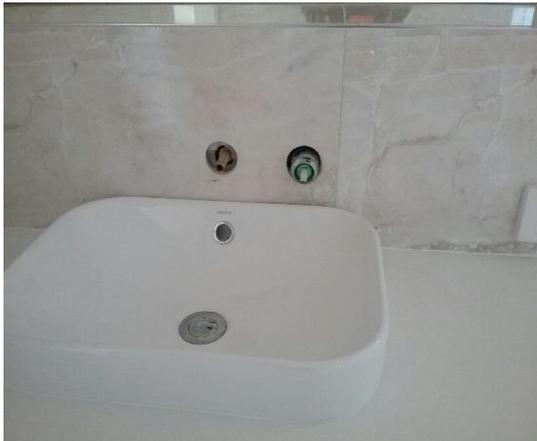
Ensuite- install missing tap and spout for vanity

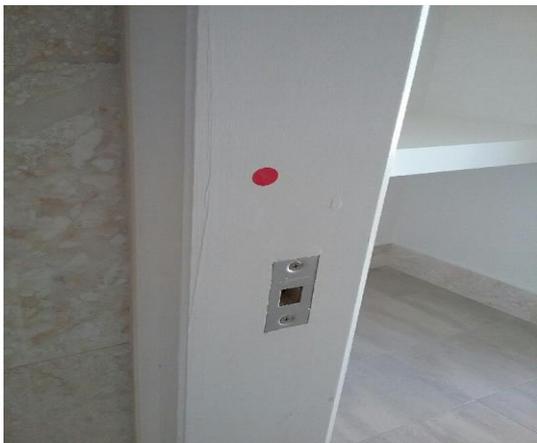
Ensuite- make good blemishes on timber frame

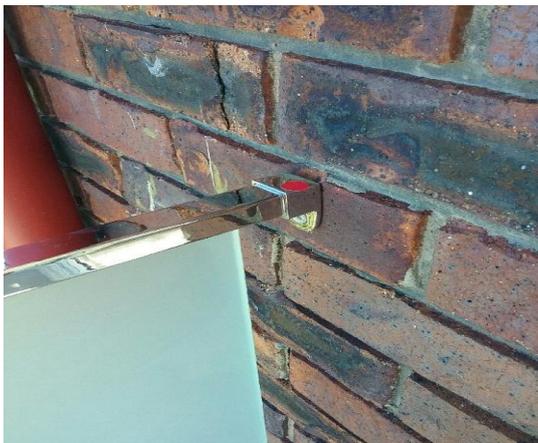
Deck- top rail to glass handrail loose, make good

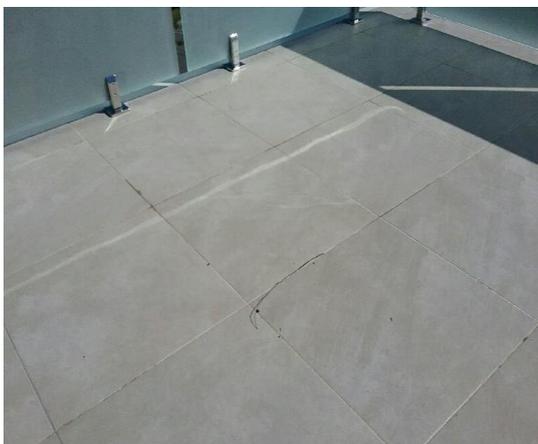
Deck- grout not consistent in colour and stained in places which may suggest moisture being retained underneath. Make good

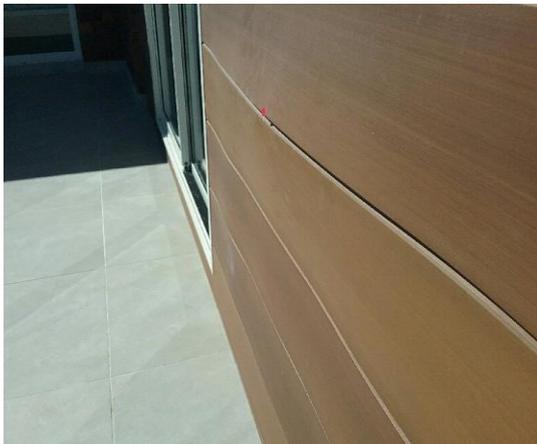
Deck- some panels of the PVC cladding are bowed, make good to all

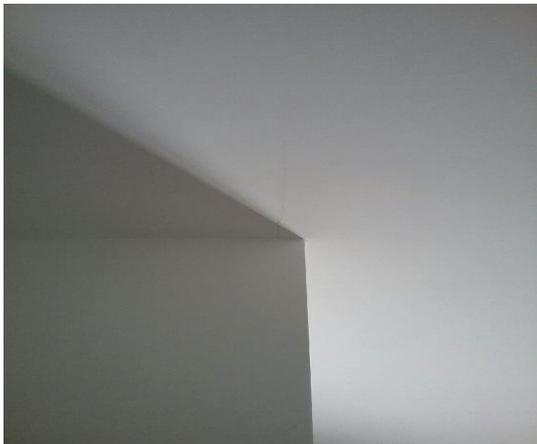
Bed 3- make good noticeable crack in ceiling

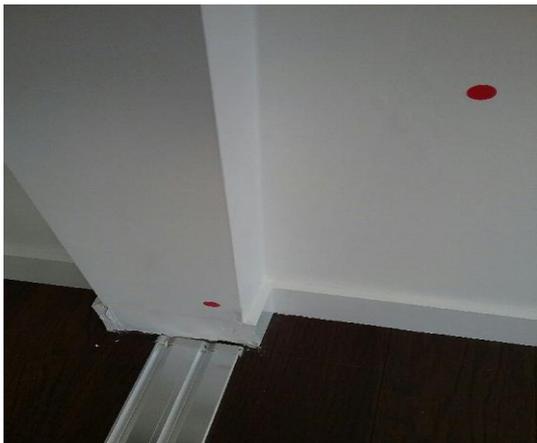
Bed 3- make good poor finish at robe track RHS and blemish on wall

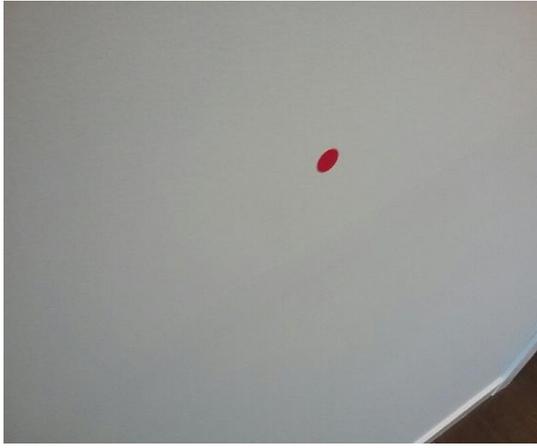
Bed 2- make good blemish on wall LHS of switch

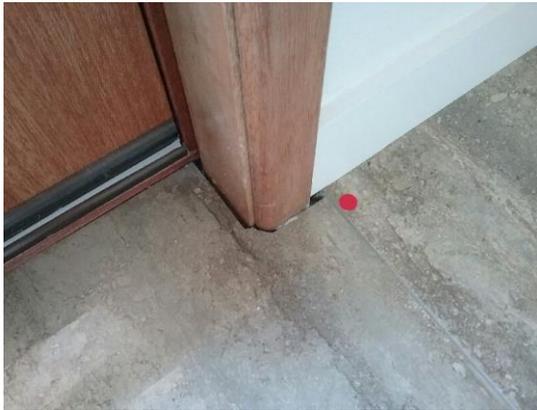
Entry- missing sealant around door fame L&RHS

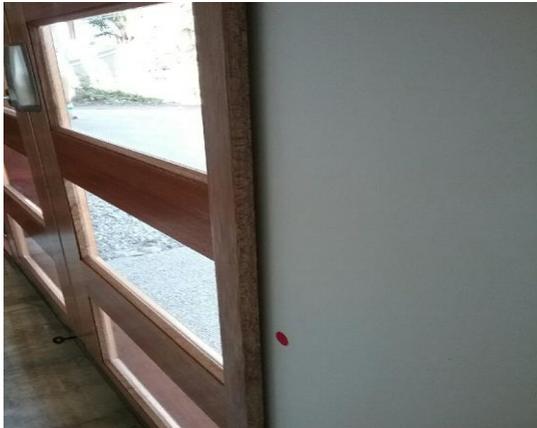
Entry- make good gap around architrave and apply final coats of varnish to timber frame.

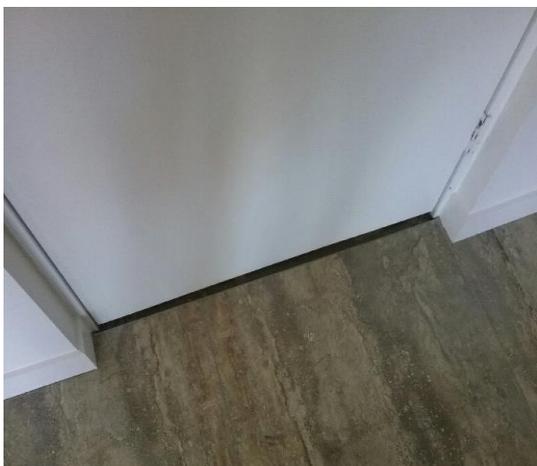
Entry- tiles have been finished off prior to door and not under door as per best practise, make good

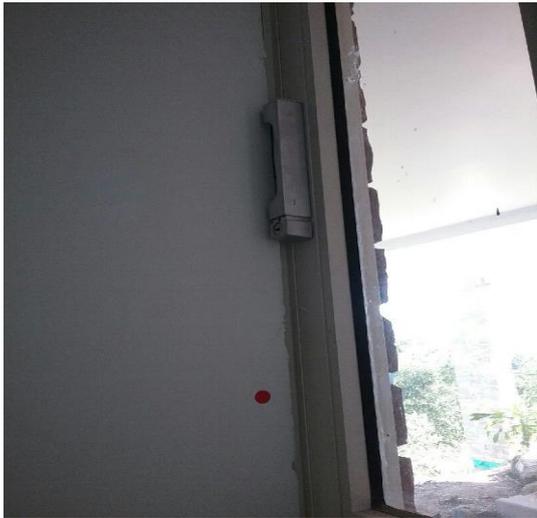
Storeroom- make good finish to plaster around window

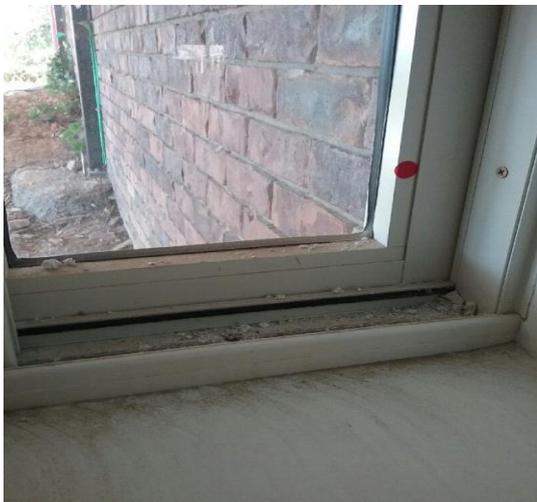
Storeroom- remove builder's debris from window sill

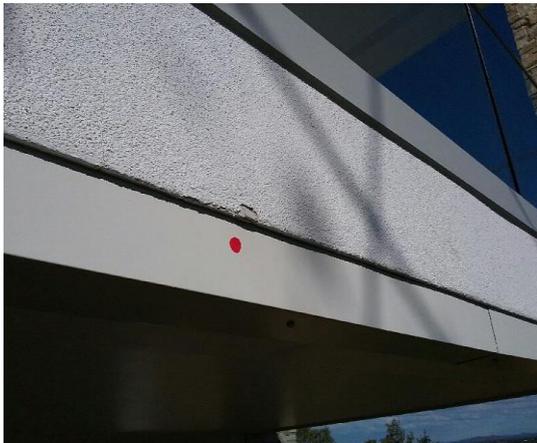
Left elevation- make good damage to edge on fibrous board

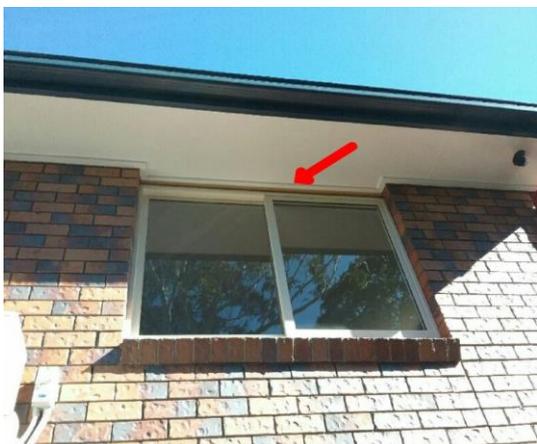
Rear elevation- complete painting of trim above window

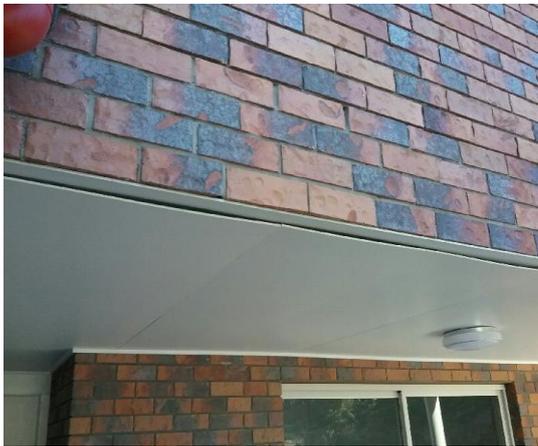
Rear elevation- make good gap to soffit sheets

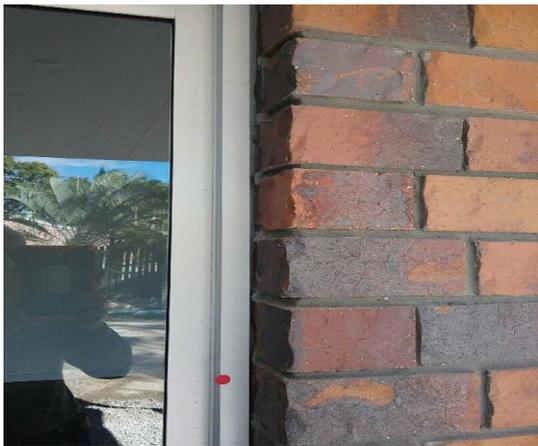
Rear elevation- all around- install same colour trim around sliding door to close gap

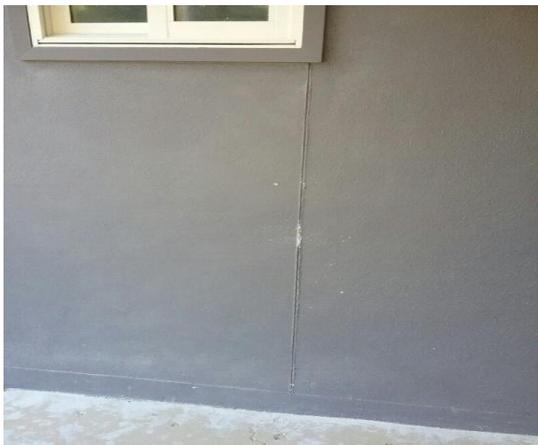
Rear elevation- make good damage to render at control joint

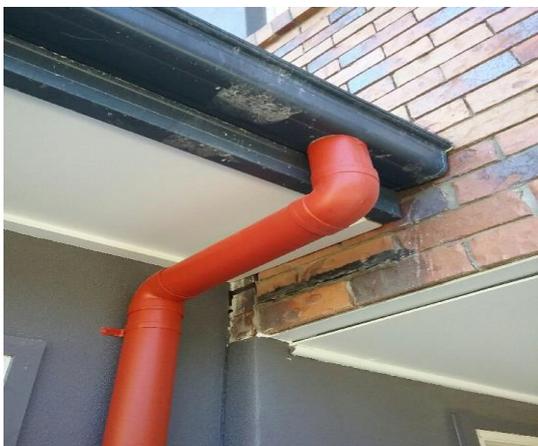
Rear elevation- clean down builders grime from gutter and fascia

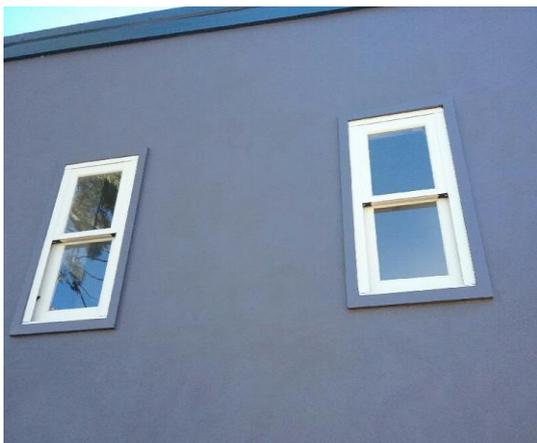
Right elevation- flashing missing from windows as required and recommended, make good
