Visual Timber Pest Inspection & Report in accordance with AS 4349.3 – 2010

3, Albert Street, Alperton, Qld, 4110

Date of Inspection: 05/08/2014

Job No. 2098

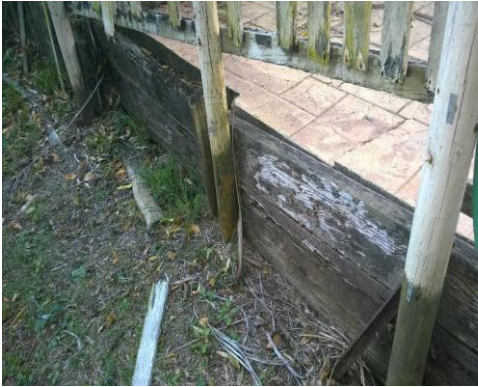
2.3 Visible evidence of subterranean termite workings and/or damage was found. Where workings and/or damage was found, it was in but not necessarily limited to the following areas: Timber retaining walls at the rear of the garden, skirting boards in the lounge.

Visible evidence of subterranean termite workings and/or damage was found at the time of inspection. It was in, but not necessarily limited to the following location(s) timber retaining walls at the rear of the garden

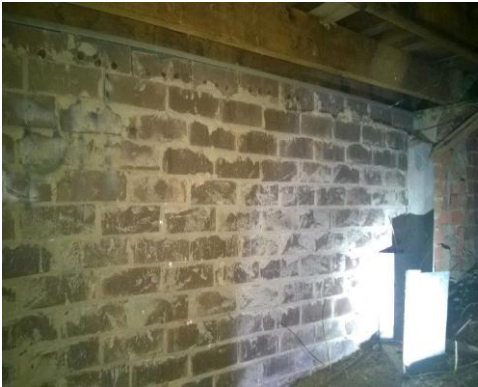
6.3 We claim no expertise in building. However, in our opinion the termite shields appear to be: Inadequate. Ant caps are compromised by the enclosed walls in the subfloor. The purpose of ant capping is to reduce the risk of concealed termite attack. The enclosed wall need to be removed and ant capping should be repaired or installed where possible.

Ant caps are compromised by the enclosed walls in the subfloor. The purpose of ant capping is to reduce the risk of concealed termite attack. The enclosed wall need to be removed and ant capping should be repaired or installed where possible.

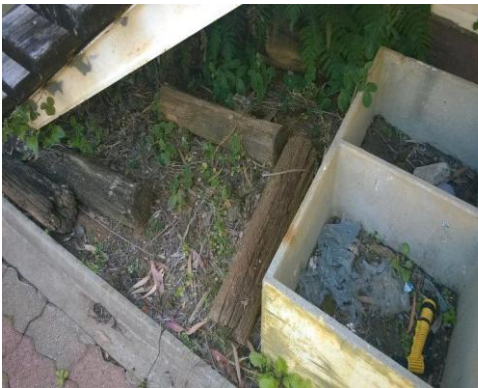
Timbers in contact with the ground, these are susceptible to termite activity. We would recommend removing away from the property

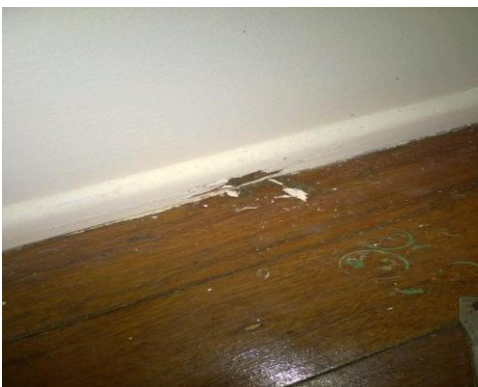
Visible evidence of subterranean termite workings and/or damage was found at the time of inspection. It was in, but not necessarily limited to the following location(s) skirting boards in the lounge
