# **Residential Building Inspection Report**

**3 Albert Street, Alpertown, Qld, 4110**

**Date of Inspection:** 05/08/2014

**Job No.** 2098

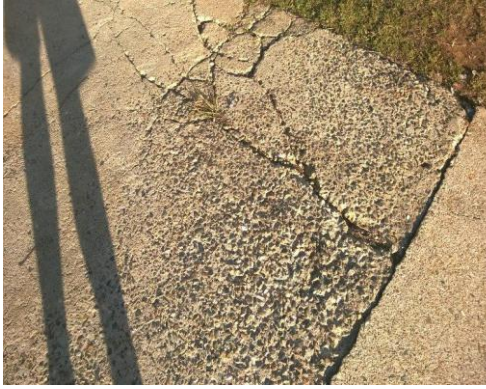
Movement cracks were visible to the concrete driveway, significant repairs are required, consult a concreter for advice

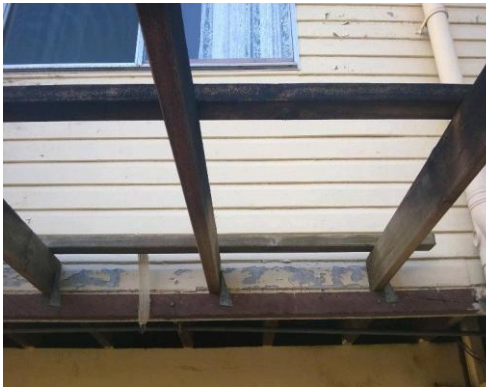
Paint stress is evident to the timber cladding, maintenance is required

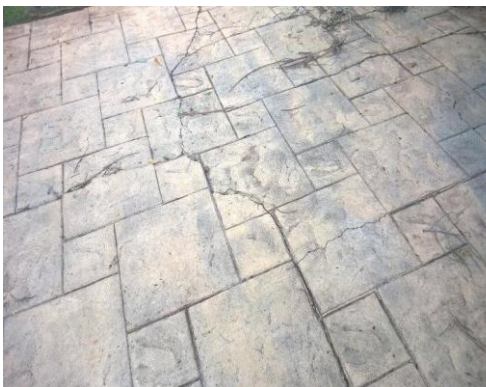
There is cracking & subsidence evident to the concrete patio at the rear of the property, replacement of the concrete is required, consult a concreter for advice

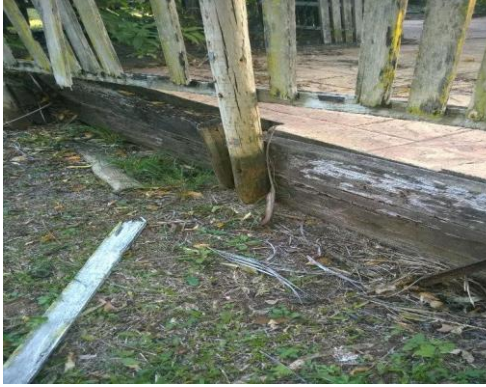
The timber retaining walls at the rear of the garden is out of vertical alignment, replacement of the retaining wall is required.

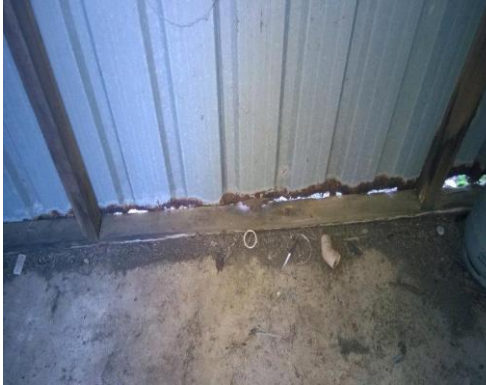
There is corrosion evident to the pool pump housing sheeting, repairs or replacement of the damage sheets is required

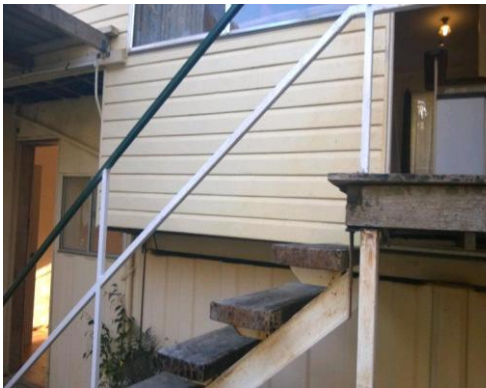
The opening to the Balustrades on the rear staircase have openings greater than 125mm. Openings in the balustrades must be constructed so that any opening does not permit a 125mm sphere to pass through it. This space is tested above the nosing line only, Ref; BCA Part 3.9.2.3 – Balustrades or other barrier construction. The above recommendation should be implemented as a matter of urgency. Immediate action must be taken to ensure that anyone entering the area is warned of this hazard.

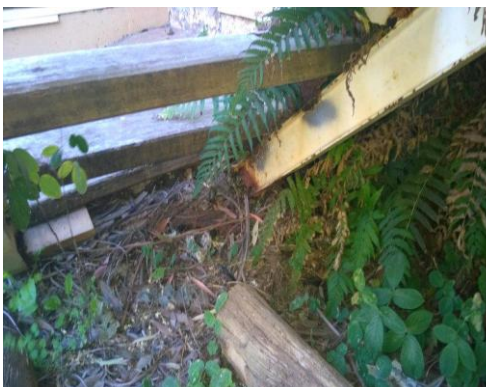
Rusting is evident to the rear staircase stringers & tread brackets, repairs are required. The above recommendation should be implemented as a matter of urgency. Immediate action must be taken to ensure that anyone entering the area is warned of this hazard.

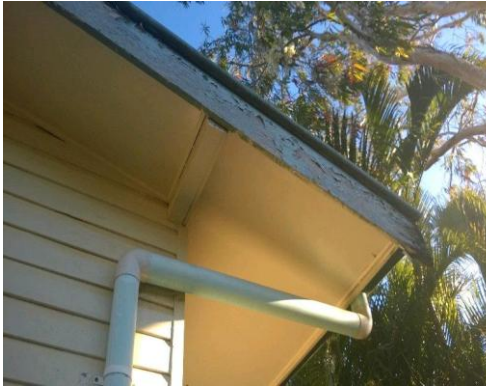
Fascia boards, eaves and barge ends are in poor condition and require repairs and painting

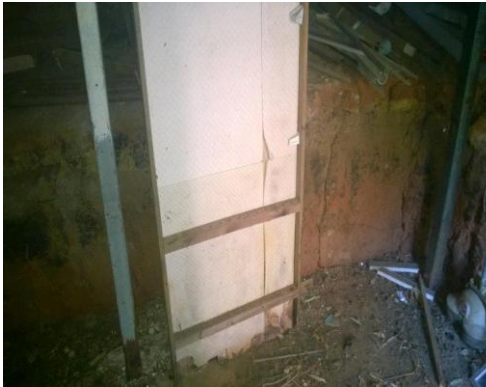
We would recommend that consideration should be made into retaining the soil banking in the subfloor area, consult a licensed builder for advice

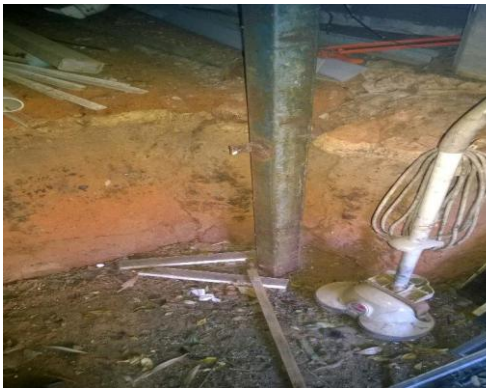
There is rust scale to the steel posts at ground level, Maintenance is required.

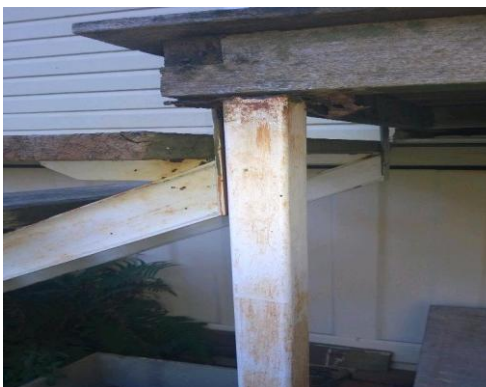
Rusting has caused structural damage to the steel posts on the rear staircase landing and repairs are essential – see a builder for expert advice

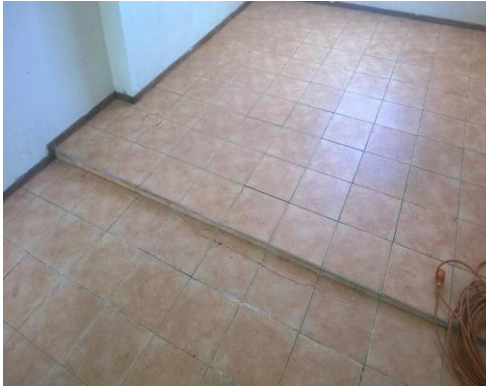
The concrete slab in the enclosed subfloor area is out of horizontal level and has extensive cracking evident to the floor tiles. This could be due to poor site preparation & settlement. We would strongly recommend consulting a licensed builder for advice

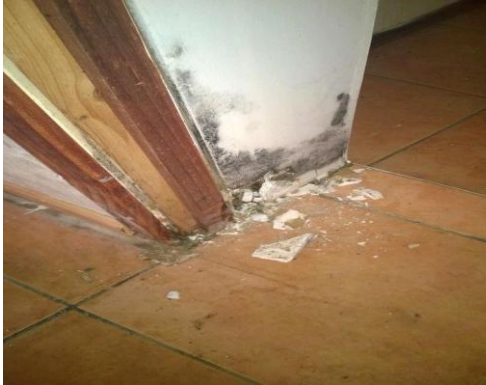
There is mould and plaster damage evident to a door reveal in the garage area. This could be due to water ingress from the roofed area adjacent to this area. We would recommend consulting a roofer for advice

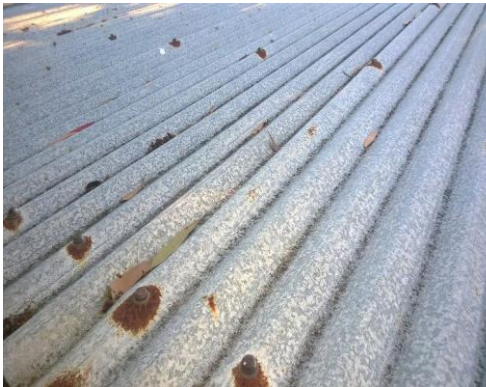
There is surface rusting evident to areas of the roofing sheeting, maintenance will prolong the life of the sheeting but expert advice from a roofing contractor must be sought

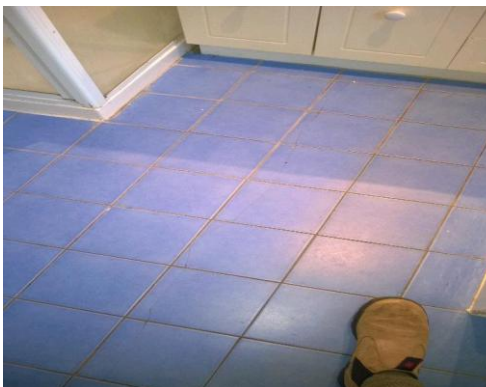
There is cracking to the bathroom floor tiles, maintenance and repair to rectify is required

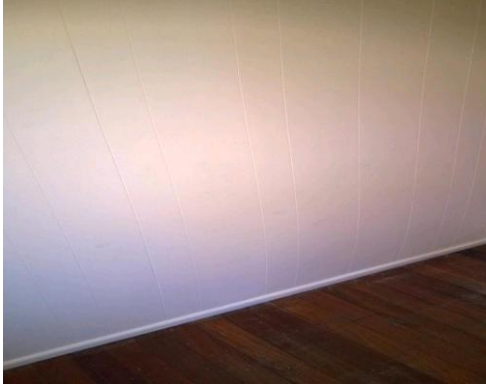
The wall paneling in the dining room is bowing. We would recommend removing the paneling and carrying out a more invasive inspection to determine the course of the problem.

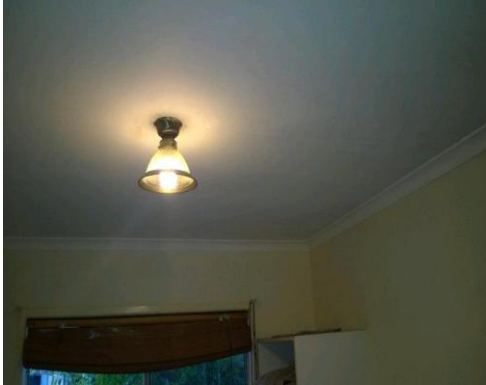
The ceiling lining in the kitchen has been patched. However, further remedial action is required to return the ceiling to a condition commensurate with the other ceilings in the dwelling

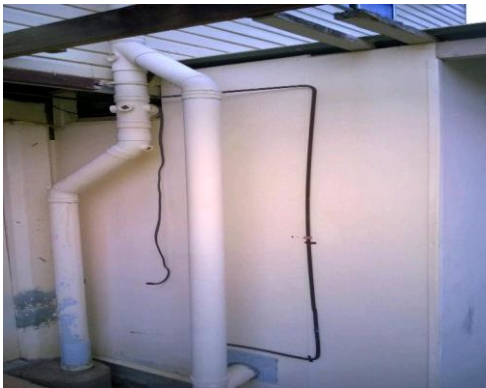
The roofed toilet at the rear has been constructed with no consideration to BCA requirements. We would recommend replacing the enclosure with a structure that complies with current building codes.
