Handover Inspection Report

Rosedale South, Qld, 4123

Date of Inspection: 19/07/2017

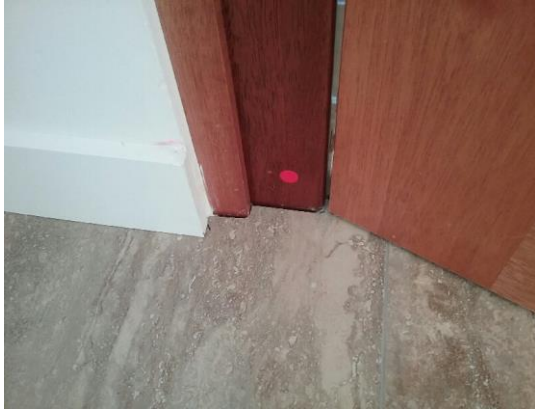
Kitchen- sealant missing around door frame, make good

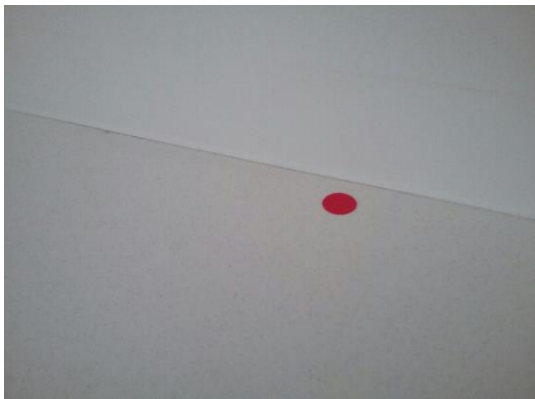
Kitchen- make good visible edge of caeser stone bench top

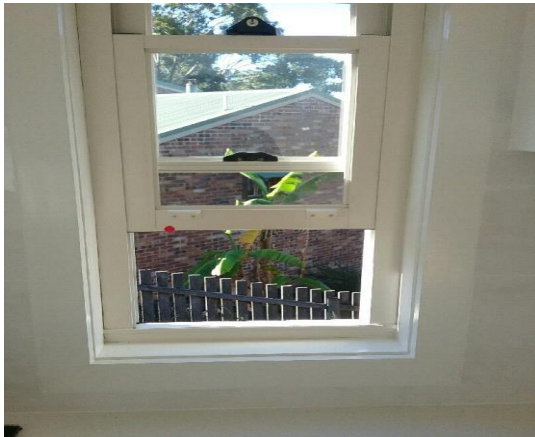
Kitchen- the 2 windows at bench height recommended to be restricted to open a maximum of 125mm or fitted with a suitable security screen as there is more than two (2) metres to the external ground level, to prevent small children falling through opening.

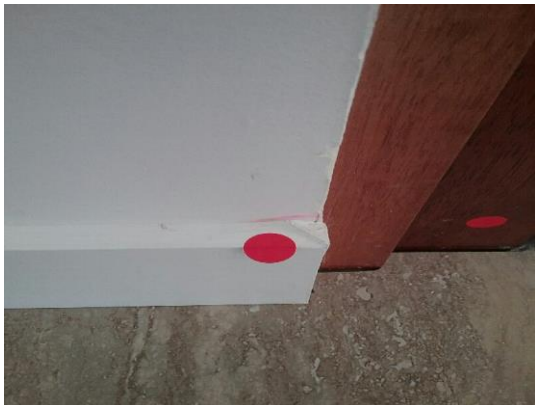
Kitchen- make good blemish and lump to skirting LHS

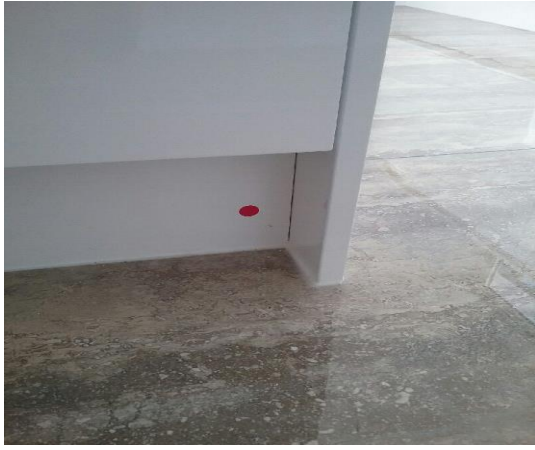
Kitchen- fill gaps to internal corners of kickboard, widespread. Review all and make good

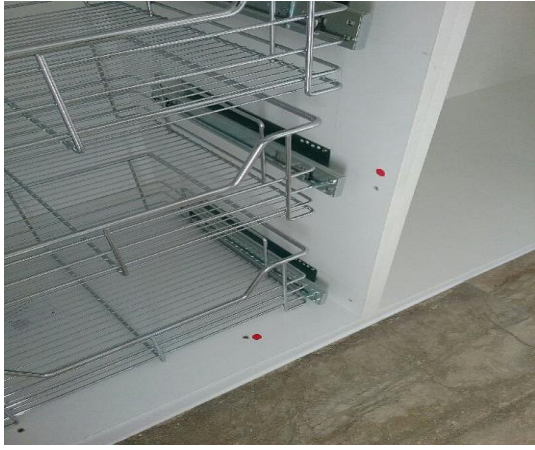
Kitchen- insert screws so as to be flush and cap off exposed screws. Widespread, review all and make good

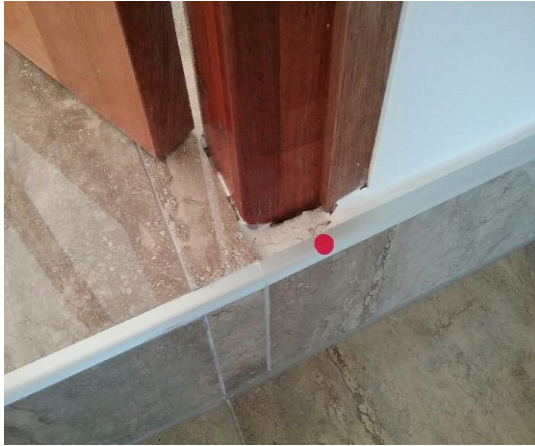
Dining- sealant missing (incomplete) around door frame, make good

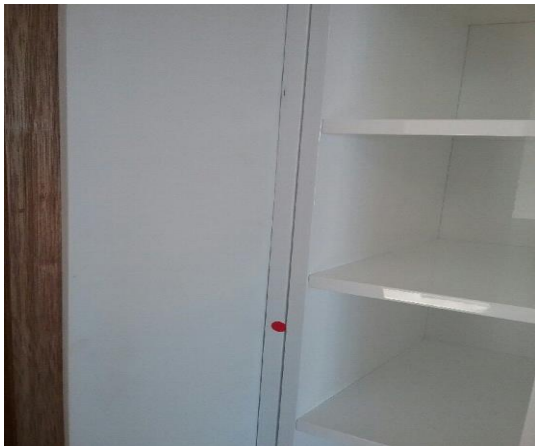
Dining- gap seal panel to wall

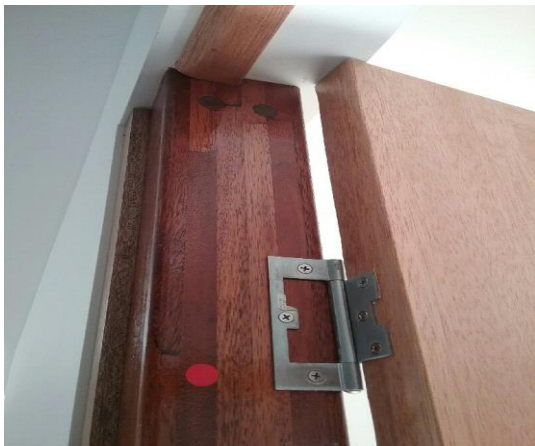
Kitchen- door stop missing both sides of double door

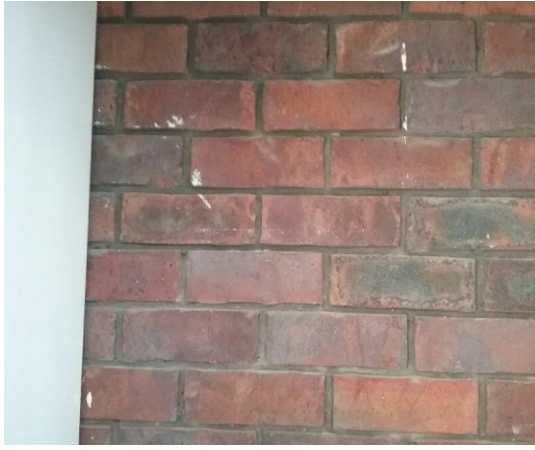
Dining- clean down plaster droppings from face brick

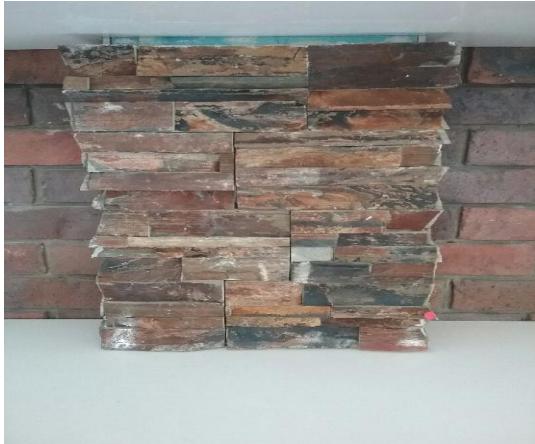
Dining- sharp edges to corners of tiles. Recommend removing sharp edges in the vicinity of the working bench area

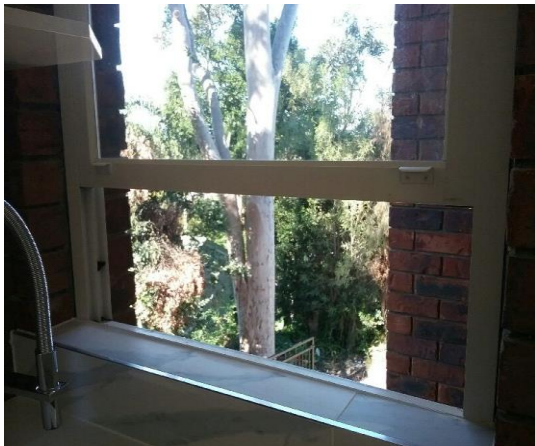
Dining- window at bench height is recommended to be restricted to open a maximum of 125mm or fitted with a suitable security screen as there is more than two (2) metres to the external ground level, to prevent small children falling through opening.

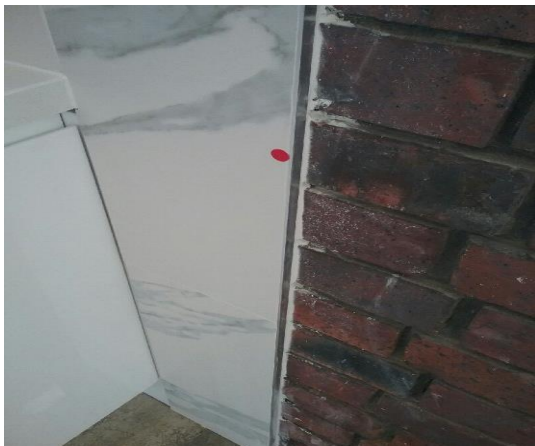
Dining- make good (clean up) untidy finish on brickwork/tile edge.

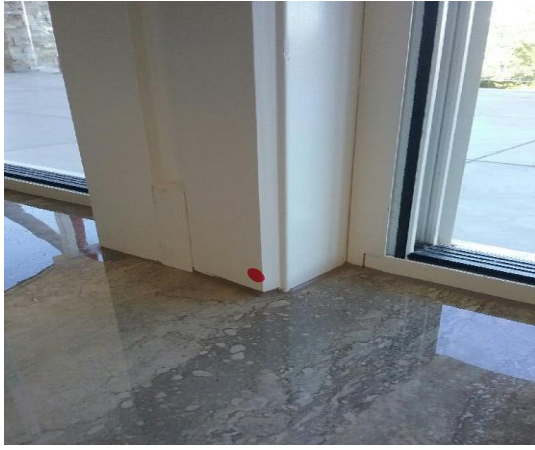
Living – make good short architrave and tidy up sealant

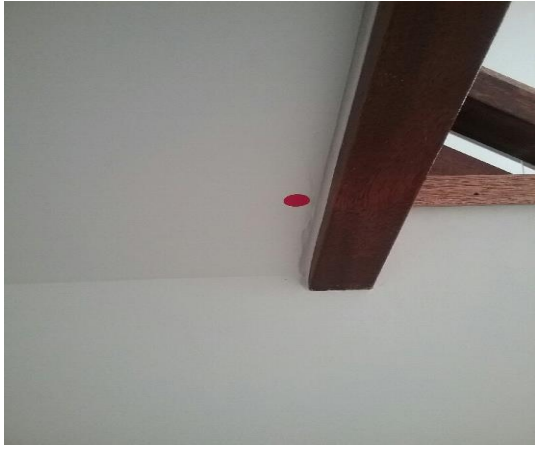
New Stairs- make good plaster blemish both sides on ceiling

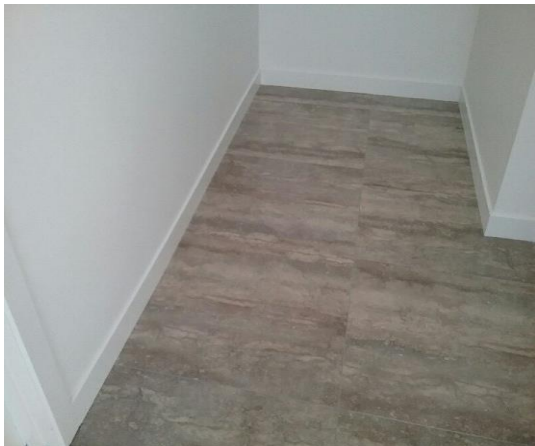
New Stairs- recommend applying sealant to tile/skirting junction to assist in protecting the skirting from moisture damage

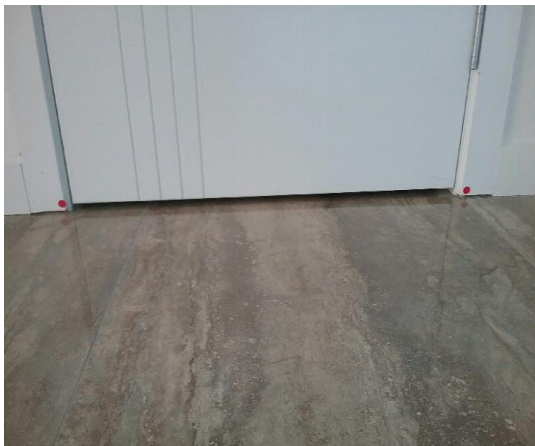
New Stairs- make good short architraves either side of door leading into storage room

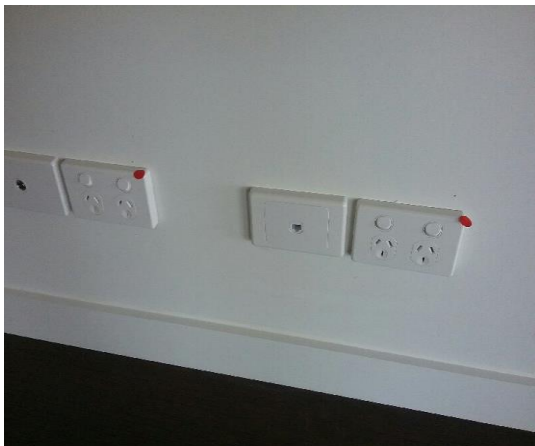
Family- make good loose GPOs

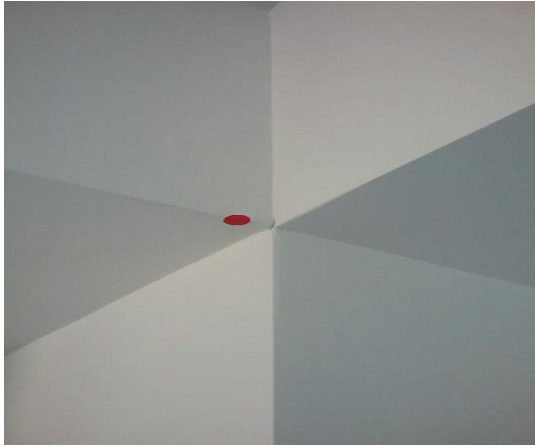
Family- make good plaster blemish to bulkhead, right in the corner

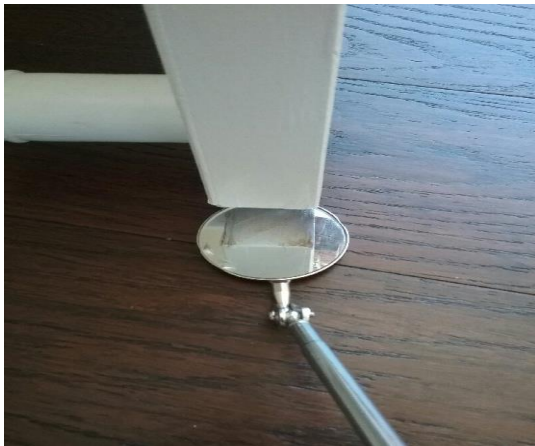
Passage- inadequate paint coverage top & bottom of ext. x 2 doors, make good

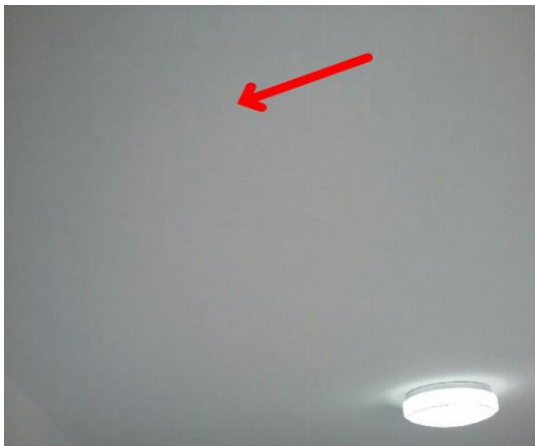
Bed 4- make good plaster blemish on ceiling

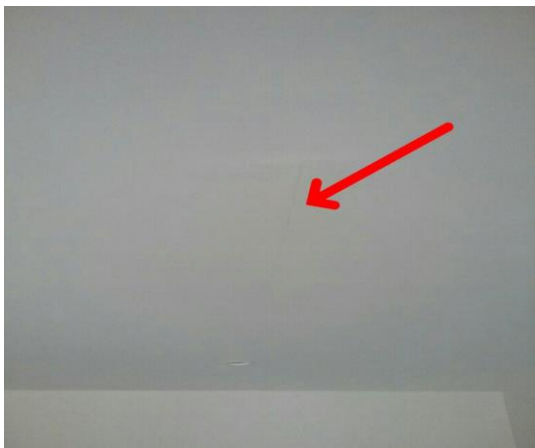
Bed 4- make good crack in ceiling

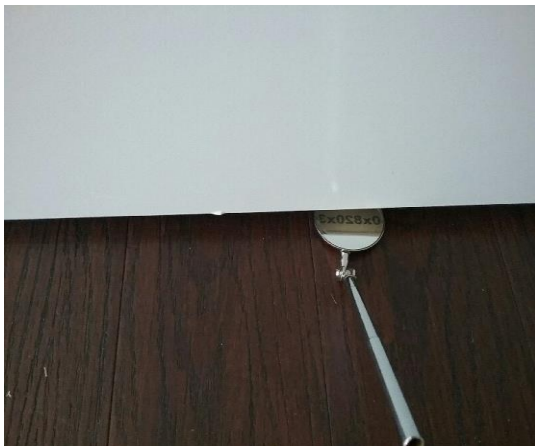
Walk in robe- paint top and bottom of door as required, review all and make good to ALL

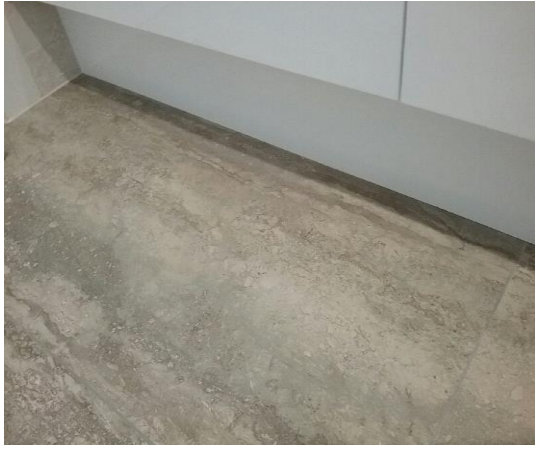
Ensuite 4- apply sealant to protect kickboard face of moisture

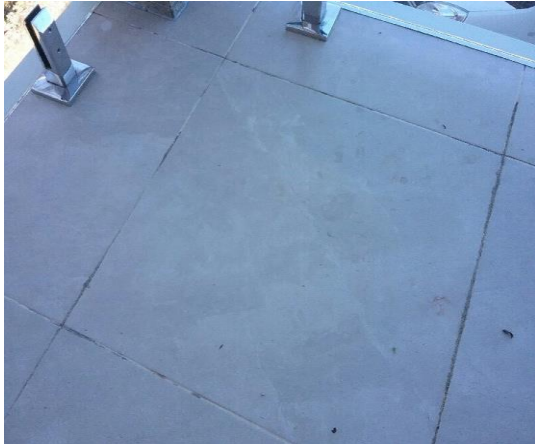
Balcony- grout not consistent and stained in places which may suggest moisture being retained underneath. Make good

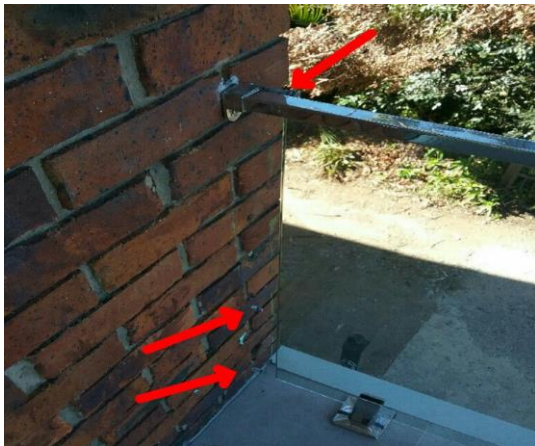
Balcony- remove bolts from wall

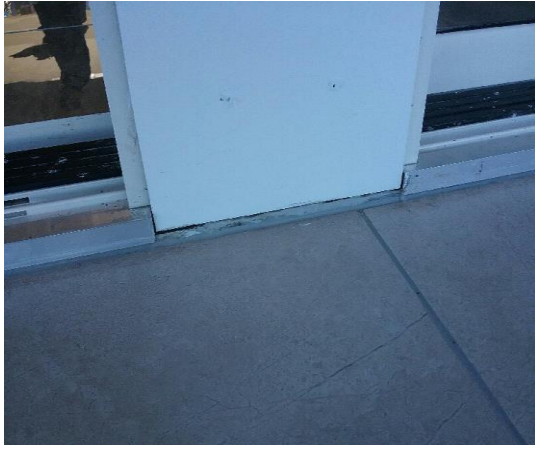
Balcony- make good finish base of cladding between both sliding door

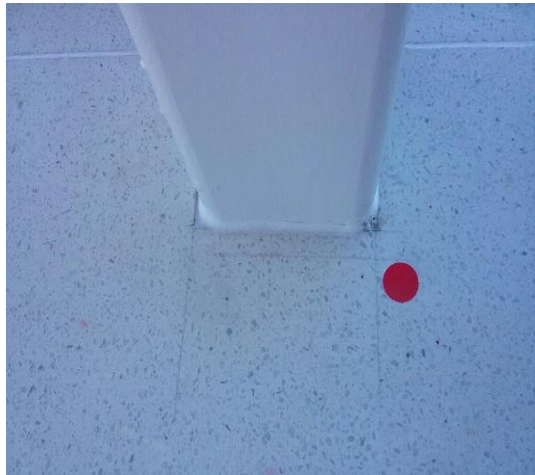
Balcony- remove pencil marks off caeser stone capping. Review all and make good

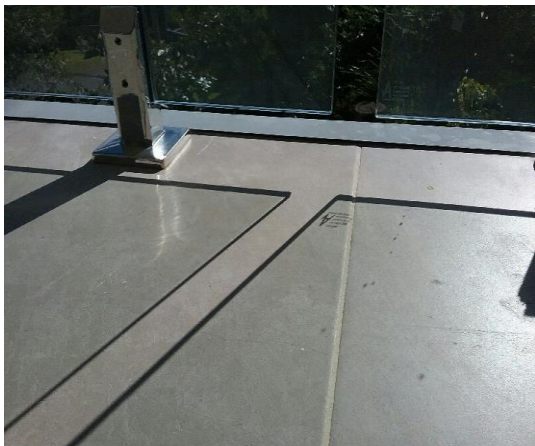
Balcony- metal capping to front edge of tiles is untidy and in particular where they overlap. Make good to all. Unknown if capping is sealed correctly to tiles and will not present moisture issues downstairs in the future. Consult with Builder for clarification and warranties

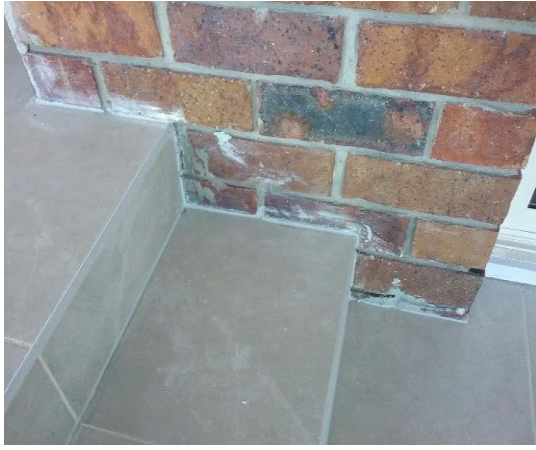
Balcony- make good glue and mortar splatter on face brickwork

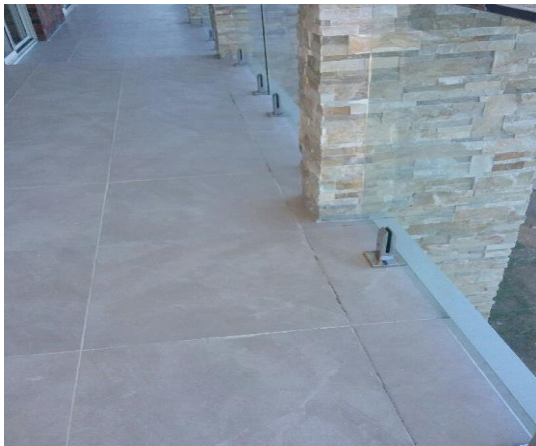
Balcony- grout not consistent and stained in places. Make good

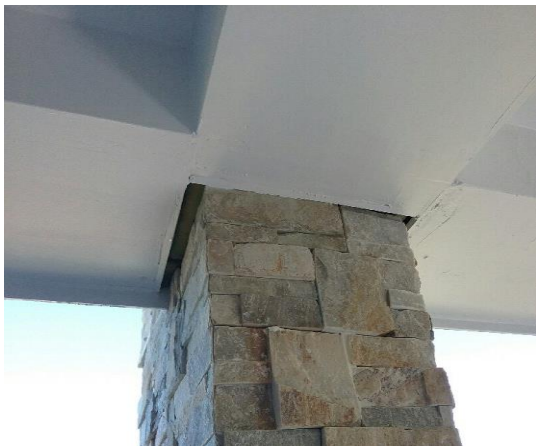
Balcony- finish to ext. bulkheads and ceilings are not finished in a tradesman like manner. Areas are lumpy and have gaps that require filling or trimming prior to painting. Make good to all

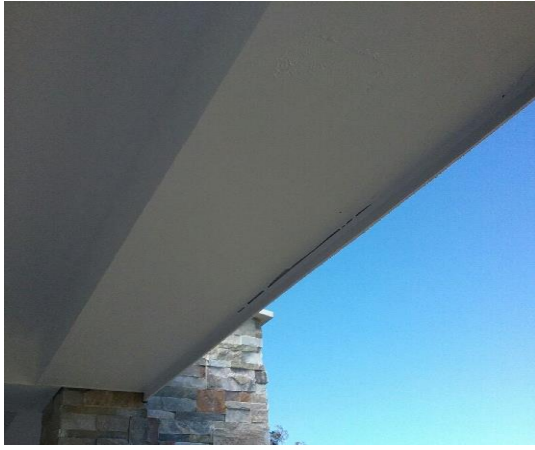
Balcony- finish to ext. bulkheads and ceilings are not finished in a tradesman like manner. Areas are lumpy and have gaps that require filling or trimming prior to painting. Make good to all

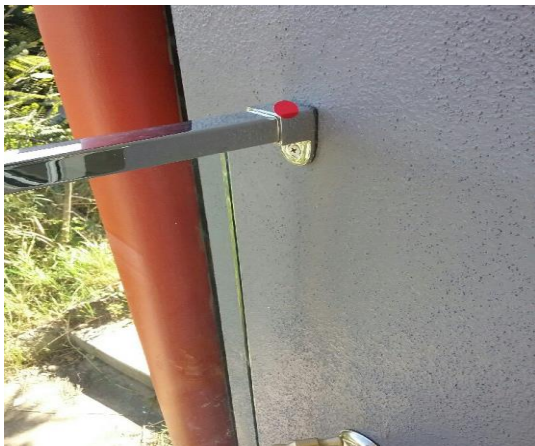
Balcony- make good loose top rail

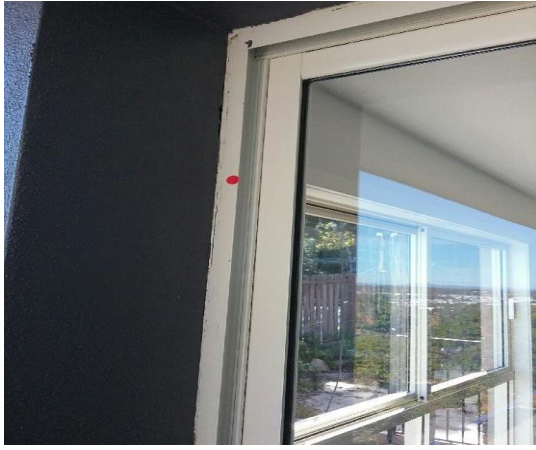
Balcony- make good along aluminium that is against render

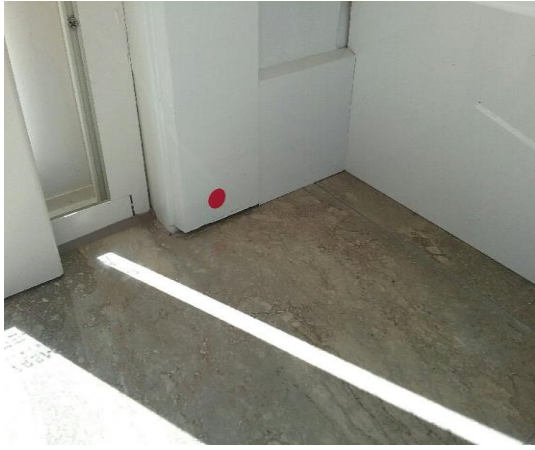
Rear entry- make good short architrave to sliding door

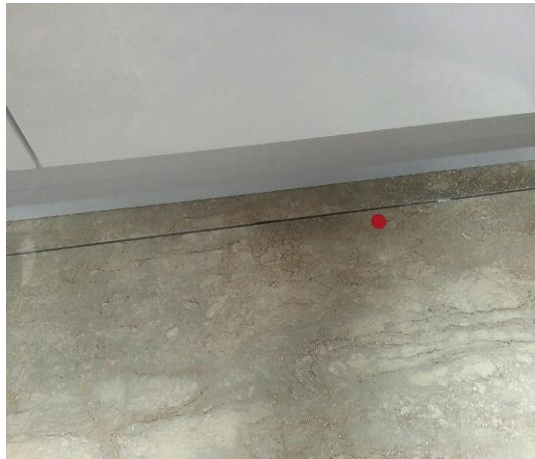
Rear entry- make good missing grout for floor in front of joinery unit

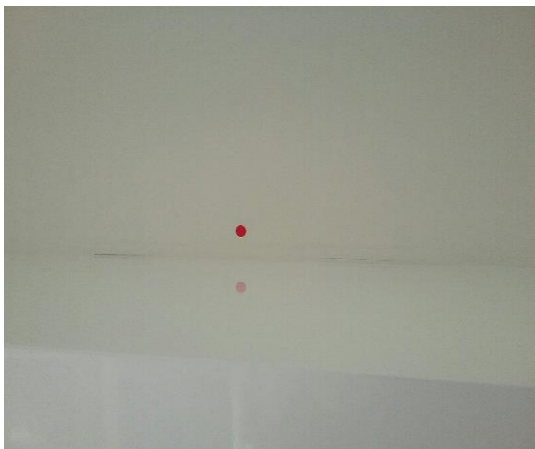
Rear entry- make good untidy finish

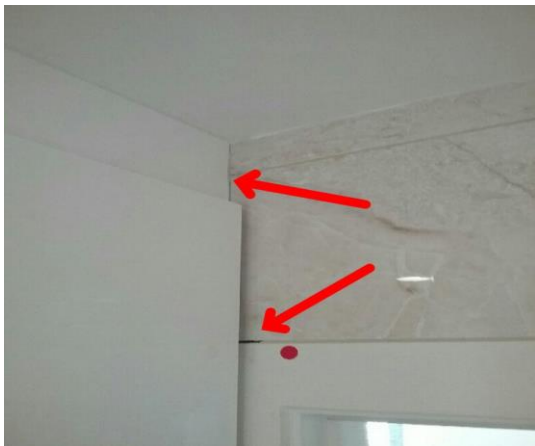
Laundry- make good missing grout above door architrave and internal corner

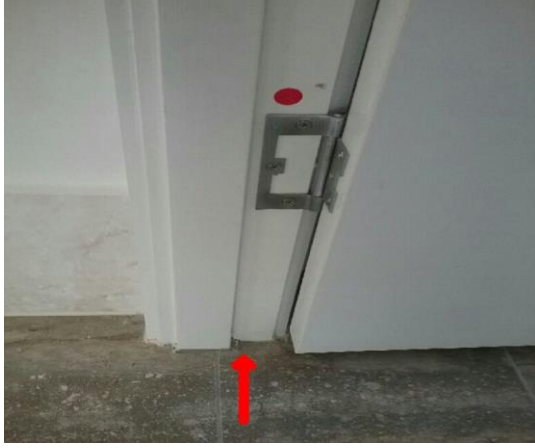
Laundry- missing sealant around door frame and blemish on door jamb, make good

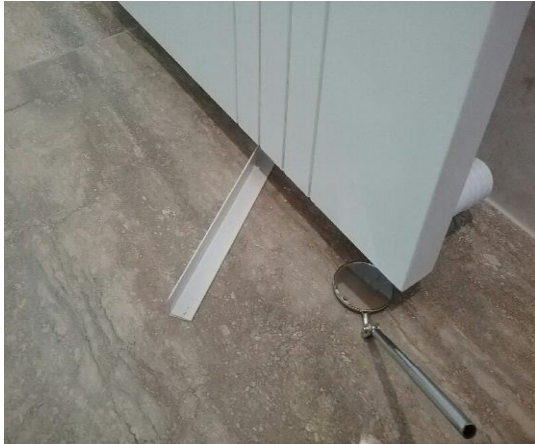
Laundry- excessive gap (>20mm) under door and top and bottom of door not painted, make good to all

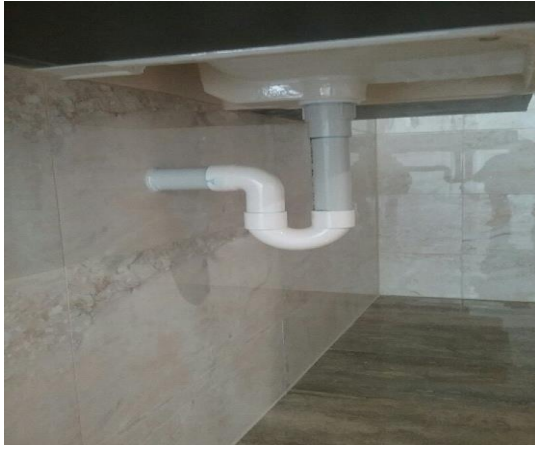
Powder Room- recommend painting exposed waste pipe under vanity one colour

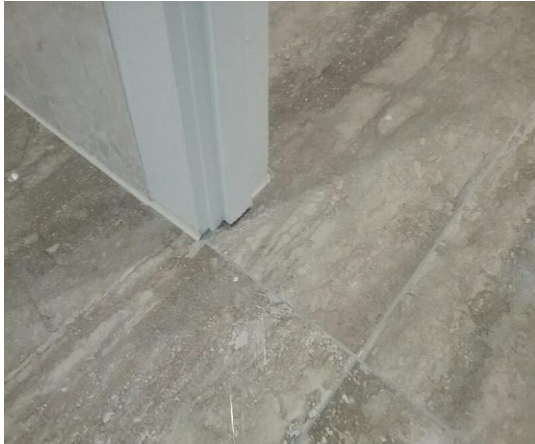
Powder Room- missing sealant around door frame, make good

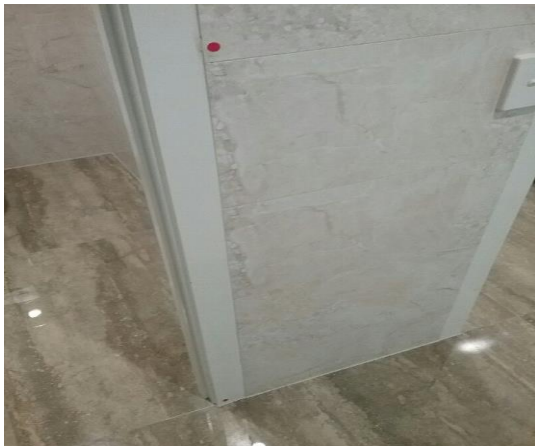
Powder room- make good crack in grout along architrave and clean off excessive grout from surfaces

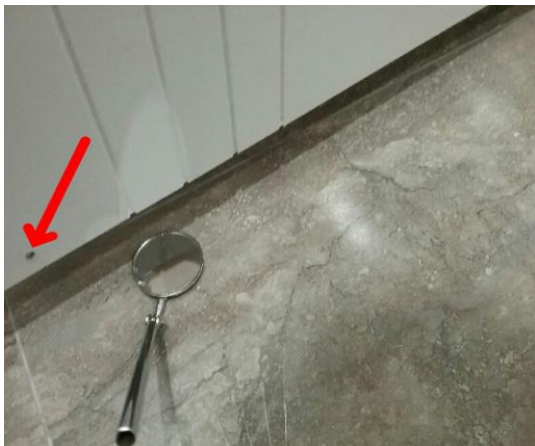
WC- Urinal- excessive gap (>20mm) under door, top and bottom of door not painted and hole in face of door, make good to all

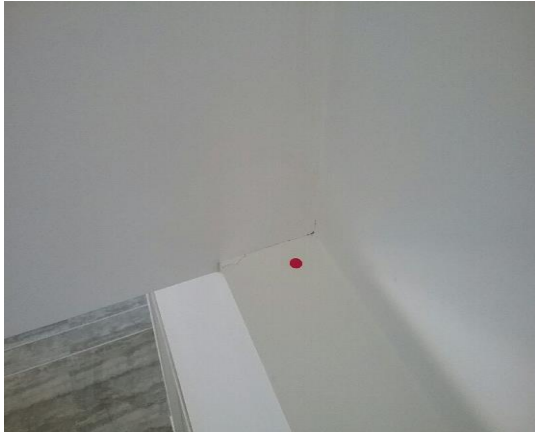
New stairs- make good crack in plaster

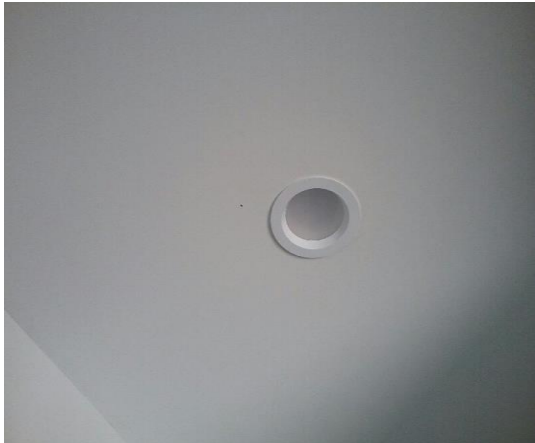
New stairs- make good hole on ceiling next to light fitting

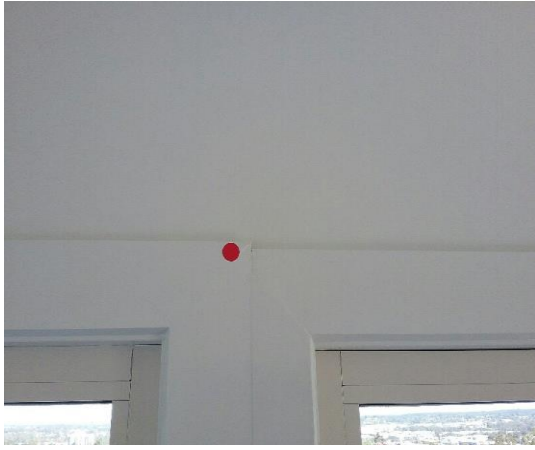
Mezzanine- make good misaligned architrave along the southern wall

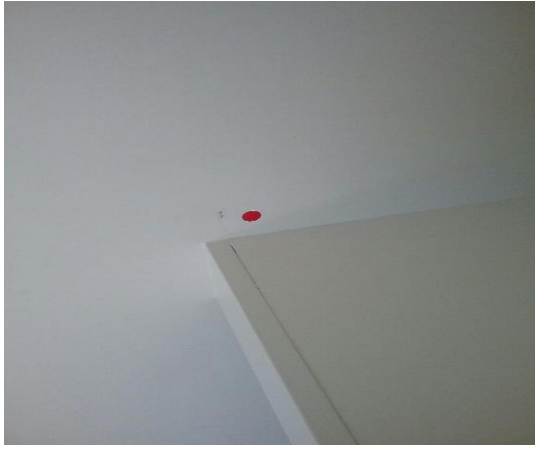
Walk in robe- make good gaps to shelving and end timber trim RHS

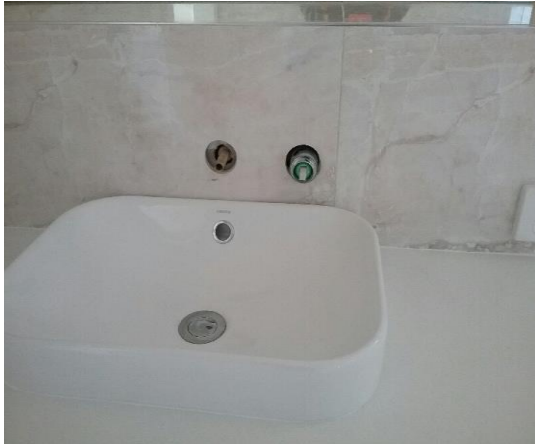
Ensuite- install missing tap and spout for vanity

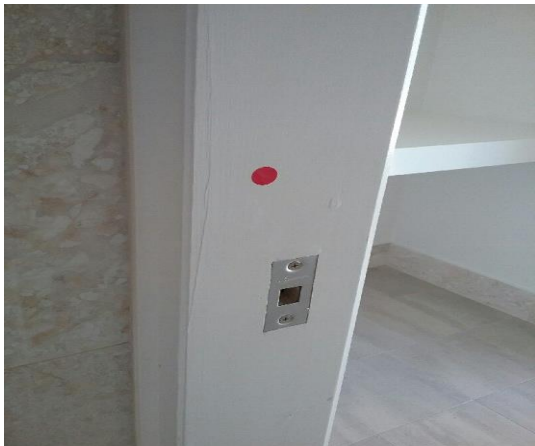
Ensuite- make good blemishes on timber frame

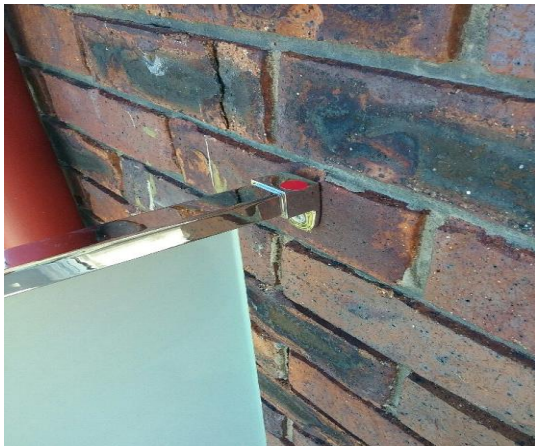
Deck- top rail to glass handrail loose, make good

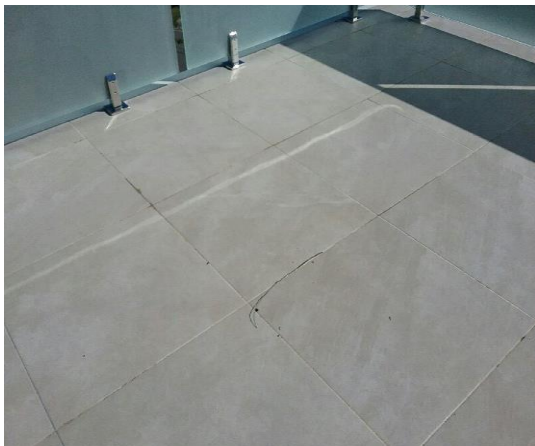
Deck- grout not consistent in colour and stained in places which may suggest moisture being retained underneath. Make good

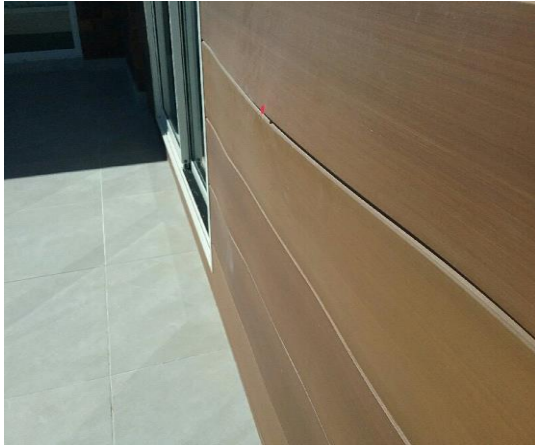
Deck- some panels of the PVC cladding are bowed, make good to all

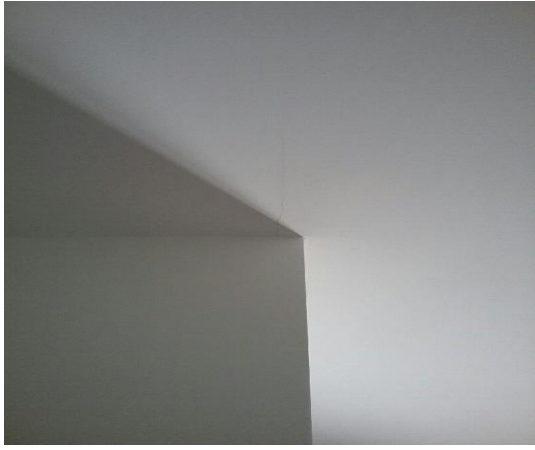
Bed 3- make good noticeable crack in ceiling

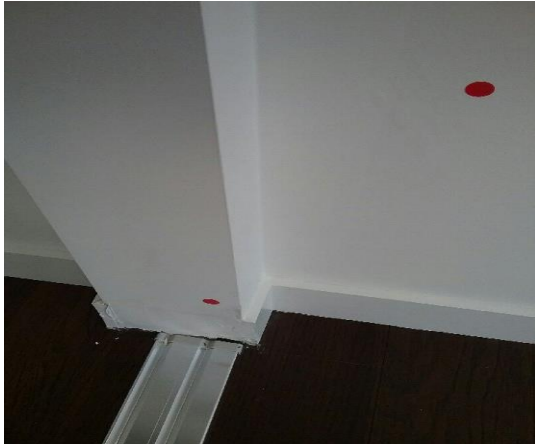
Bed 3- make good poor finish at robe track RHS and blemish on wall

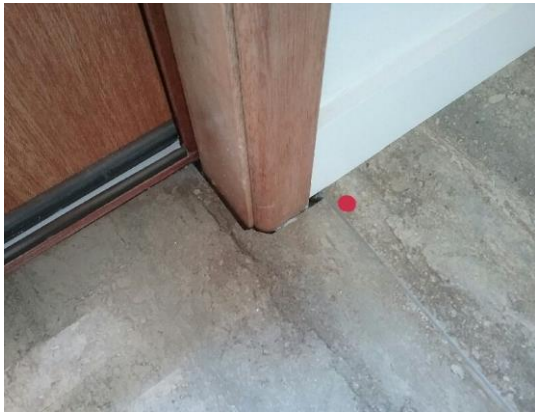
Entry- missing sealant around door frame L&RHS

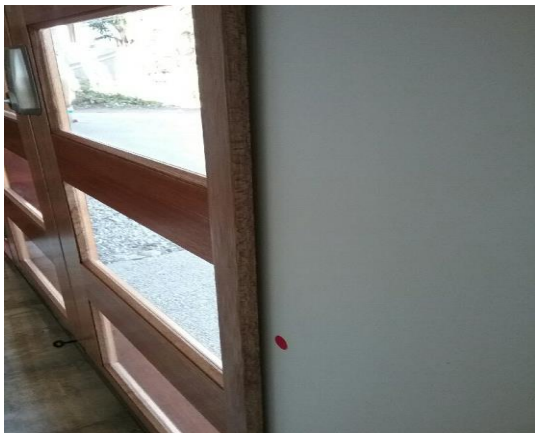
Entry- make good gap around architrave and apply final coats of varnish to timber frame.

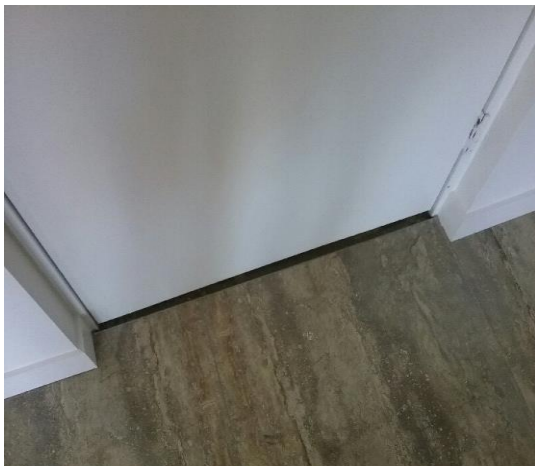
Entry- tiles have been finished off prior to door and not under door as per best practise, make good

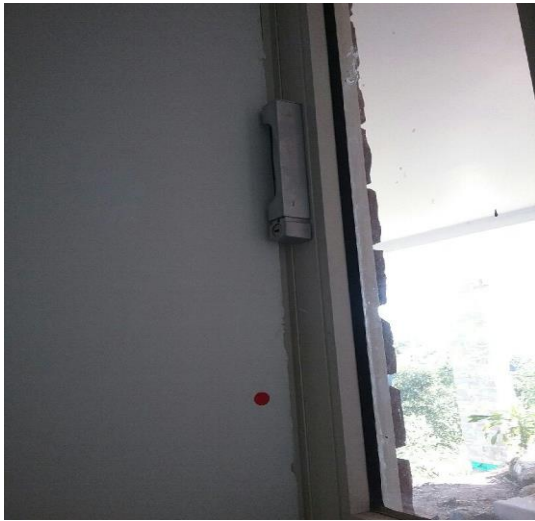
Storeroom- make good finish to plaster around window

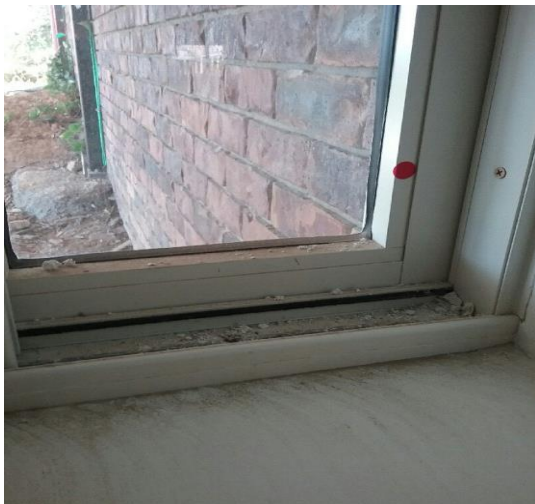
Storeroom- remove builder's debris from window sill

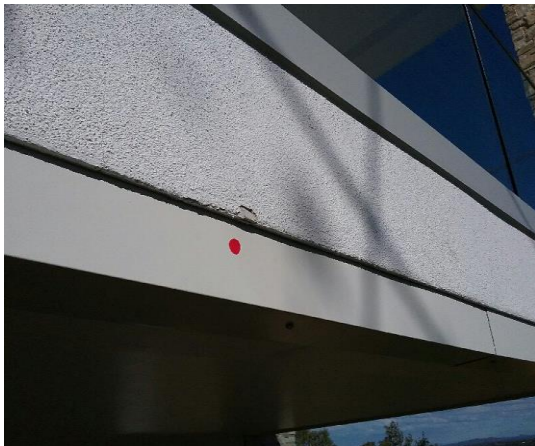
Left elevation- make good damage to edge on fibrous board

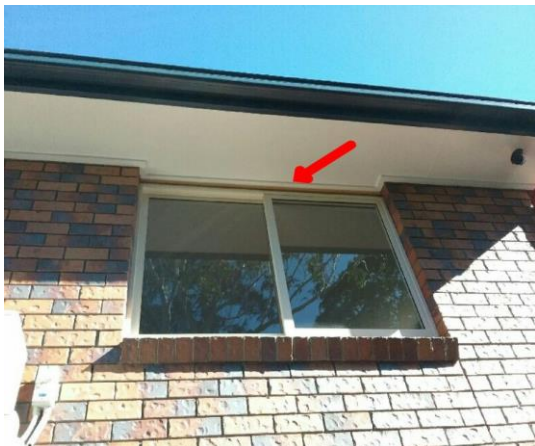
Rear elevation- complete painting of trim above window

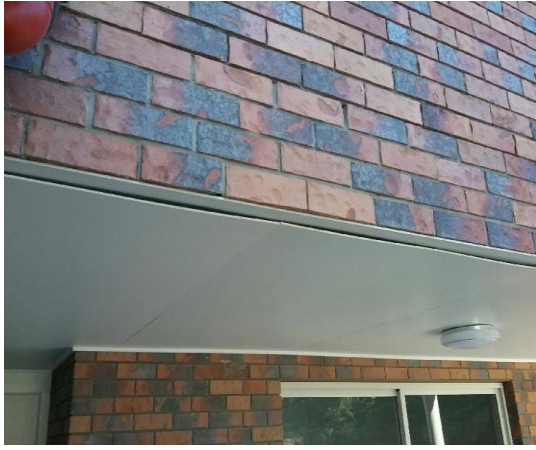
Rear elevation- make good gap to soffit sheets

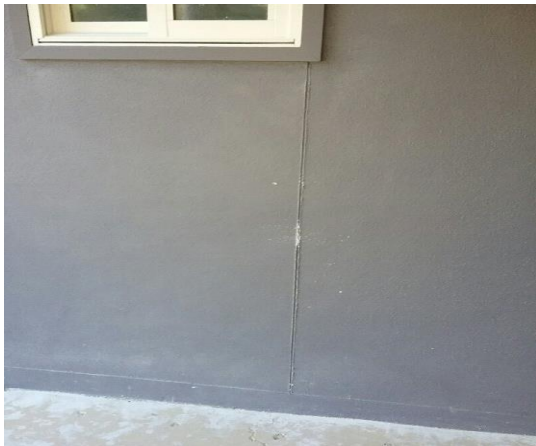
Rear elevation- make good damage to render at control joint

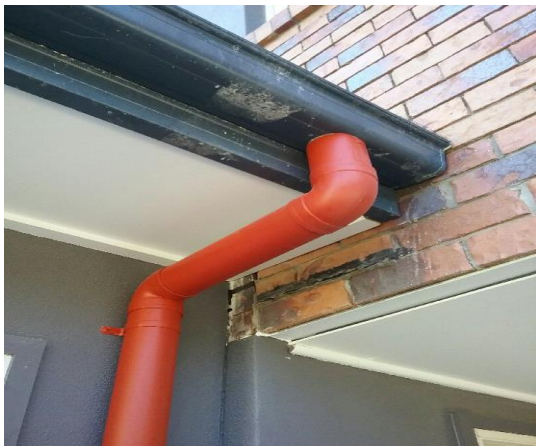
Rear elevation- clean down builders grime from gutter and fascia

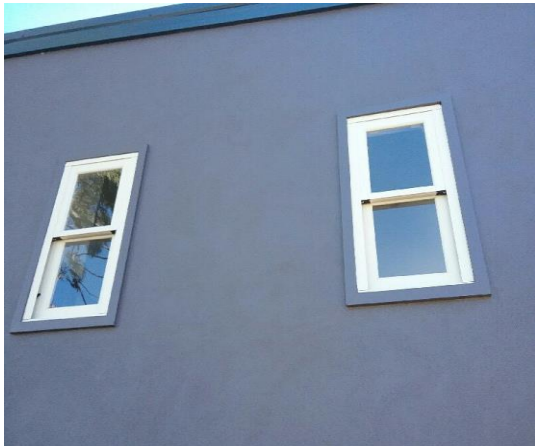
Right elevation- flashing missing from windows as required and recommended, make good
