# Handover Inspection Report

Rosedale South, Qld, 4123

**Date of Inspection:** 19/07/2017

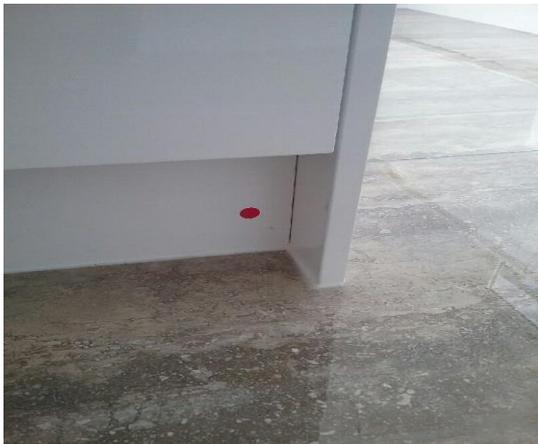
Kitchen- fill gaps to internal corners of kickboard, widespread. Review all and make good

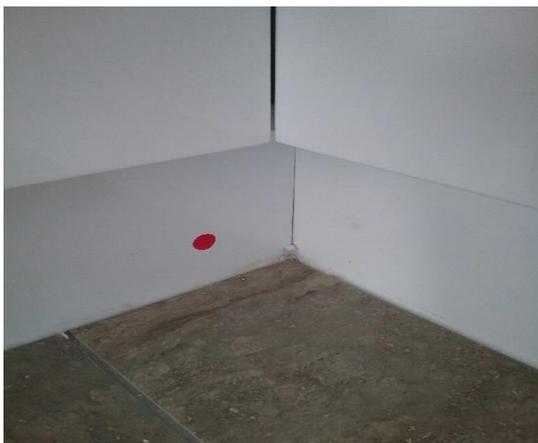
As above

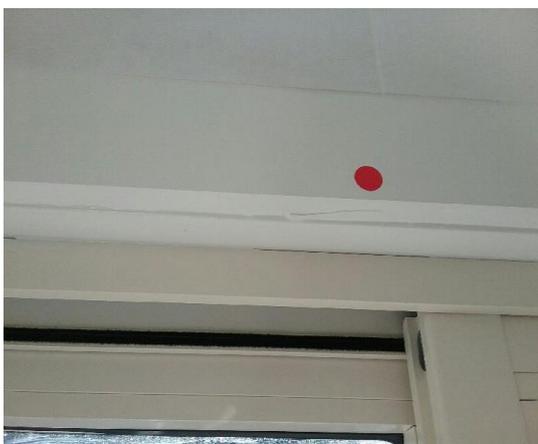
Kitchen- make good split in architrave to window above sink

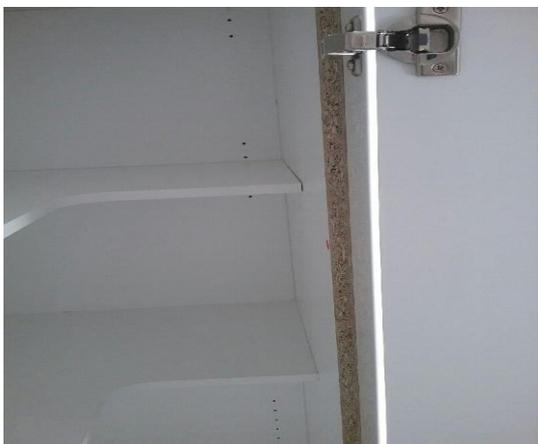
Kitchen- install edge strip to joinery panel in pantry

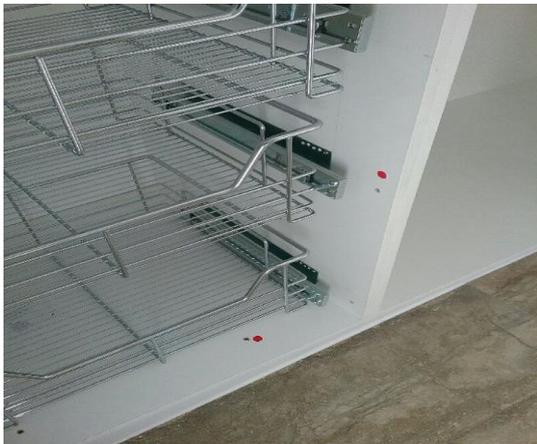
Kitchen- insert screws so as to be flush and cap off exposed screws. Widespread, review all and make good

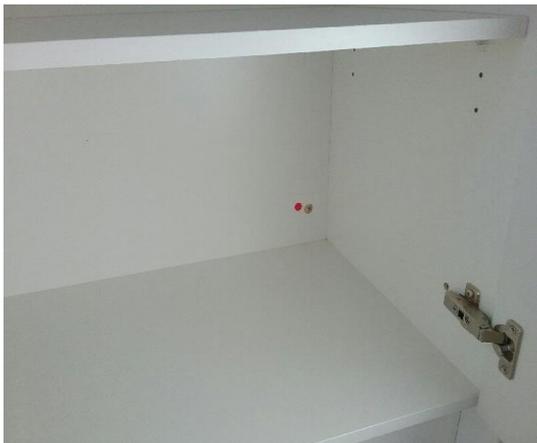
Kitchen- as above

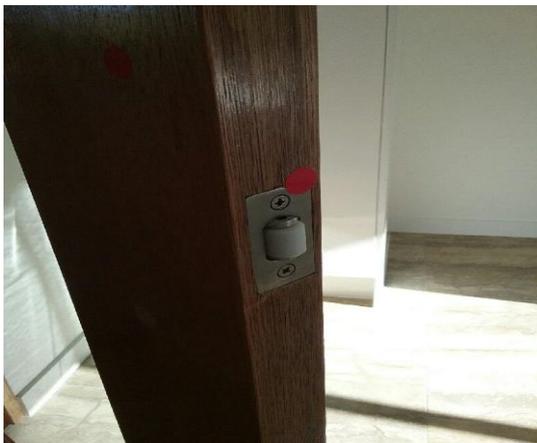
Kitchen- double door are difficult to close and open, ease spring to roll latch

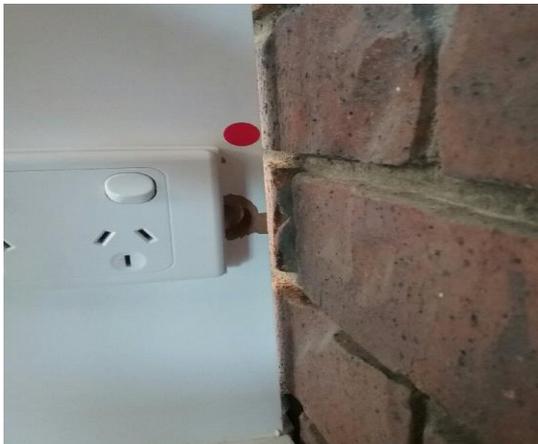
Dining- make good hole in joinery panel RHS of GPO

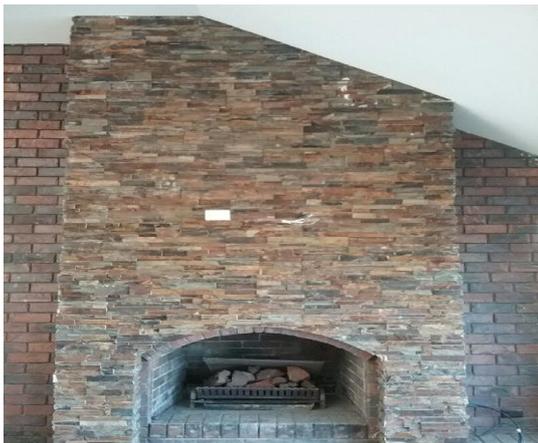
Dining- clean down plaster droppings from face brick

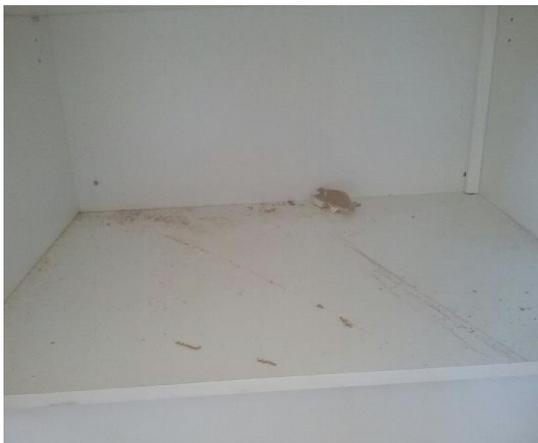
Dining- island bench- review all cupboards, cap off screws and clean out

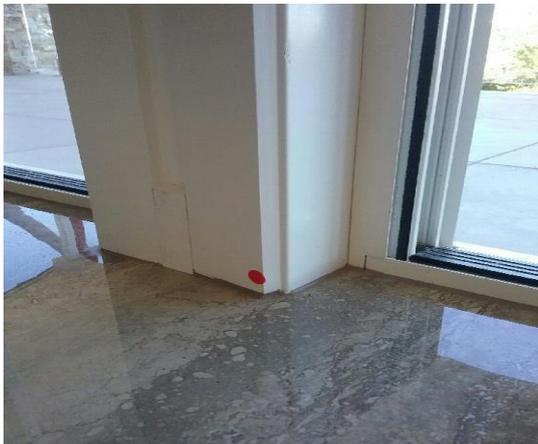
Living – make good short architrave and tidy up sealant

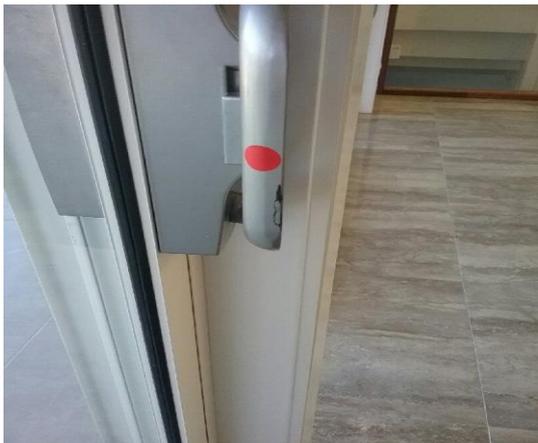
Living- make good scratch sliding door handle

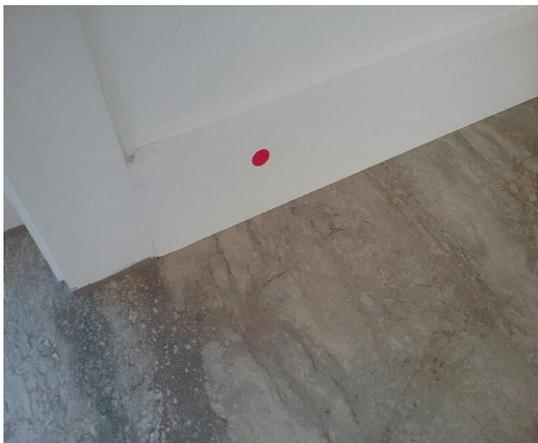
Living- install sealant to tile/skirt junction to give a consistent finish through out

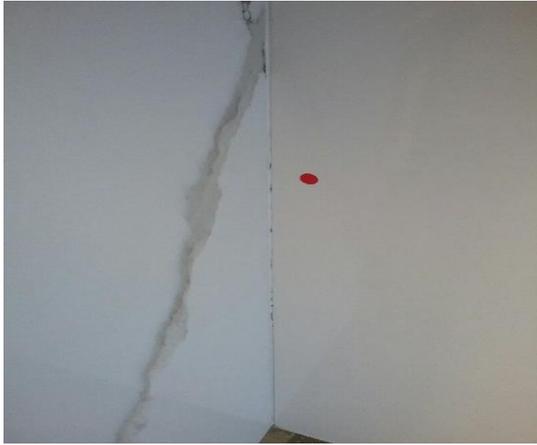
Dining- make good poor finish to fill to island bench LHS

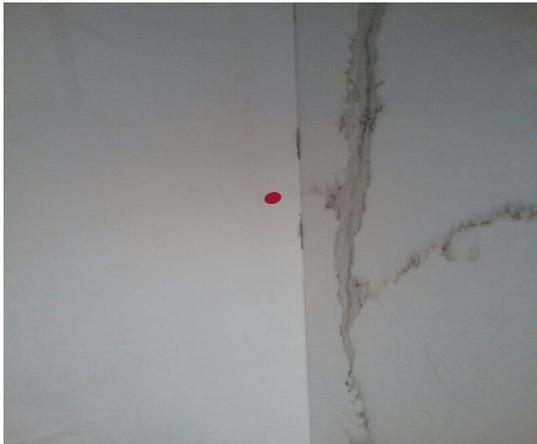
Dining- make good poor finish to fill to island bench RHS

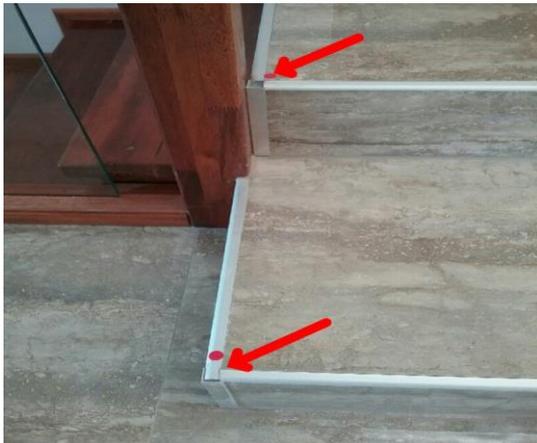
New Stairs- entry steps- make good poor finish to tile metal edge mitres. Unsatisfactory workmanship

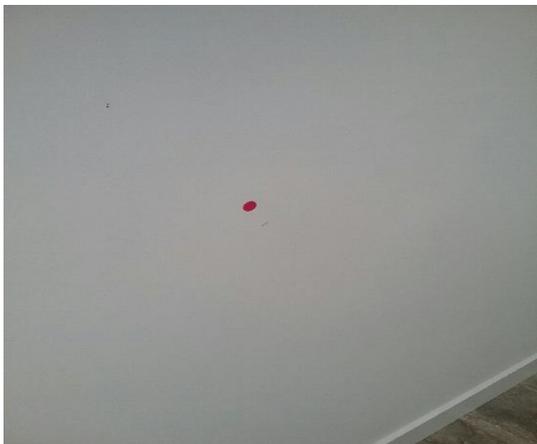
New Stairs- make good blemish on wall

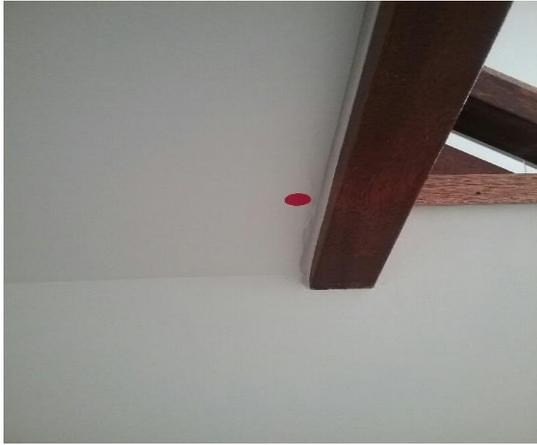
New Stairs- make good plaster blemish both sides on ceiling

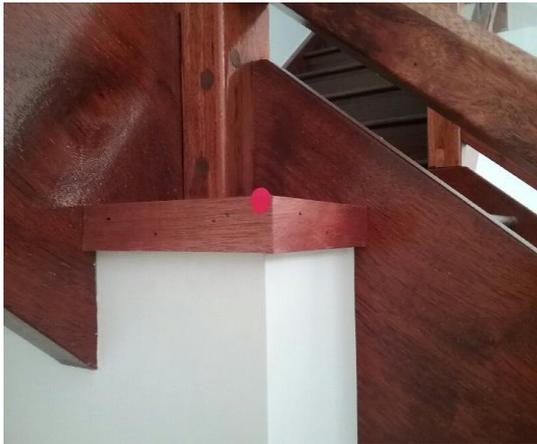
New Stairs- make good by filling holes & completing the clear coating on timber trim, both sides of the stairs

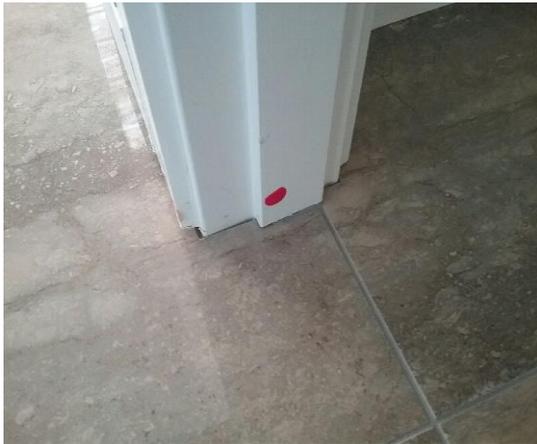
Stairs- storage- incomplete application of sealant around door frame, make good

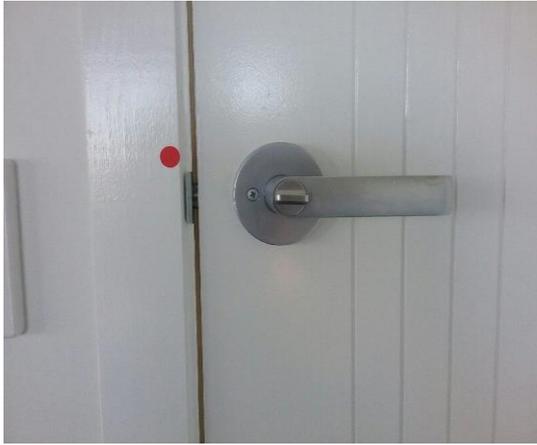
Study- excessive play in striker, make good

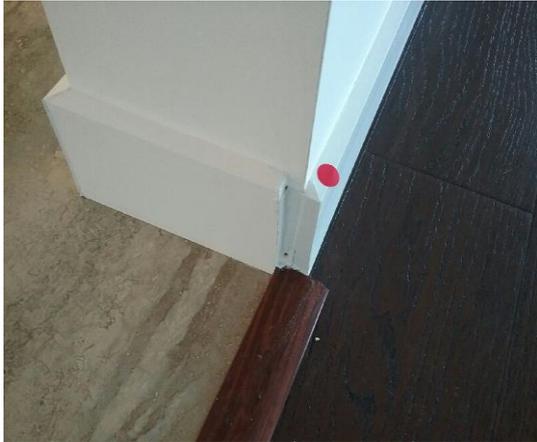
Family- make good poor finish/workmanship to skirting

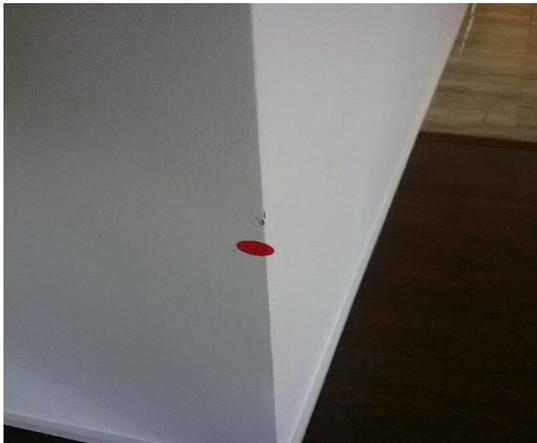
Family- make good paint blemish on ext. corner of wall

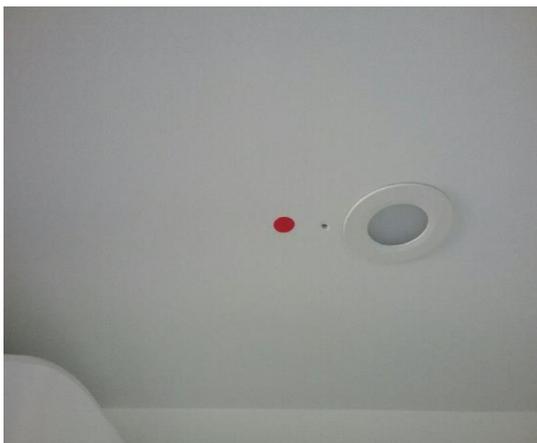
Family- make good hole next to light fitting RHS of A/C

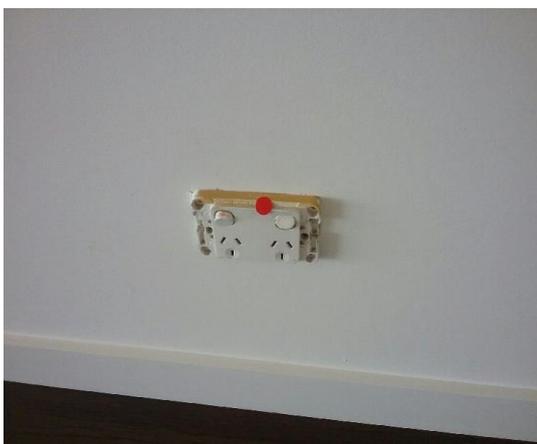
Family- install cover to GPO

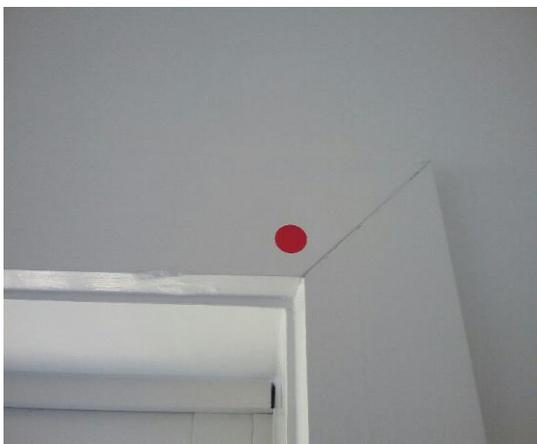
Family- make good chip in architrave and align mitre so as it is flush

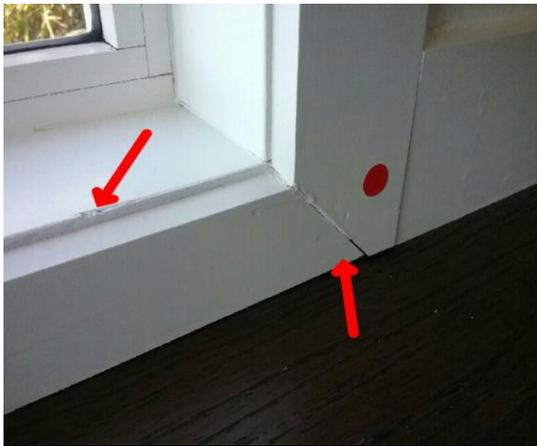
Family- make good chip in reveal and rectify poor finish to mitre

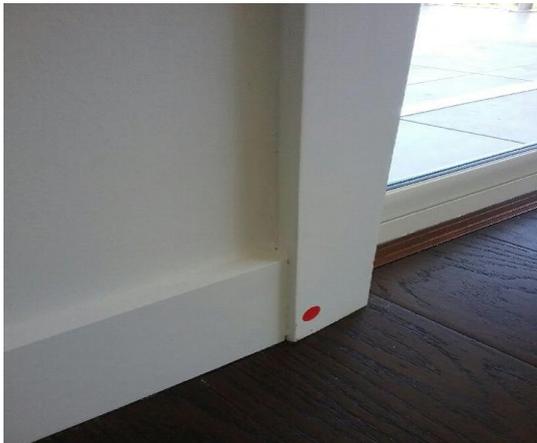
Family- make good connection of architrave and skirting (make flush) consistent with others

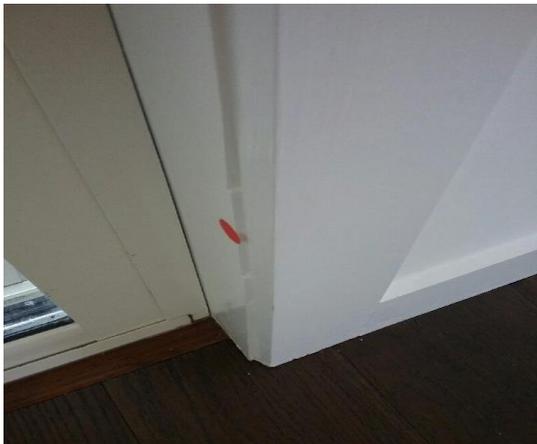
Family- make good chipped reveal of window frame

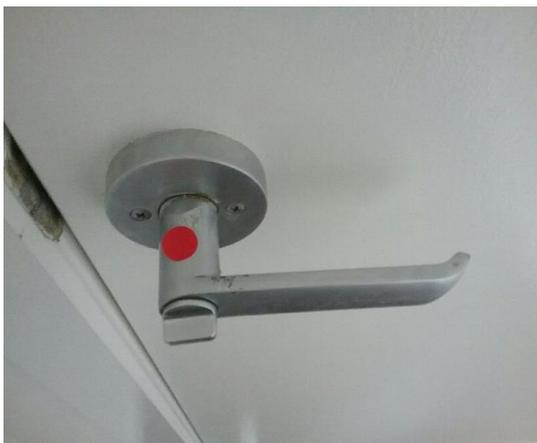
Passage- make good scratches on handle, RHS

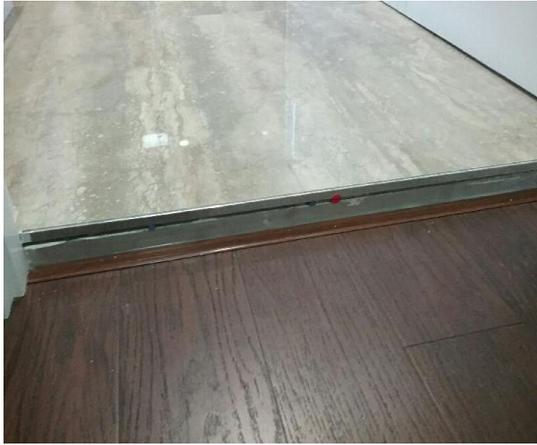
Ensuite 4- make good aluminium edge of tiles and remove wedges

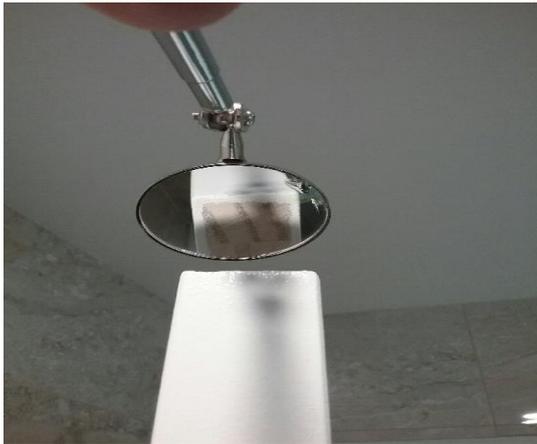
Ensuite 4- paint top and bottom of door as required, review all and make good to ALL

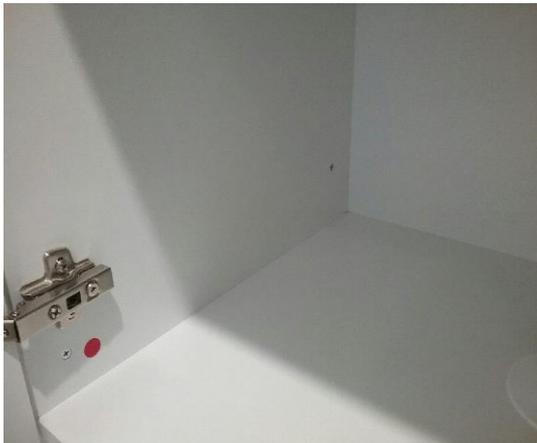
Ensuite 4- cap all exposed screws in joinery. Review all and make good

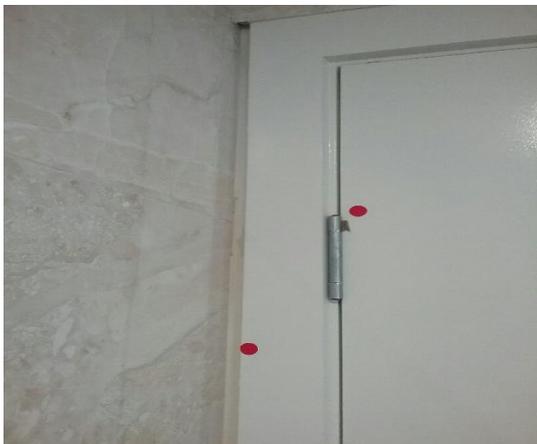
Ensuite 4- make good gap LHS of door (no tile currently) to a tradesman like manner. Make good chip in door face adjacent hinge

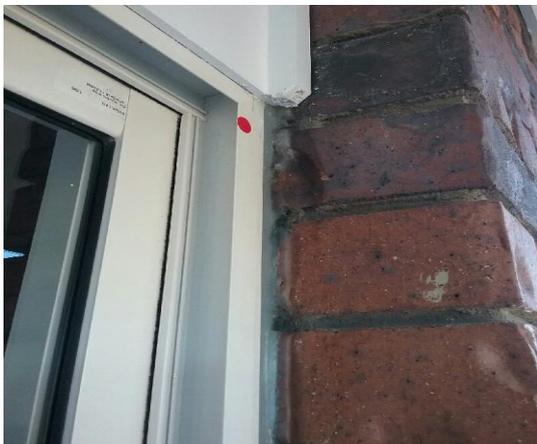
Balcony- silicon applied lumpy, untidy and smeared on face brickwork, make good

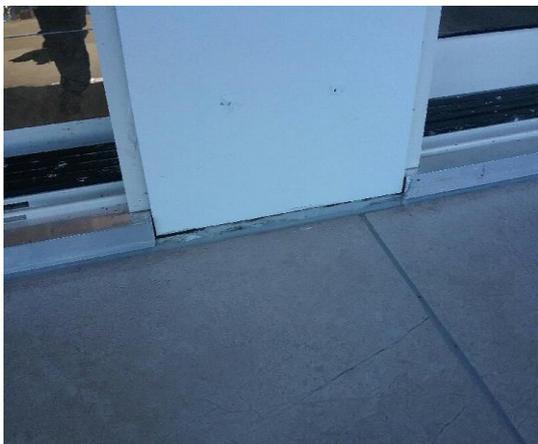
Balcony- make good finish base of cladding between both sliding door

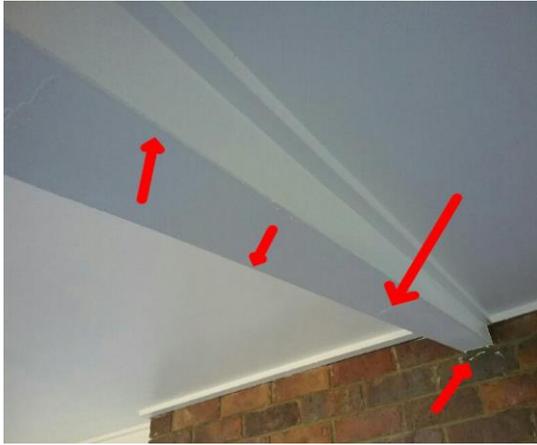
Balcony- finish to ext. bulkheads and ceilings are not finished off in a tradesman like manner. Areas are lumpy and have not been sanded prior to painting. Make good to all

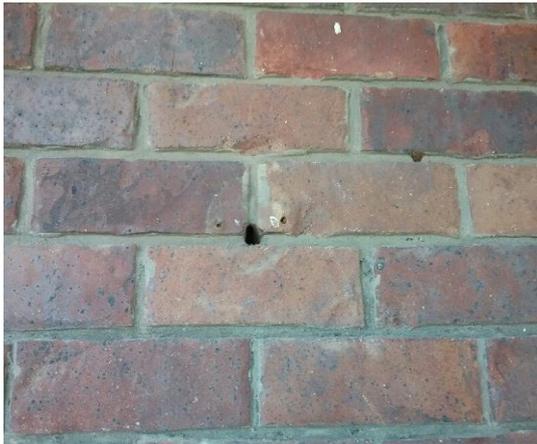
Balcony- fill hole to face brickwork

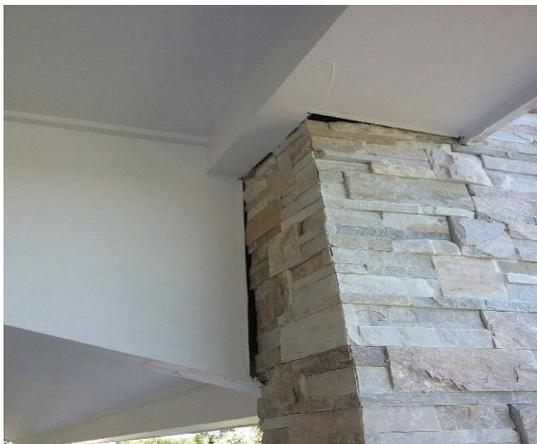
Balcony- finish to ext. bulkheads and ceilings are not finished in a tradesman like manner. Areas are lumpy and have gaps that require filling or trimming prior to painting. Make good to all

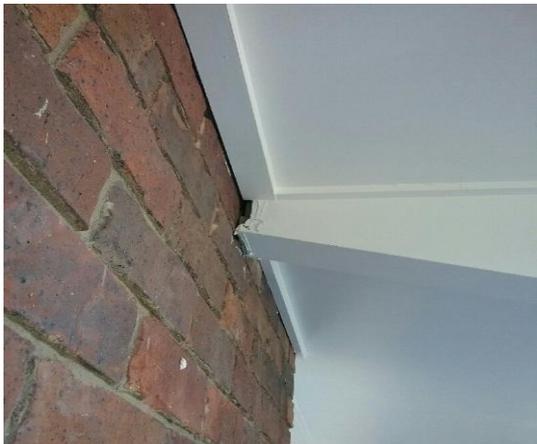
Balcony- finish to ext. bulkheads and ceilings are not finished in a tradesman like manner. Areas are lumpy and have gaps that require filling or trimming prior to painting. Make good to all

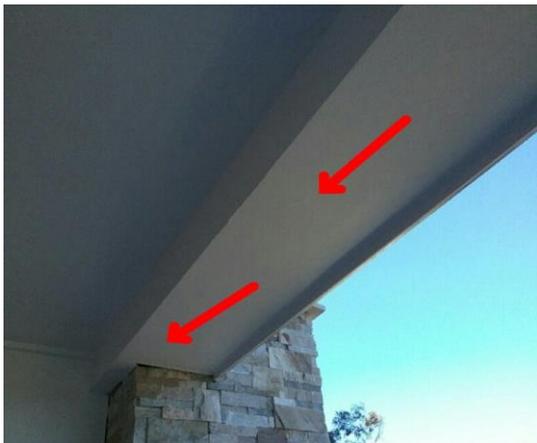
Balcony- finish to ext. bulkheads and ceilings are not finished off in a tradesman like manner. Areas are lumpy and have not been sanded prior to painting. Make good to all

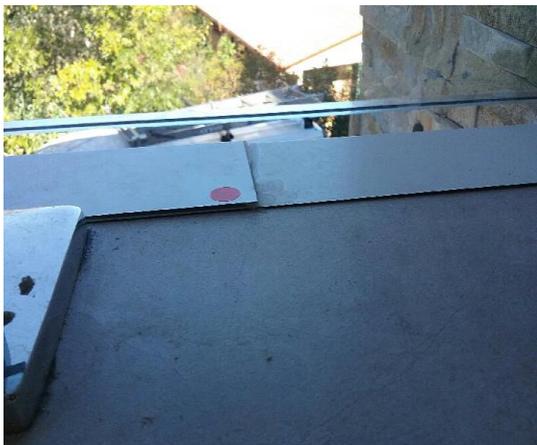
Balcony- metal capping to front edge of tiles is untidy and in particular where they overlap. Make good to all

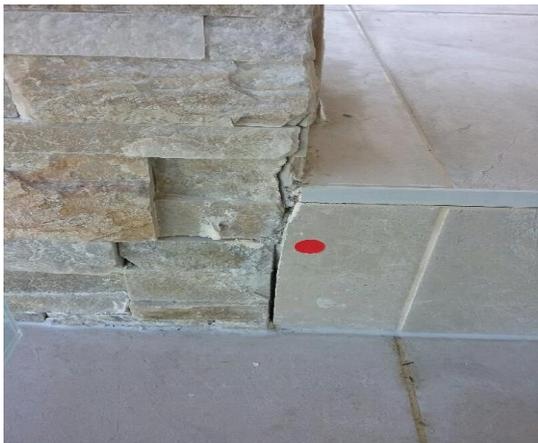
Balcony- make good gap to tiles

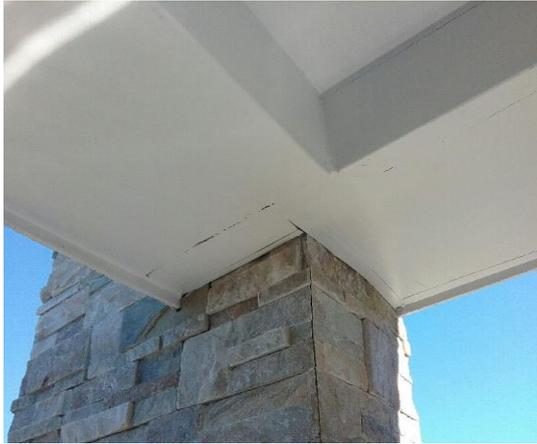
Balcony- finish to ext. bulkheads and ceilings are not finished in a tradesman like manner. Areas are lumpy and have gaps that require filling or trimming prior to painting. Make good to all

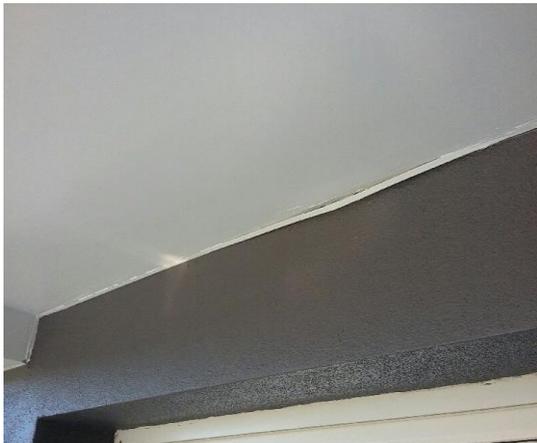
Balcony- finish to ext. bulkheads and ceilings are not finished in a tradesman like manner. Areas are lumpy and have gaps that require filling or trimming prior to painting. Make good to all

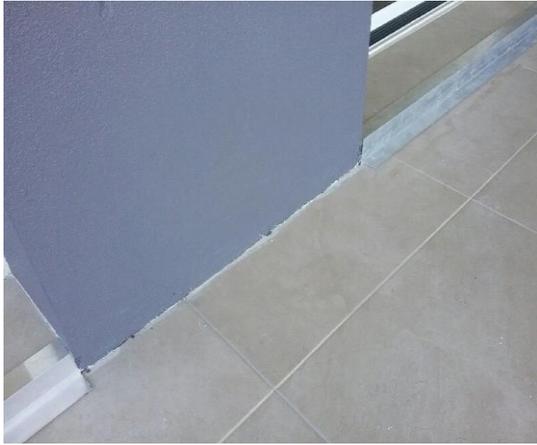
Balcony- sharpen finish to render and tile junctions.  
Remove all silicon smears on tiles.

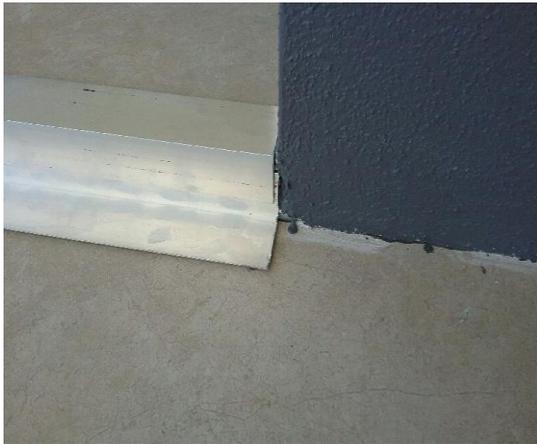
Balcony- make good hole visible RHS of the capping

**NOTE:** not clear why this aluminium angle is in place?  
Means of fixing of capping may present a water entry issue  
in the future and consideration should be taken to ensure  
ALL certificates and guarantees are presented by the  
Builder. Consult with Builder for clarification

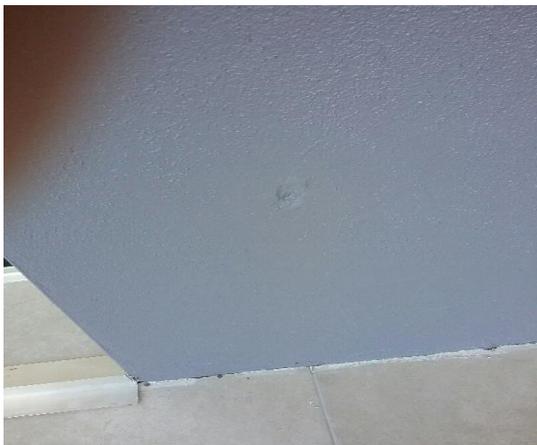
Balcony- sharpen finish to render and tile junctions and fill  
dent in render. Make good to all

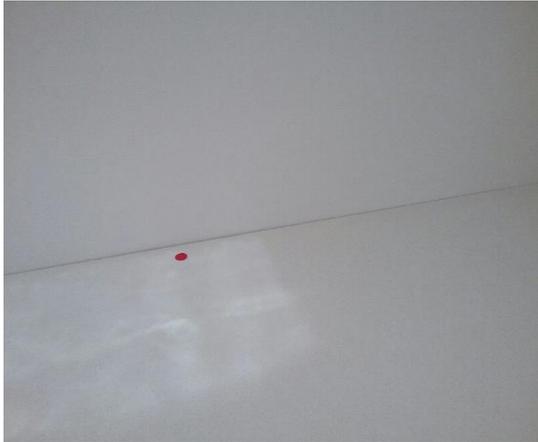
Rear entry- apply sealant to wall/bench top junction

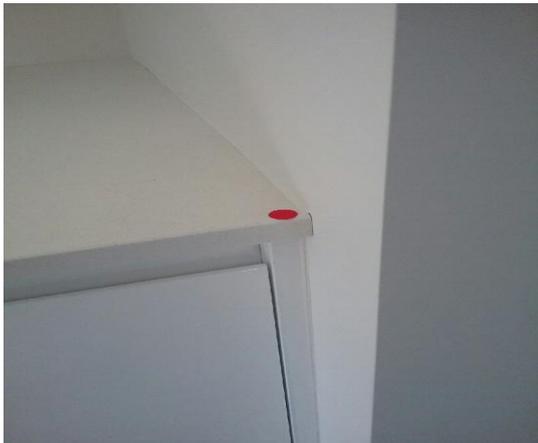
Rear entry- make good gap down face of caeser stone bench top

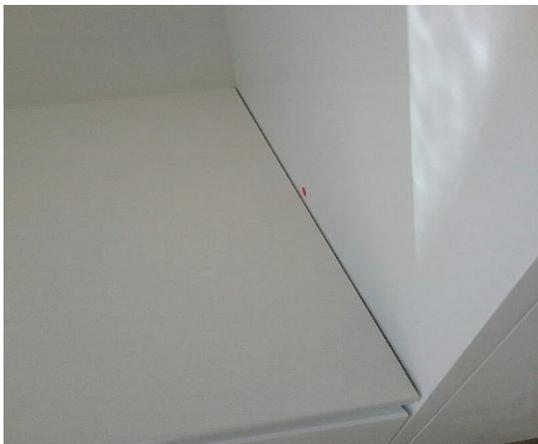
Rear entry- apply sealant to joinery panel/bench top junction

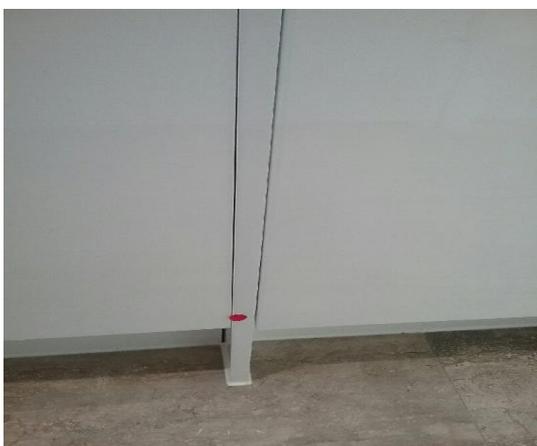
Laundry- maker good clashing draws

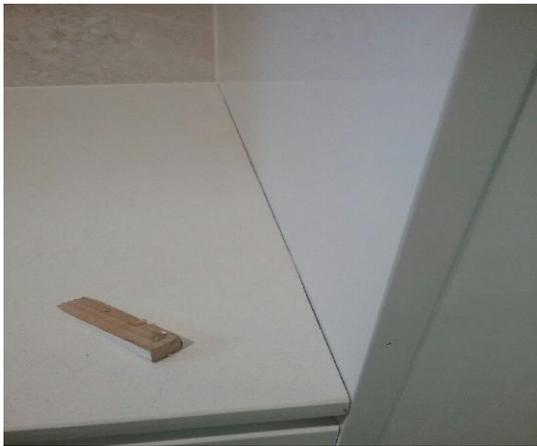
Laundry- gap fill bench top to joinery panel

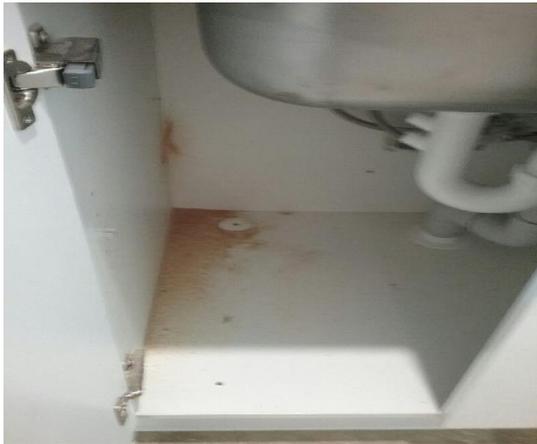
Laundry- clean out cupboard of builder's debris and tidy up hole drilled in unit in joinery panel

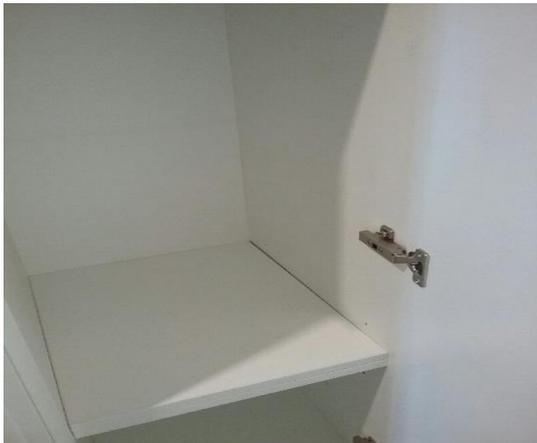
Laundry- more shelf brackets are required so to install shelf

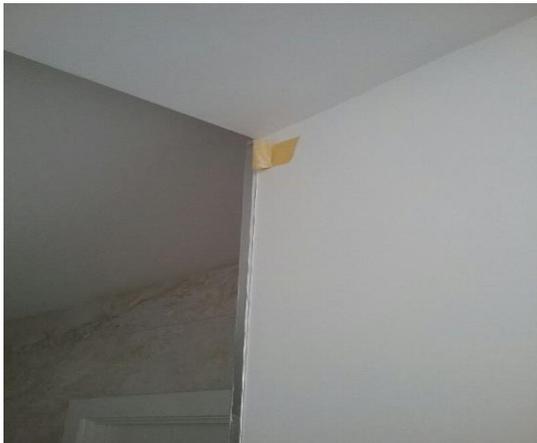
Powder Room- tile trim extrusion proud of wall, make good

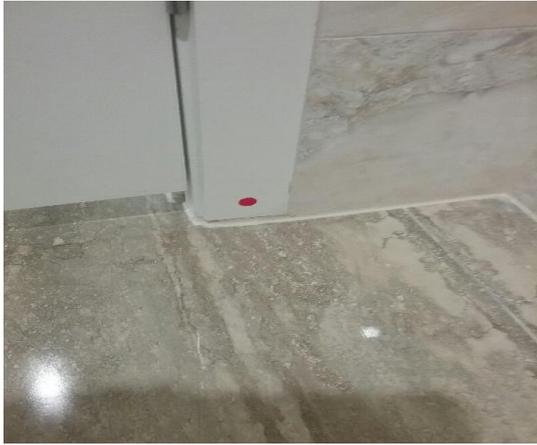
WC- Toilet- make good short architrave

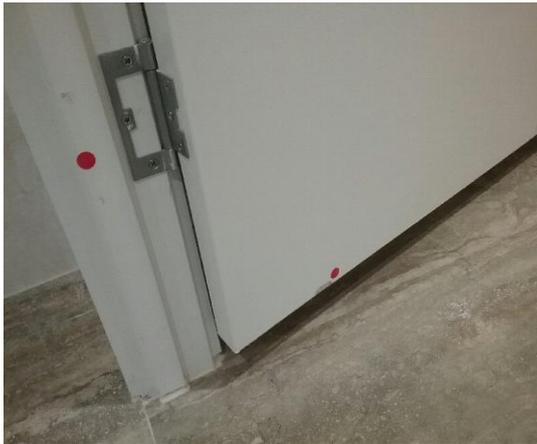
WC- Toilet- excessive gap (>20mm) under door, top and bottom of door not painted and blemishes on face of door and door jamb, make good to all

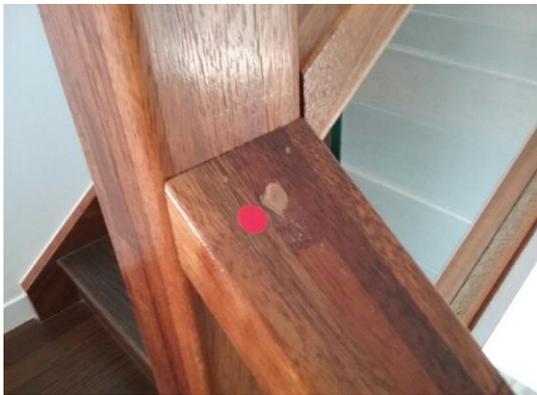
New stairs- make good poor finish and colour of filler on handrails and posts in general

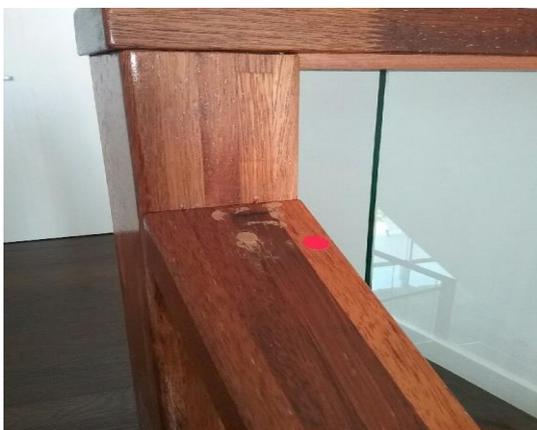
New stairs- make good poor finish and colour of filler on handrails and posts in general

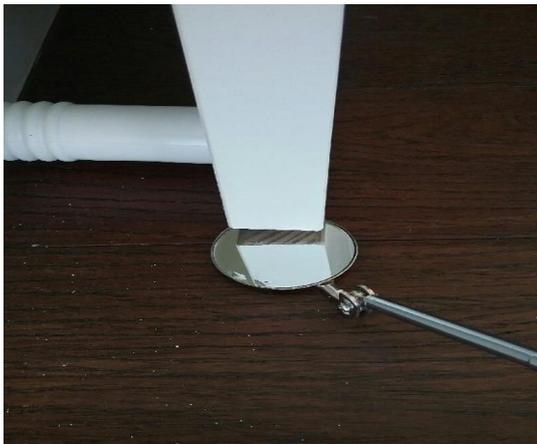
Mezzanine- paint top and bottom of doors as required

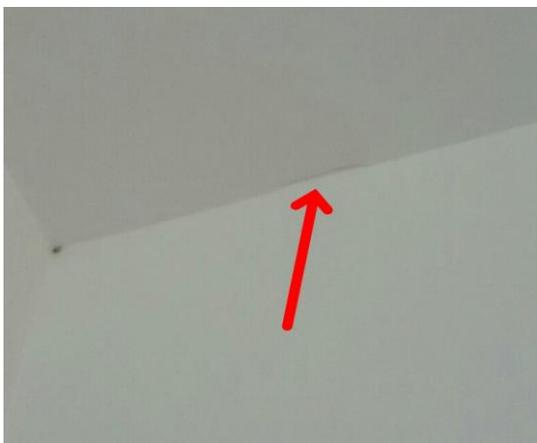
Mezzanine- make good plaster blemish to ceiling in square set corner

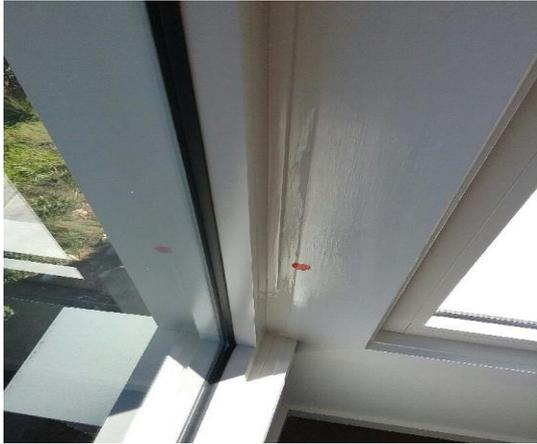
Mezzanine- make good inconsistent finish to timber trim/jamb

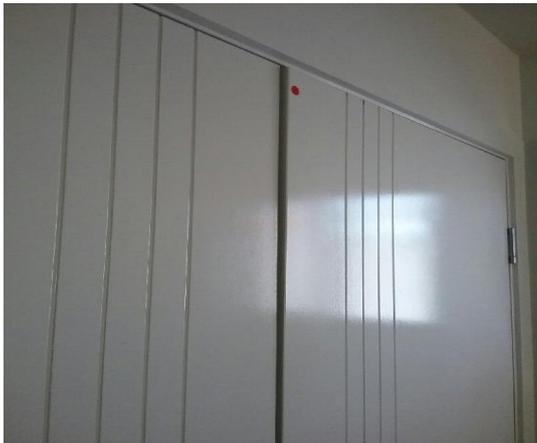
Gallery- make good misaligned doors, reduce gap in centre. Currently greater than 5mm

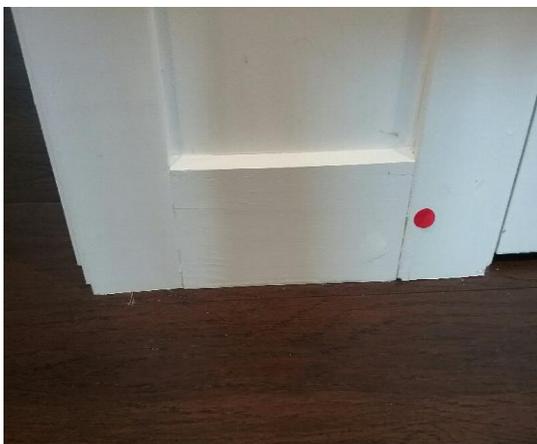
Gallery- make good finish to skirting fill LHS of the pair of doors

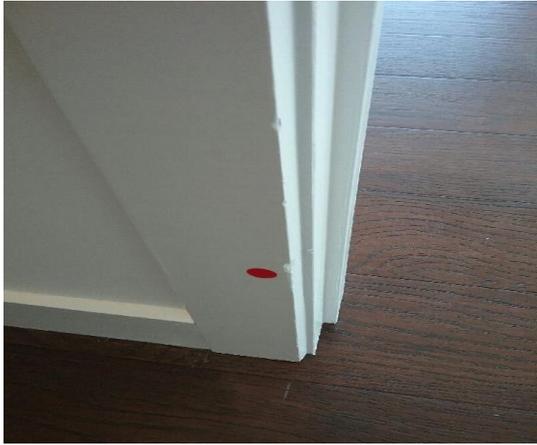
Bed 1- make good blemishes on door frame and architraves

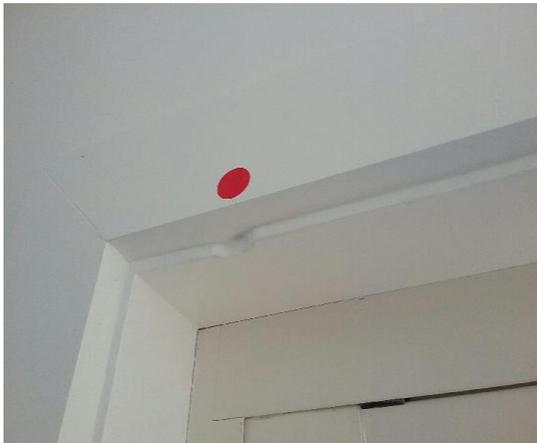
Bed 1- make good poor patch LHS of GPO

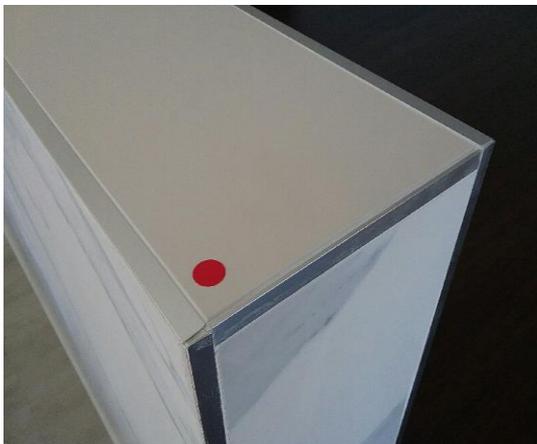
Bed 1- make good chip in door frame reveal

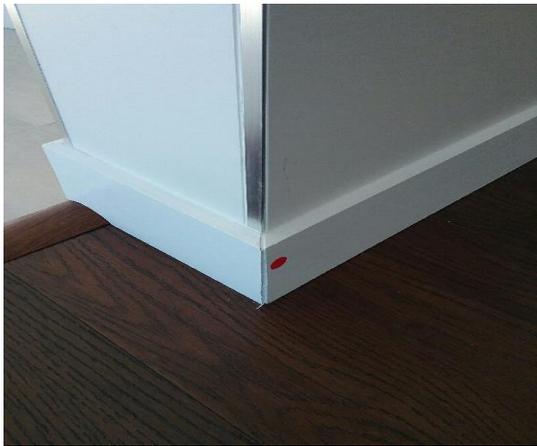
Bed 1- bath- make good poor fitment of aluminium edging (open mitre) and file sharp edges

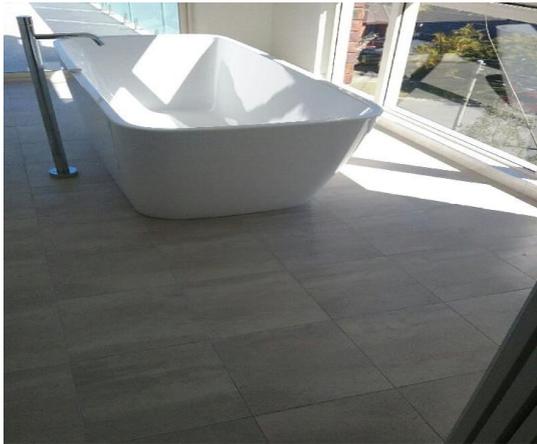
Bed 1- bath- make good poor fitment/fill to skirting mitre

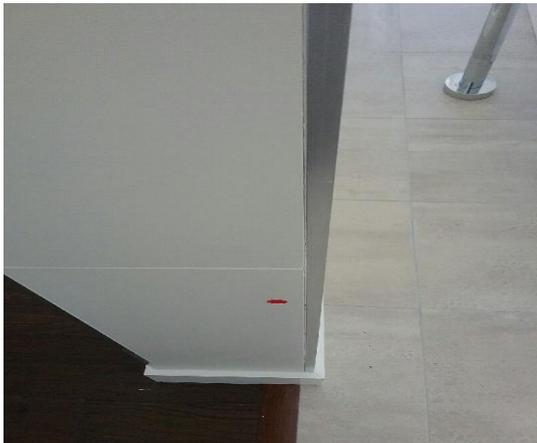
Bed 1- bath- consult with the Builder/Certifier to **confirm** that a floor waste is not required. **Currently no floor waste installed and no overflow device provided in bath tub in case of accidental overfilling.**

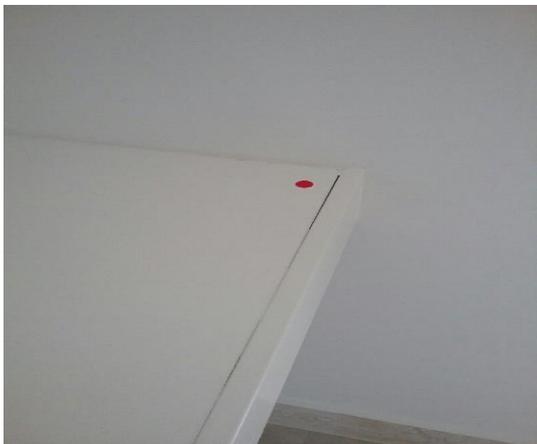
Bed 1- bath- make good tile edge to low wall

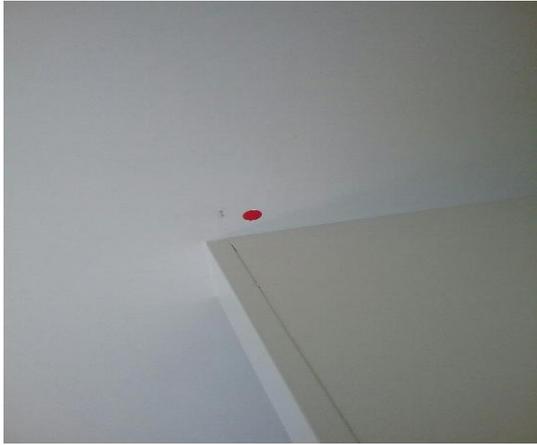
Walk in robe- make good gaps to shelving and end timber trim LHS

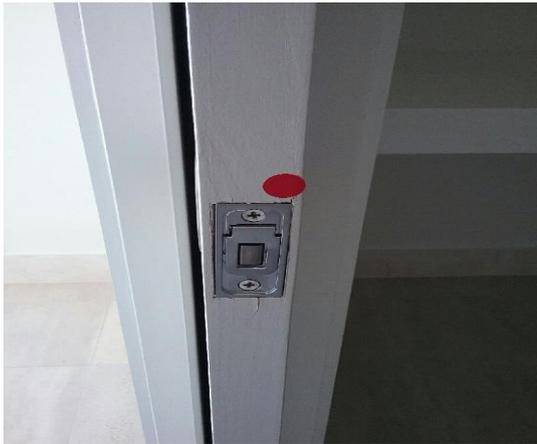
Walk in robe- make good gaps to shelving and end timber trim RHS

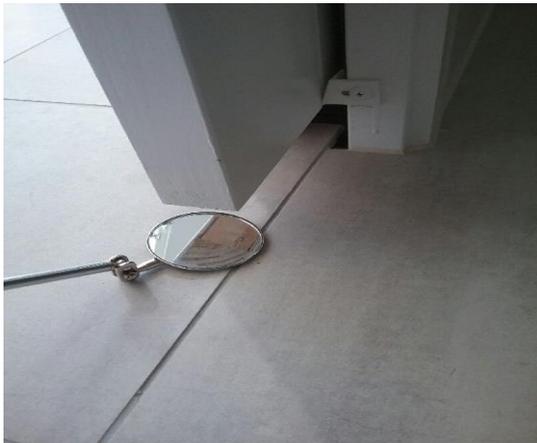
Walk in robe - make good finish around sliding door striker

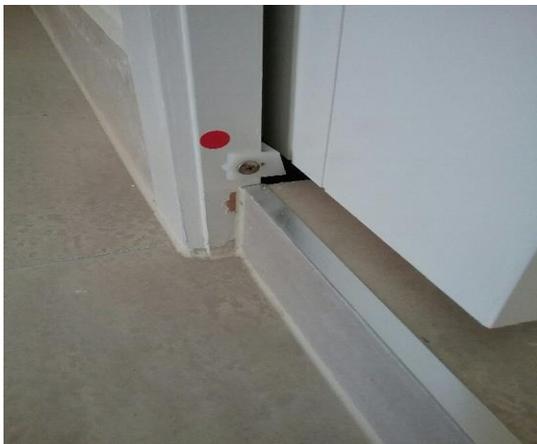
Walk in robe - excessive gap (>20mm) (currently 40mm) under door and not painted top and bottom of doors, make good to all

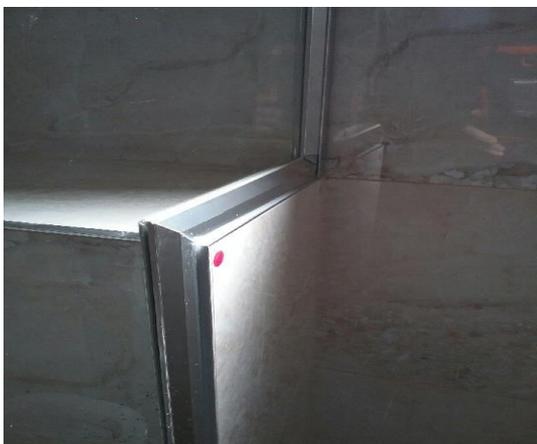
Ensuite- make good blemishes on timber frame

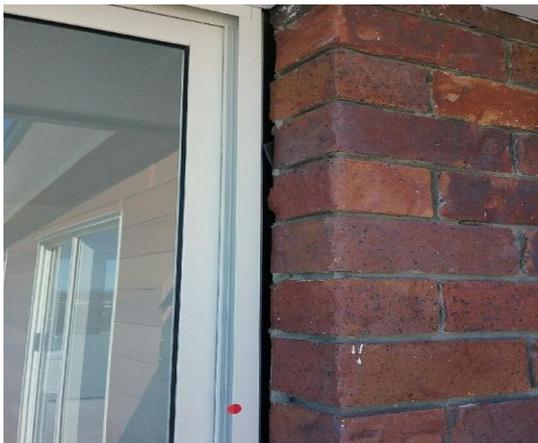
Deck- tile upstand and trim sitting slightly proud of sliding door sill and in my view, appears that it may prevent water escaping freely from door sill. **Consult with Builder/Certifier that all waterproofing has been carried out as per Australian Standards**

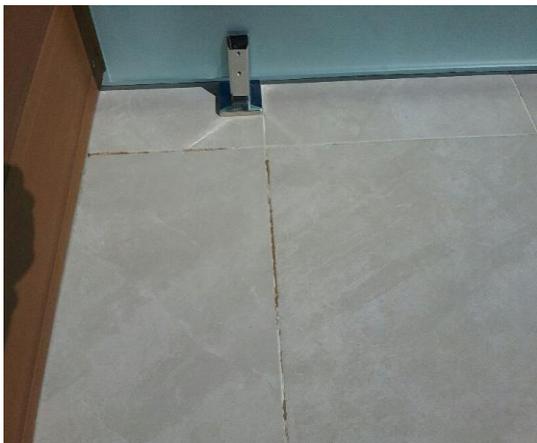
Deck- additional sealant required against PVC cladding & windows/doors, review all and make good to all

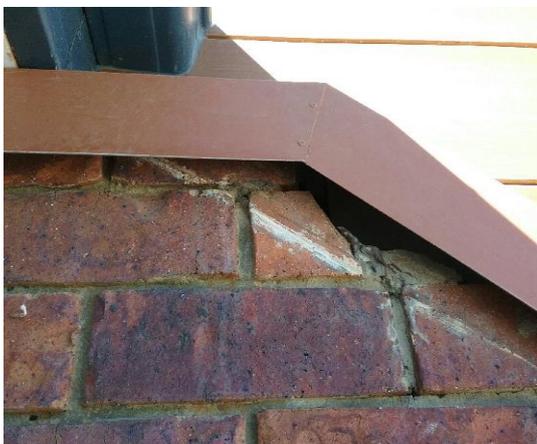
Deck- same as above however in another section of the deck

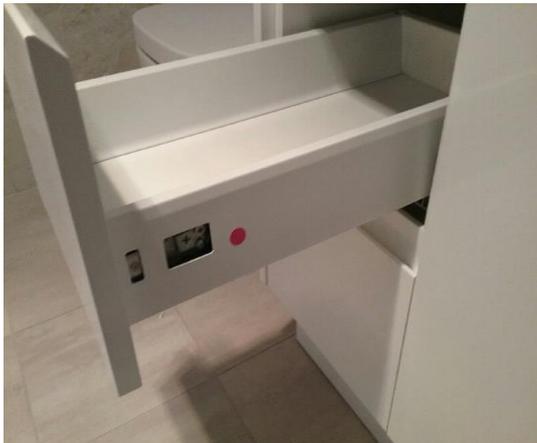
Ensuite 3- install caps to screws in unit

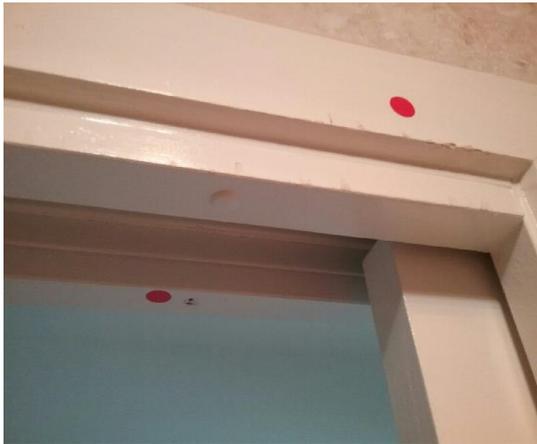
Ensuite 3- make good blemishes to door frame

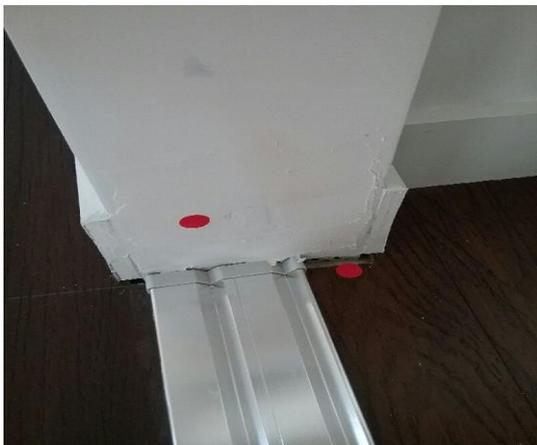
Bed 3- make good poor finish at robe track RHS and blemish on wall

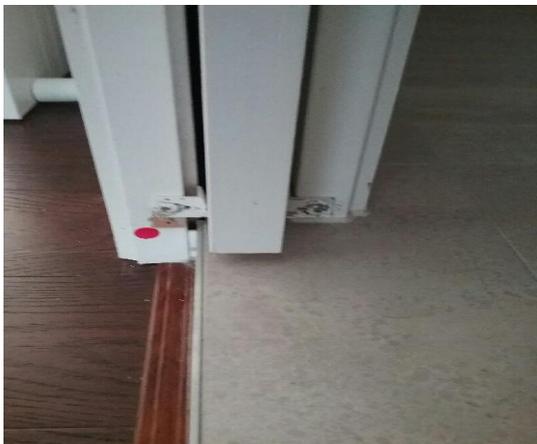
Bed 3- make good poor finish at robe track LHS

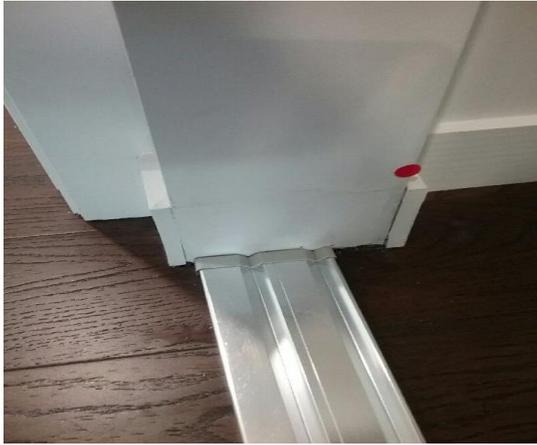
Ensuite 3- make good paint blemishes on sliding door frame

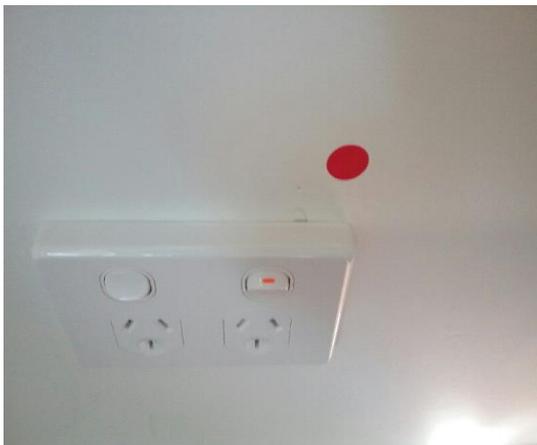
Bed 2- make good plaster blemishes on wall

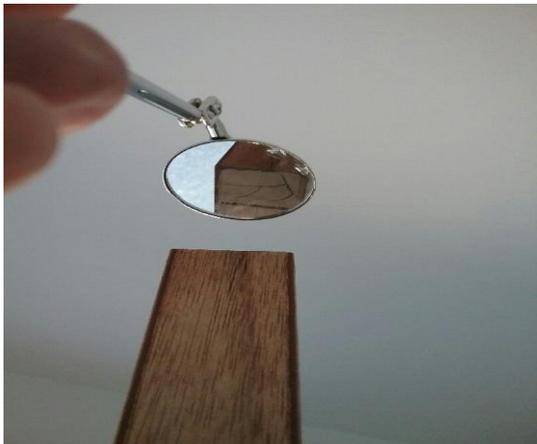
Entry- make good blemish to plaster on ceiling

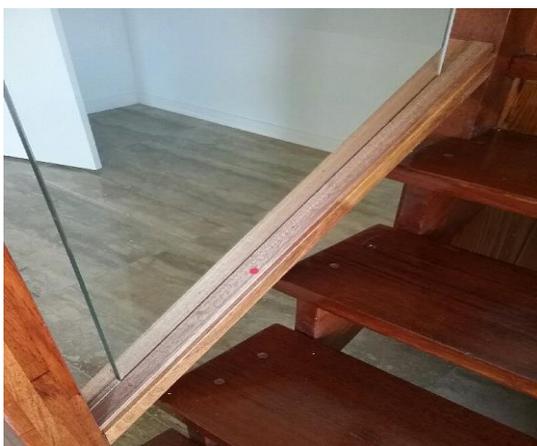
Entry stairs- The riser spacing on the staircase are not compliant to the building code. The riser opening if your staircase is of 'Open Rise Construction' must not allow a 125mm sphere to pass through, Refer BCA Part 3.9.1.3 – Staircase Construction, consult the Builder/Certifier for clarification.
