# Handover Inspection Report

Rosedale South, Qld, 4123

**Date of Inspection:** 19/07/2017

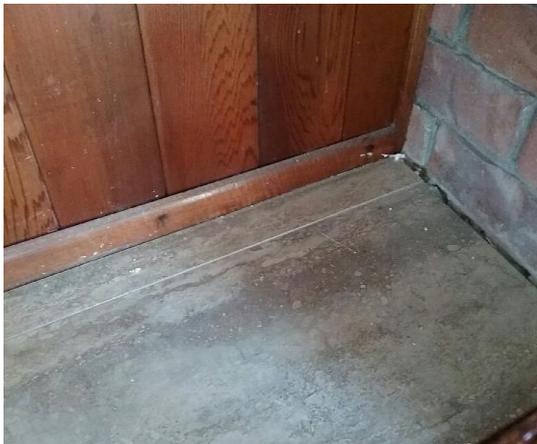
Entry stairs- make good poor or incomplete finish under stairs

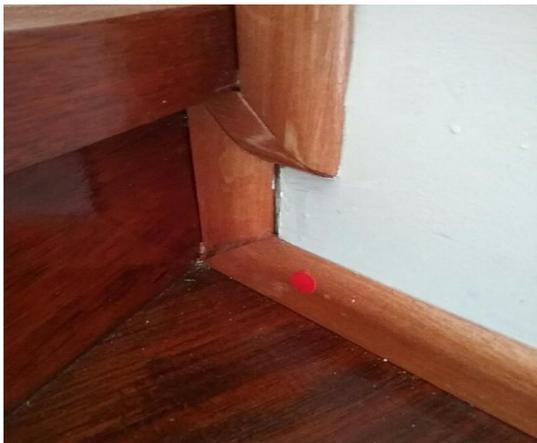
Entry stairs- make good finish to trim/wall just prior to turning corner

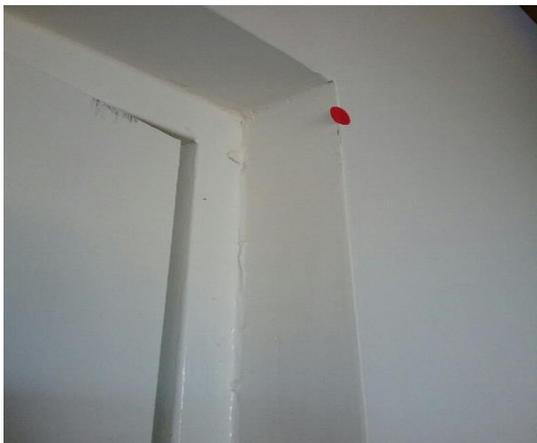
Entry- make good finish around door leading into store room

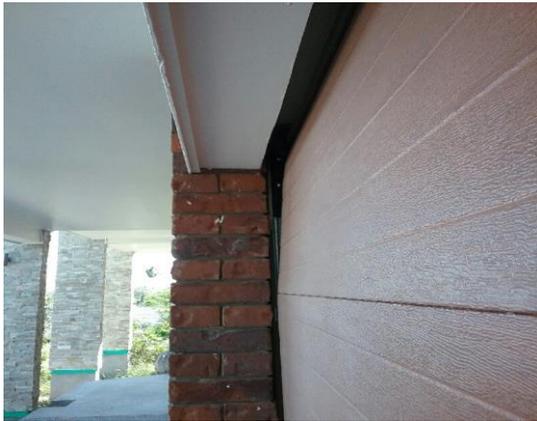
Front elevation- Garage- make good fitment of garage door LHS.

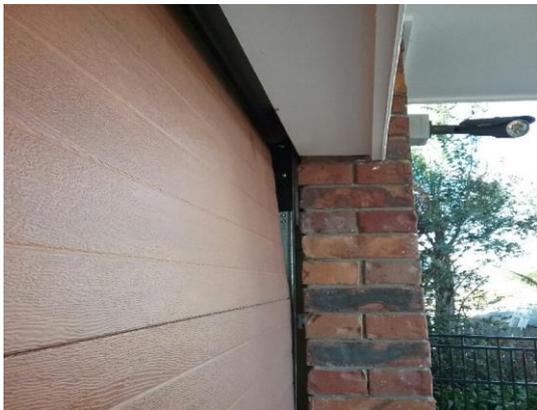
Front elevation- Garage- make good fitment of garage door RHS

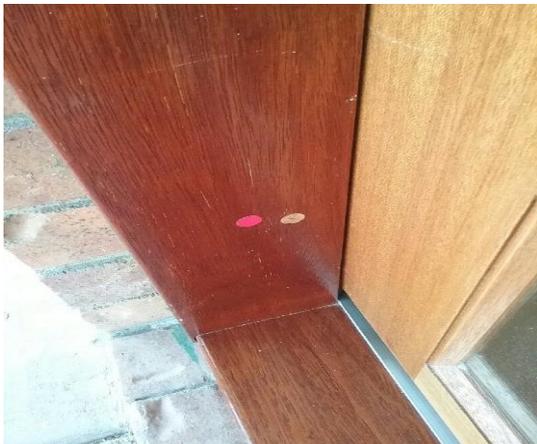
Front elevation- Entry- make good filler colour to match timber and finish. Review all and rectify

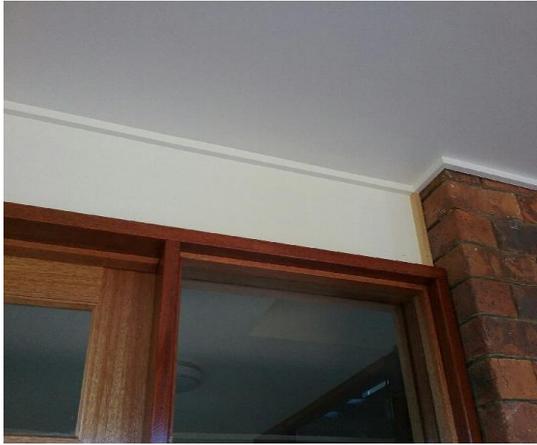
Front elevation- Entry- complete works above entry door

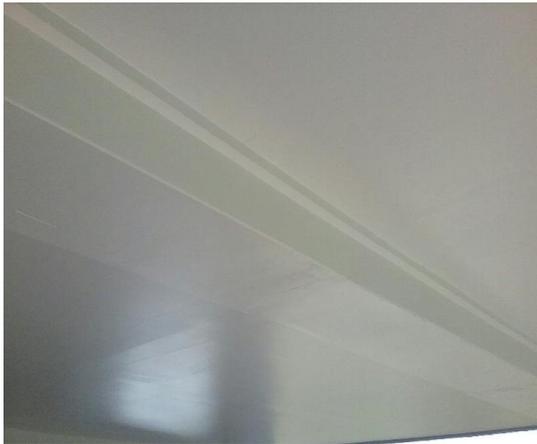
Front elevation- undercroft- finish to ext. bulkheads and ceilings are not finished off in a tradesman like manner. Areas are lumpy and have not been sanded prior to painting. Make good to all

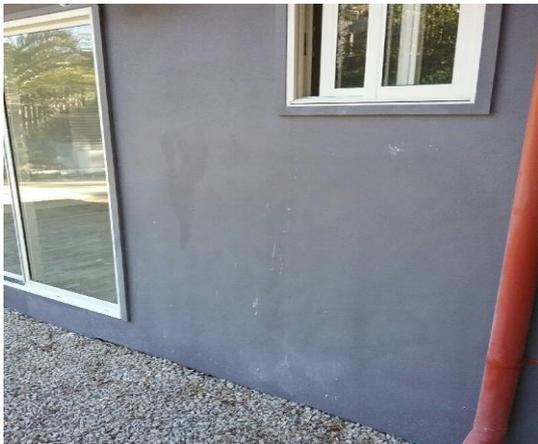
Rear elevation- wash down wall of builder's grime

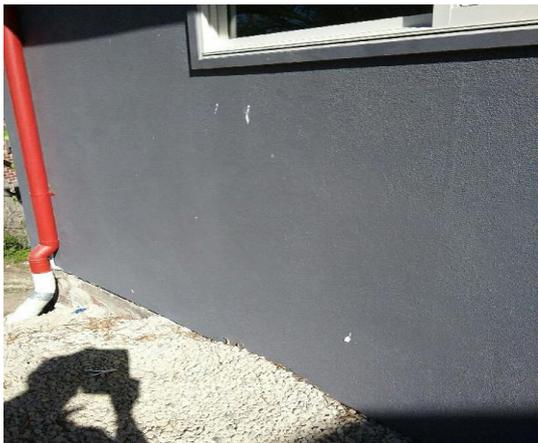
Rear elevation- make good blemishes on wall under window

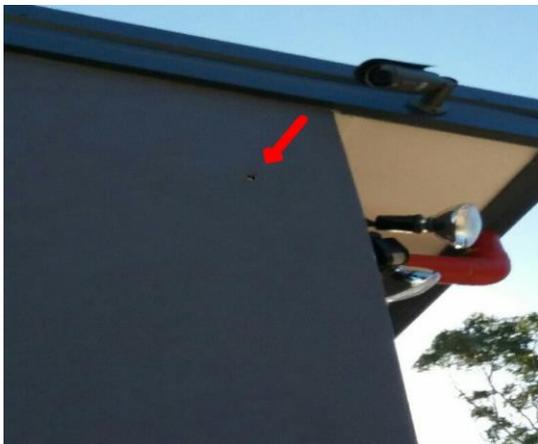
Right elevation- make good hole in wall

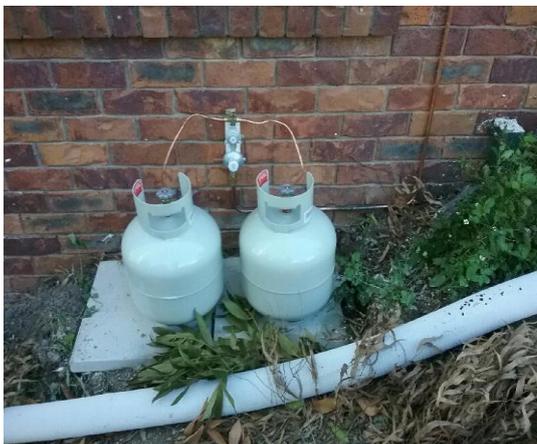
Right elevation- as per AS5601.1 LPG gas cylinders are to be restrained from falling by a chain fixed to the wall, make good and safe
