Handover Inspection Report

Rosedale South, Qld, 4123

Date of Inspection: 19/07/2017

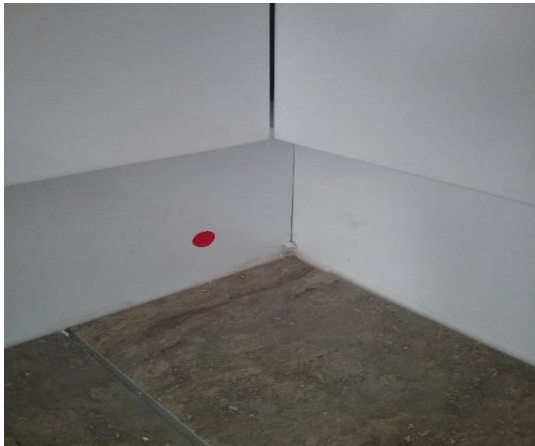
As above

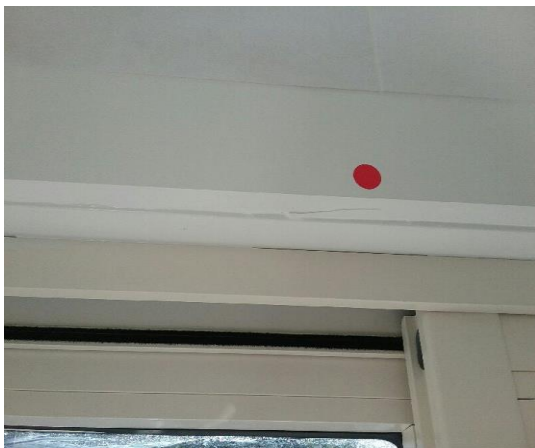
Kitchen- make good split in architrave to window above sink

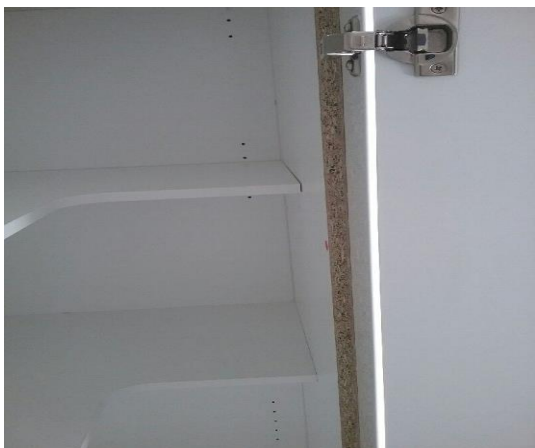
Kitchen- install edge strip to joinery panel in pantry

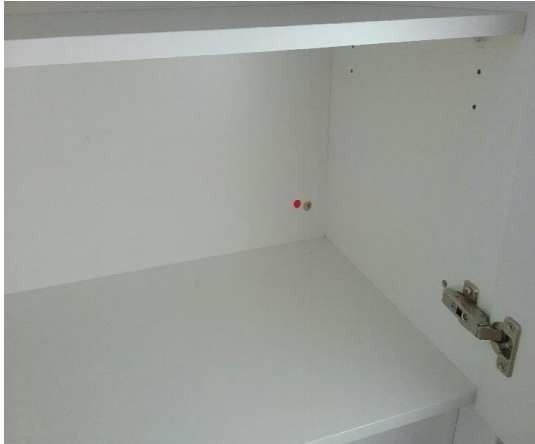
Kitchen- as above

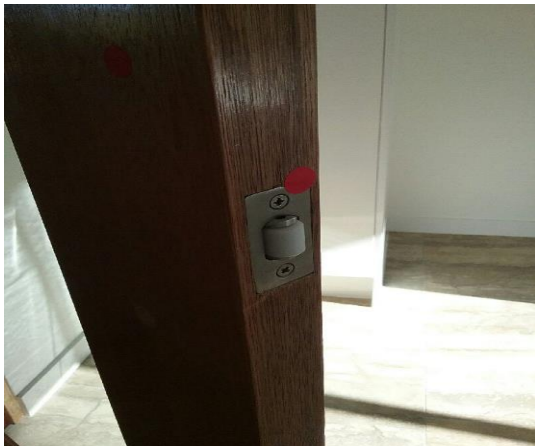
Kitchen- double door are difficult to close and open, ease spring to roll latch

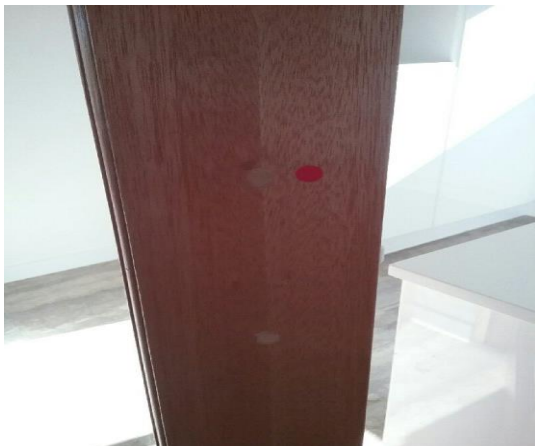
Kitchen- make good poor finish and colour of filler on face of door

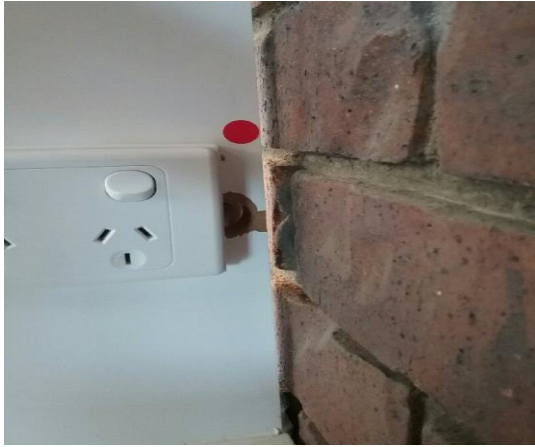
Dining- make good hole in joinery panel RHS of GPO

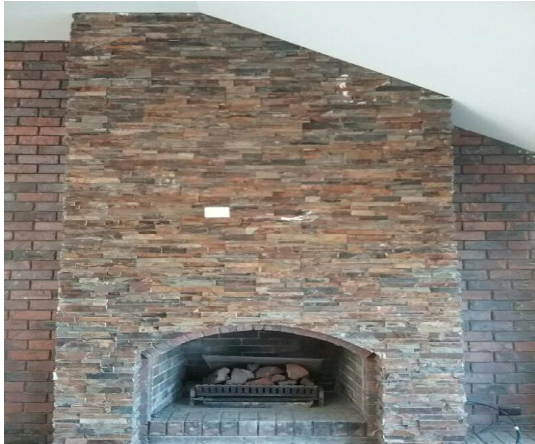
Dining- clean down plaster droppings from face brick

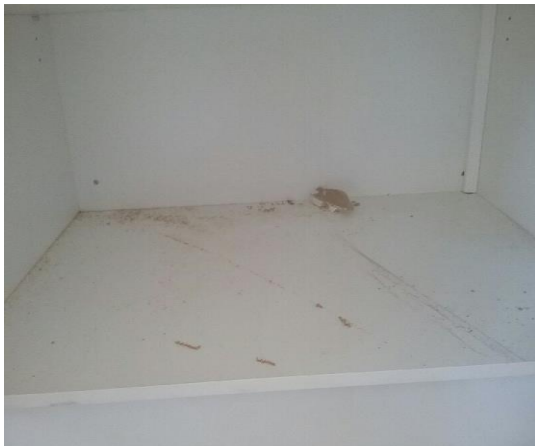
Dining- island bench- review all cupboards, cap off screws and clean out

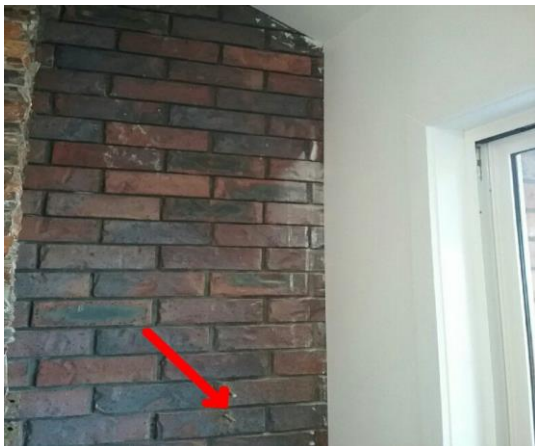
Living - clean down face bricks. Remove protruding bolts

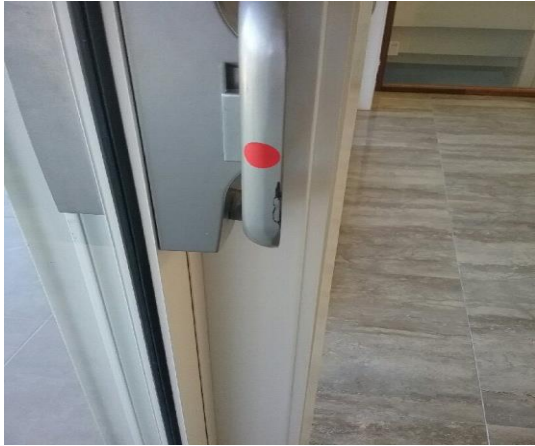
Living- make good scratch sliding door handle

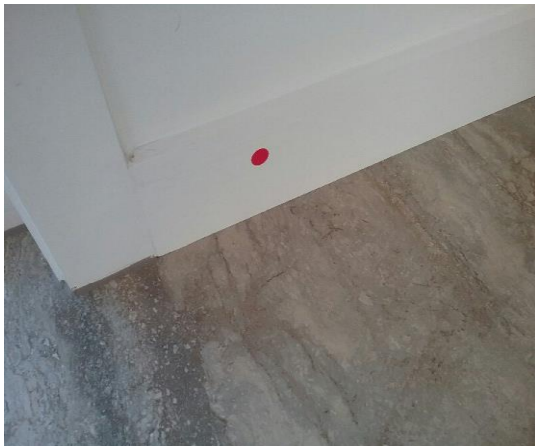
Living- install sealant to tile/skirt junction to give a consistent finish through out

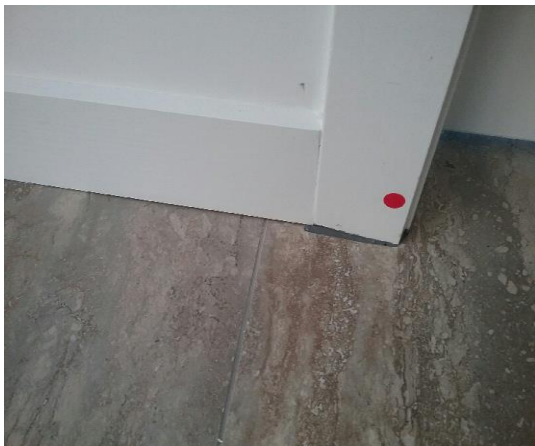
Stairs- make good architrave and/or sealant

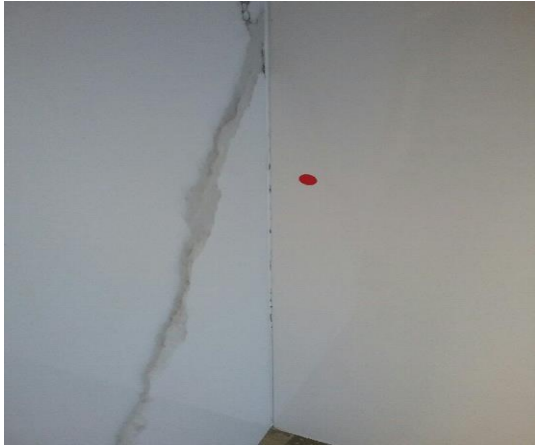
Dining- make good poor finish to fill to island bench LHS

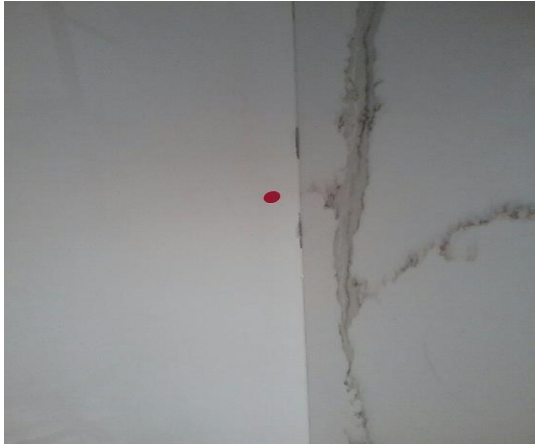
Dining- make good poor finish to fill to island bench RHS

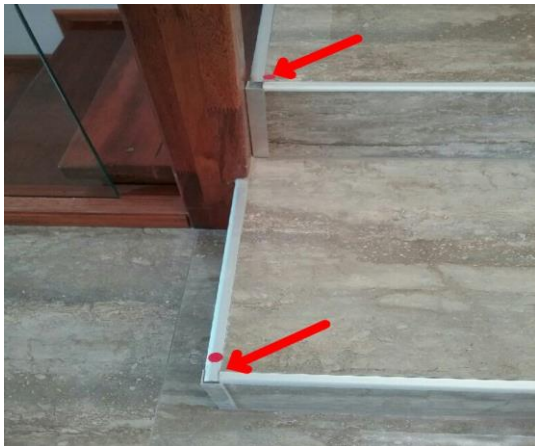
New Stairs- entry steps- make good poor finish to tile metal edge mitres. Unsatisfactory workmanship

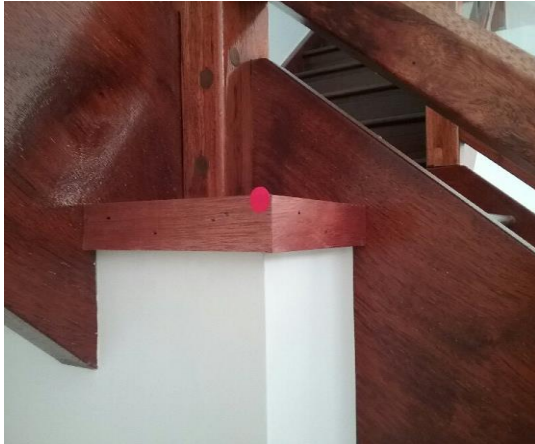
New Stairs- make good by filling holes & completing the clear coating on timber trim, both sides of the stairs

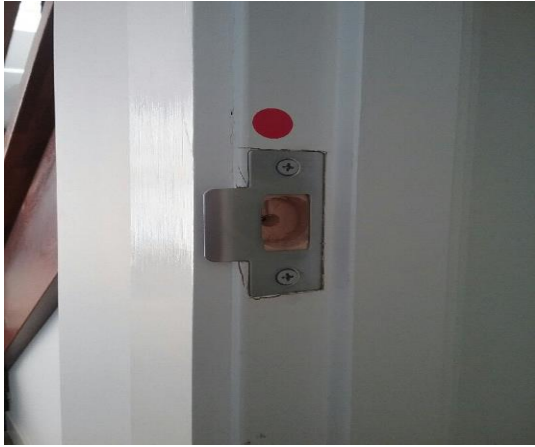
New Stairs- make good around striker plate leading into storage area under stairs

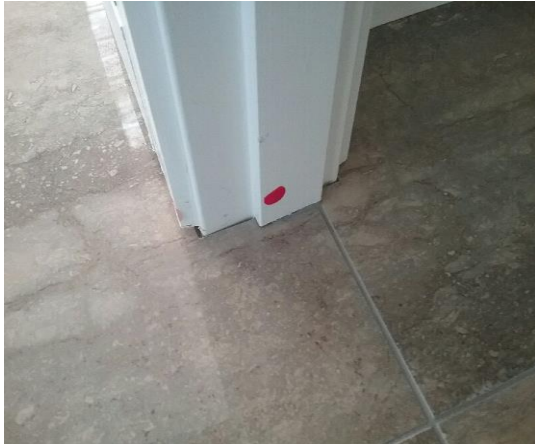
Stairs- storage- incomplete application of sealant around door frame, make good

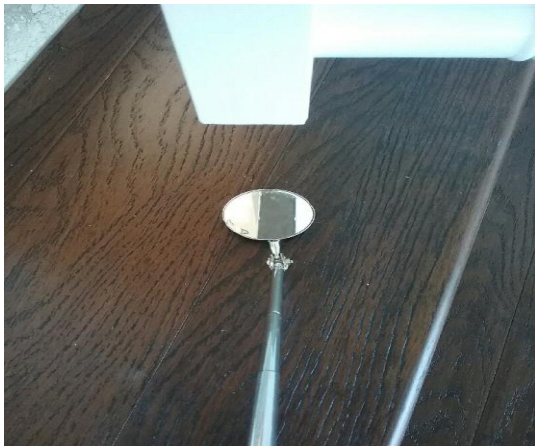
Study- paint top and bottom of door as required, review all and make good to ALL

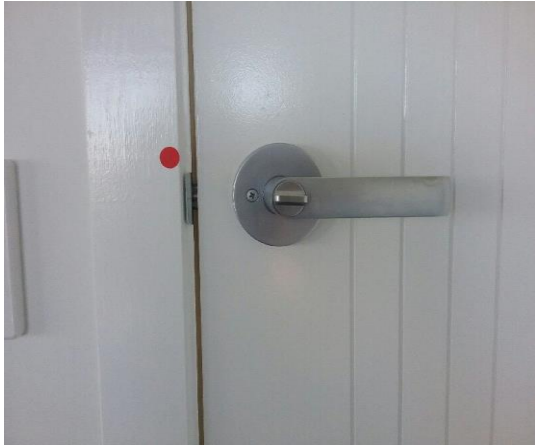
Study- excessive play in striker, make good

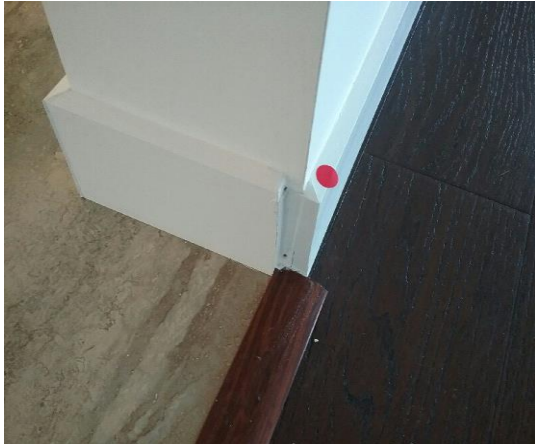
Family- make good poor finish/workmanship to skirting

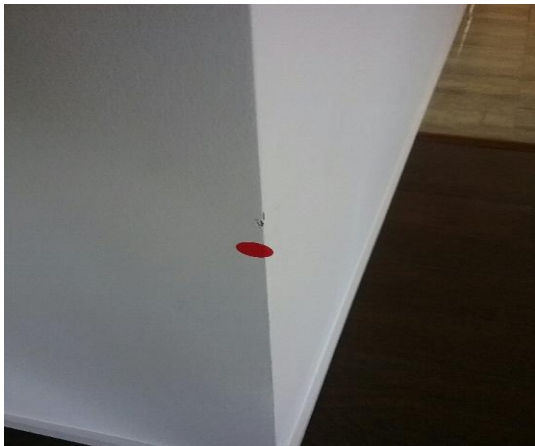
Family- make good paint blemish on ext. corner of wall

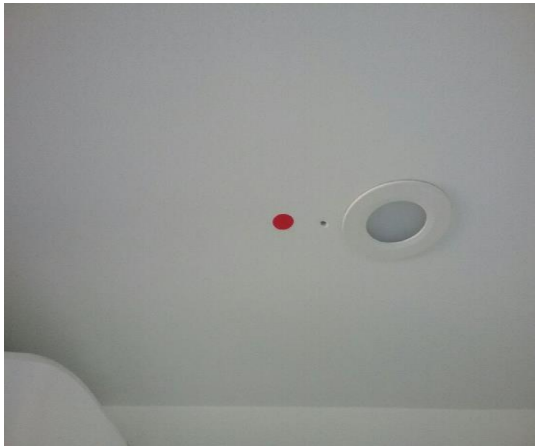
Family- make good hole next to light fitting RHS of A/C

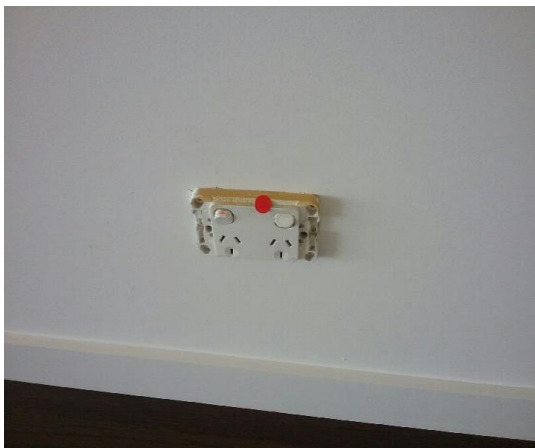
Family- install cover to GPO

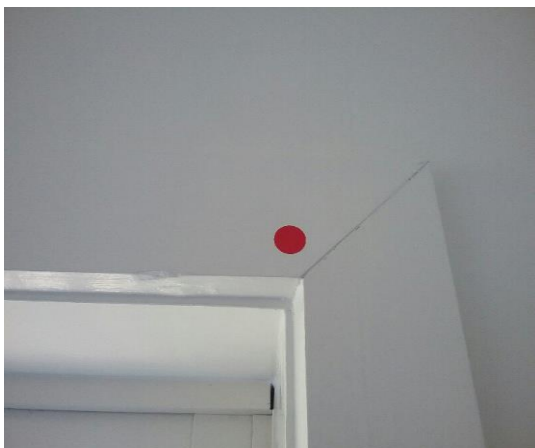
Family- make good chip in architrave and align mitre so as it is flush

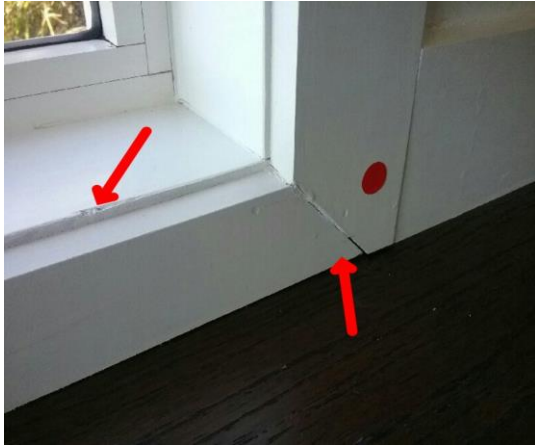
Family- make good chip in reveal and rectify poor finish to mitre

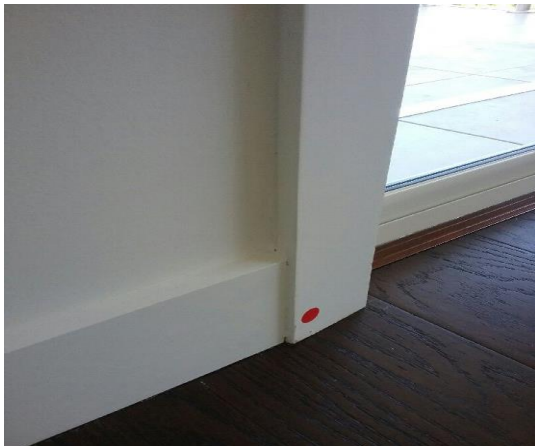
Family- make good connection of architrave and skirting (make flush) consistent with others

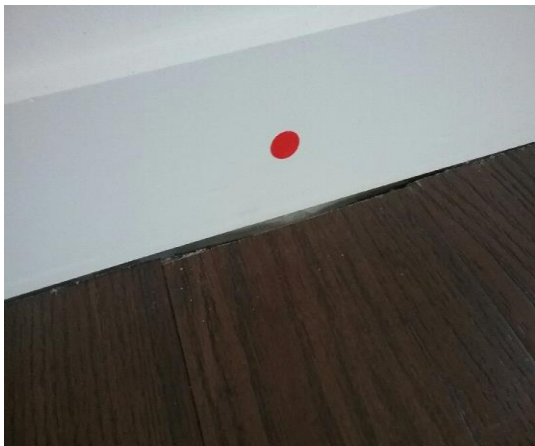
Family- make good floor board short. Gap present

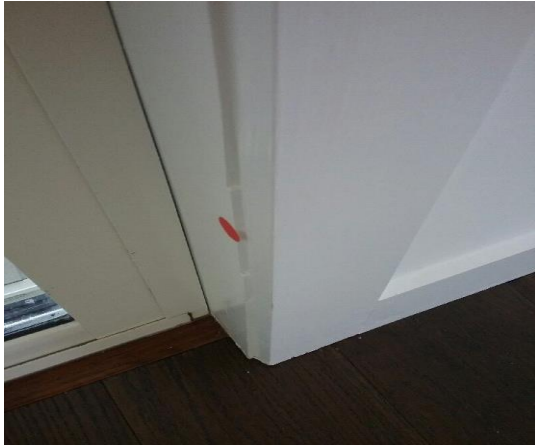
Family- make good chipped reveal of window frame

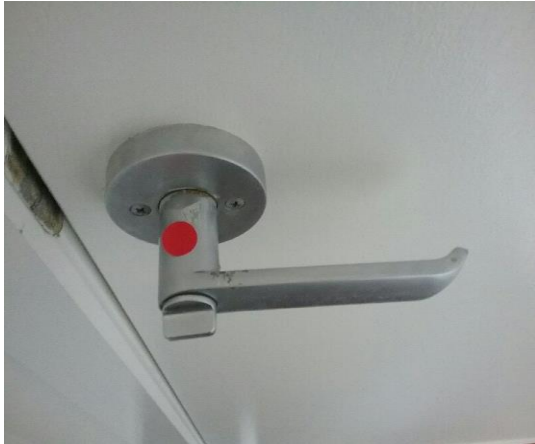
Passage- make good scratches on handle, RHS

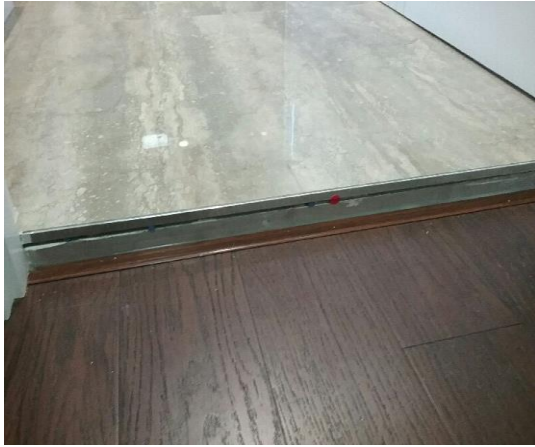
Ensuite 4- make good aluminium edge of tiles and remove wedges

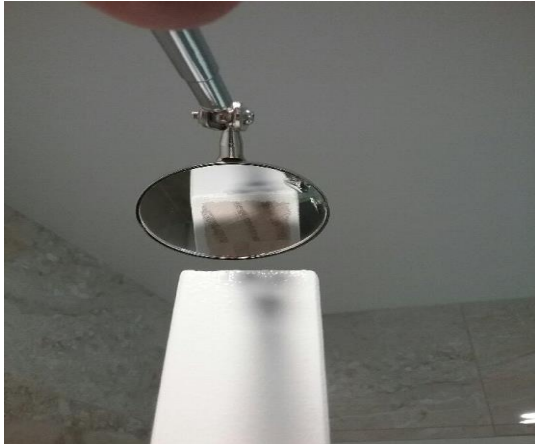
Ensuite 4- paint top and bottom of door as required, review all and make good to ALL

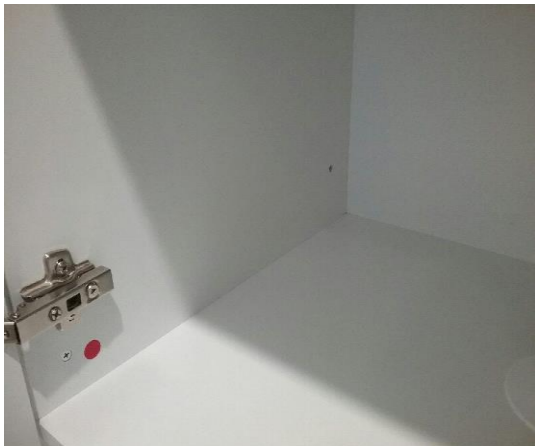
Ensuite 4- cap all exposed screws in joinery. Review all and make good

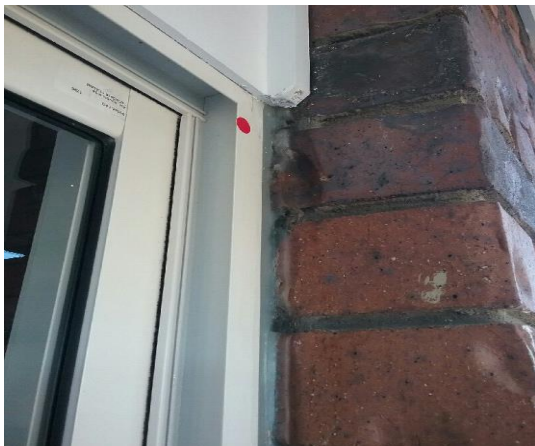
Balcony- silicon applied lumpy, untidy and smeared on face brickwork, make good

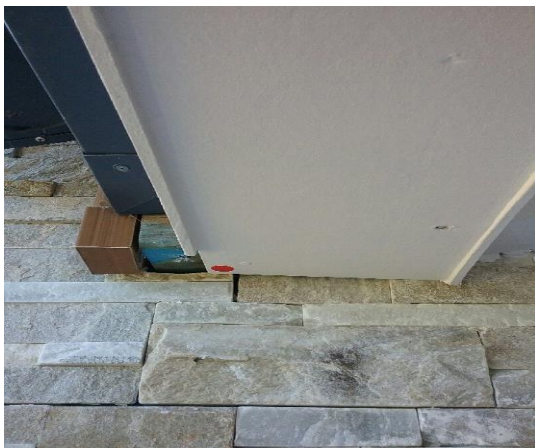
Balcony- make good finish and detail at end of bulkhead.

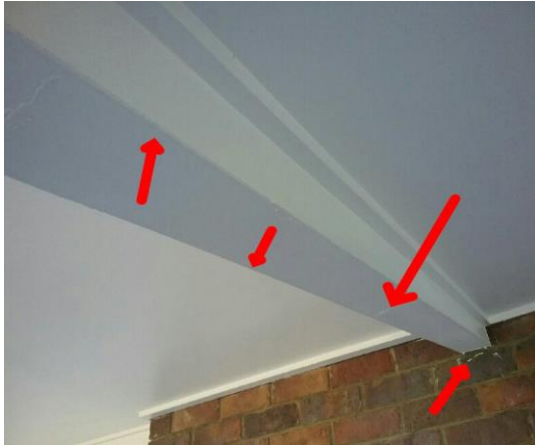
Balcony- finish to ext. bulkheads and ceilings are not finished off in a tradesman like manner. Areas are lumpy and have not been sanded prior to painting. Make good to all

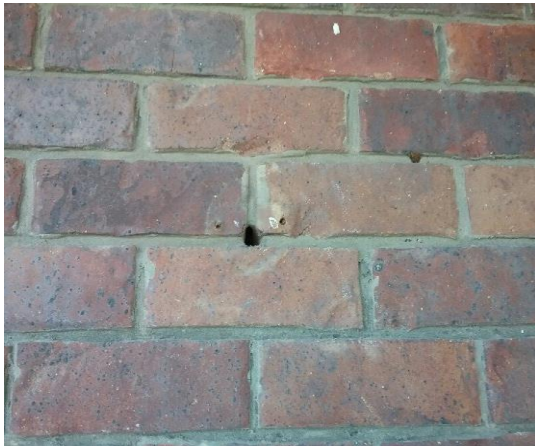
Balcony- fill hole to face brickwork

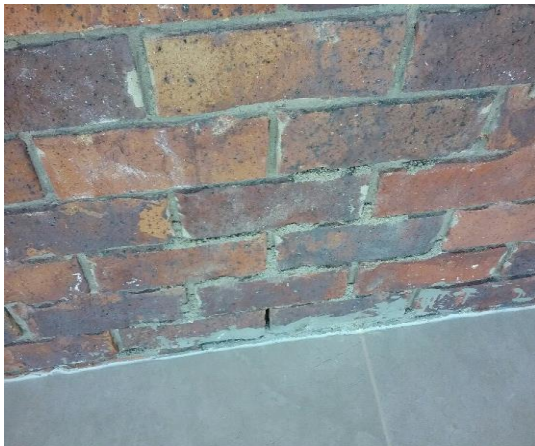
Balcony- glue and concrete splashed on face brickwork, remove all and make good

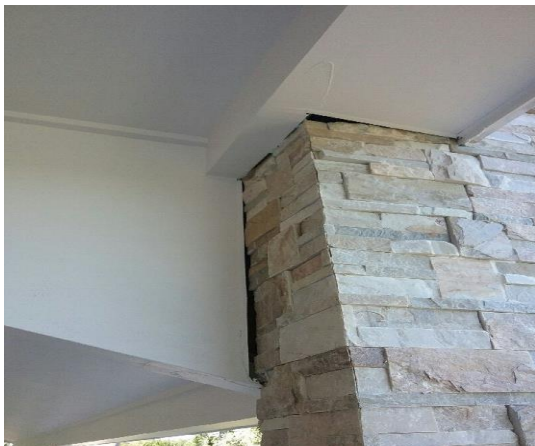
Balcony- finish to ext. bulkheads and ceilings are not finished in a tradesman like manner. Areas are lumpy and have gaps that require filling or trimming prior to painting. Make good to all

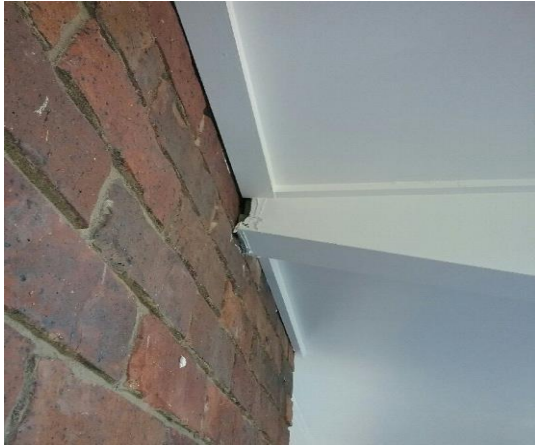
Balcony- finish to ext. bulkheads and ceilings are not finished in a tradesman like manner. Areas are lumpy and have gaps that require filling or trimming prior to painting. Make good to all

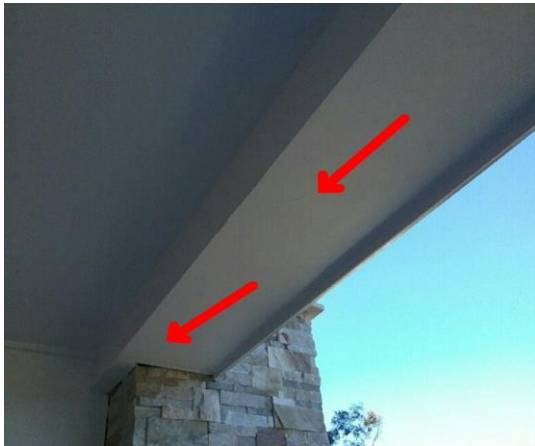
Balcony- finish to ext. bulkheads and ceilings are not finished off in a tradesman like manner. Areas are lumpy and have not been sanded prior to painting. Make good to all

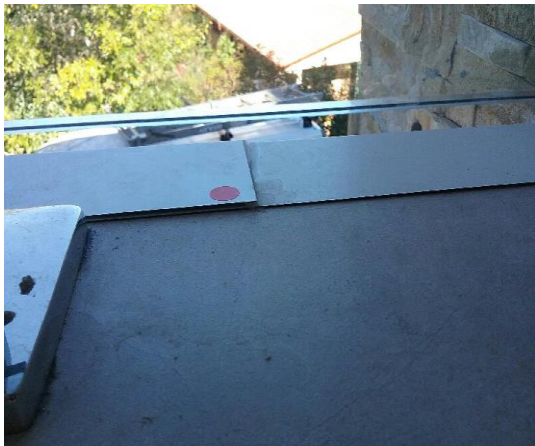
Balcony- metal capping to front edge of tiles is untidy and in particular where they overlap. Make good to all

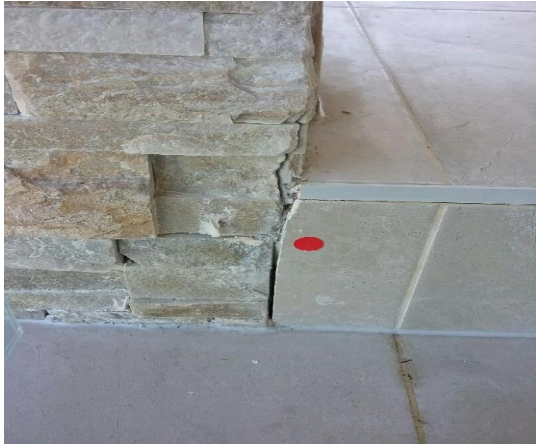
Balcony- make good gap to tiles

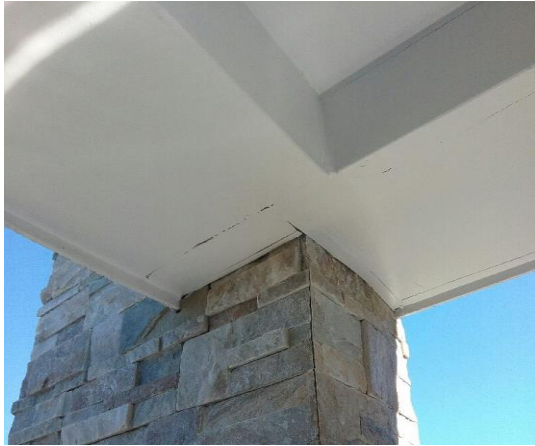
Balcony- finish to ext. bulkheads and ceilings are not finished in a tradesman like manner. Areas are lumpy and have gaps that require filling or trimming prior to painting. Make good to all

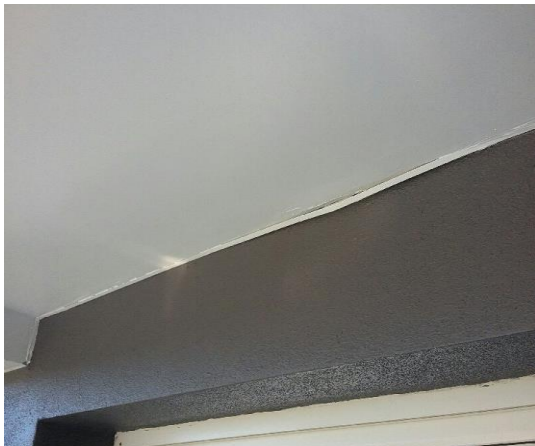
Balcony- finish to ext. bulkheads and ceilings are not finished in a tradesman like manner. Areas are lumpy and have gaps that require filling or trimming prior to painting. Make good to all

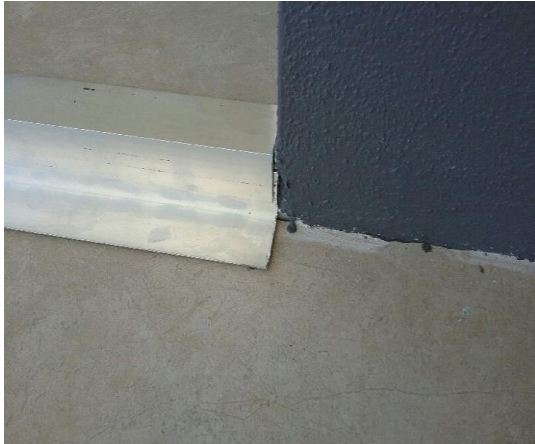
Balcony- make good hole visible RHS of the capping

NOTE: not clear why this aluminium angle is in place?
Means of fixing of capping may present a water entry issue
in the future and consideration should be taken to ensure
ALL certificates and guarantees are presented by the
Builder. Consult with Builder for clarification

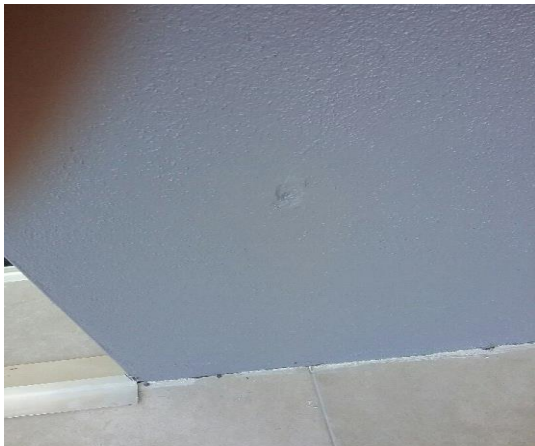
Balcony- sharpen finish to render and tile junctions and fill
dent in render. Make good to all

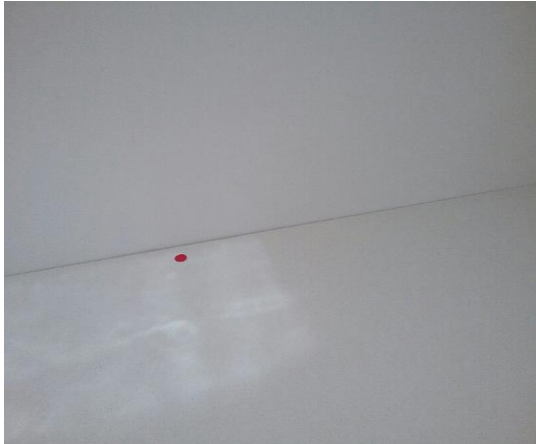
Rear entry- apply sealant to wall/bench top junction

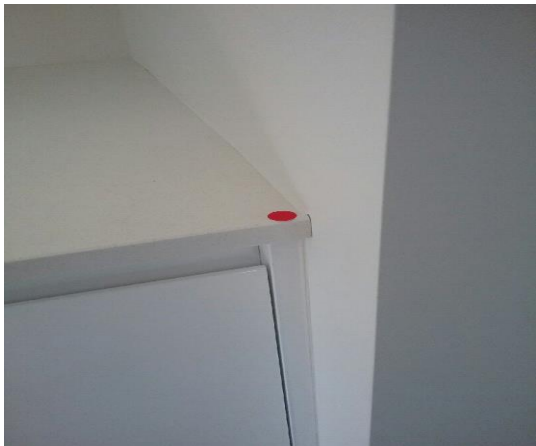
Rear entry- make good gap down face of caeser stone bench top

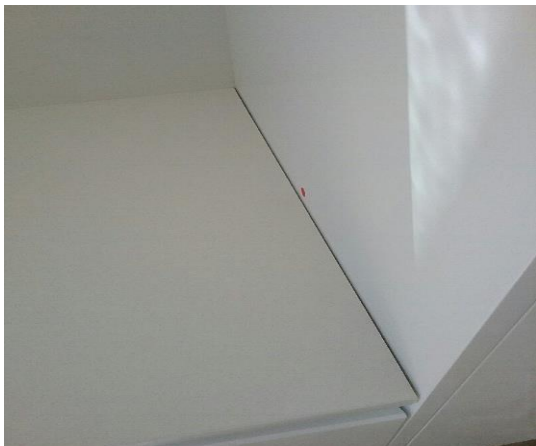
Rear entry- apply sealant to joinery panel/bench top junction

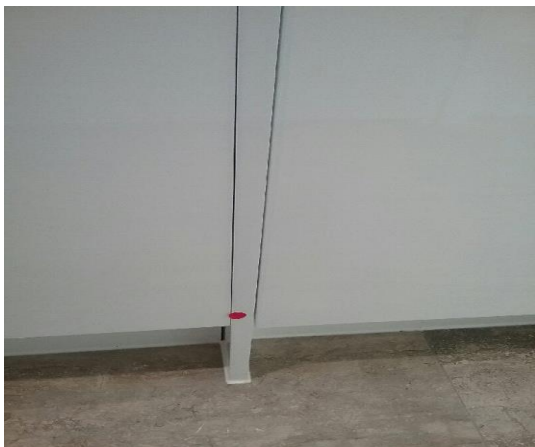
Laundry- maker good clashing draws

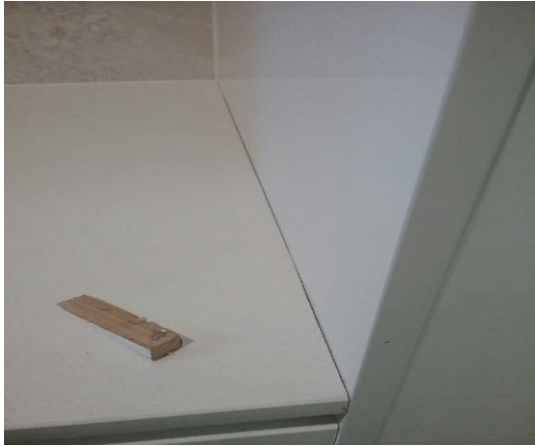
Laundry- gap fill bench top to joinery panel

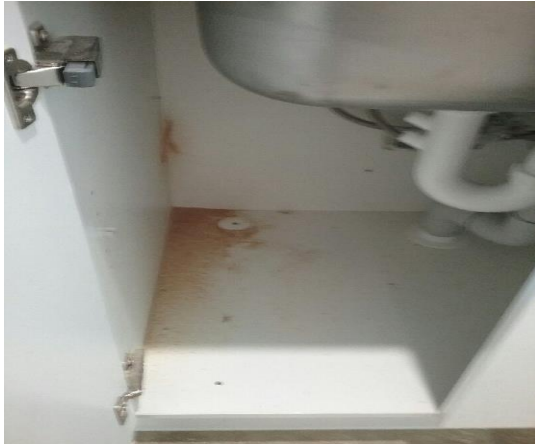
Laundry- clean out cupboard of builder's debris and tidy up hole drilled in unit in joinery panel

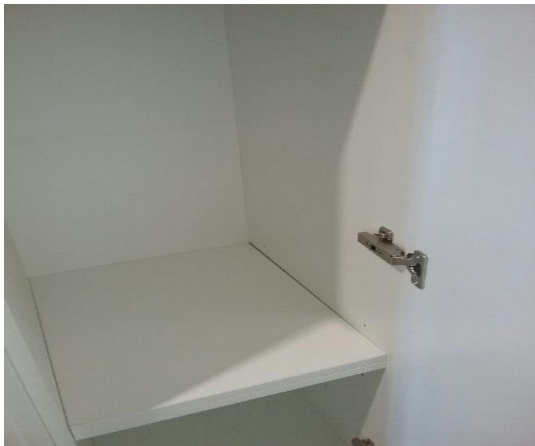
Laundry- more shelf brackets are required so to install shelf

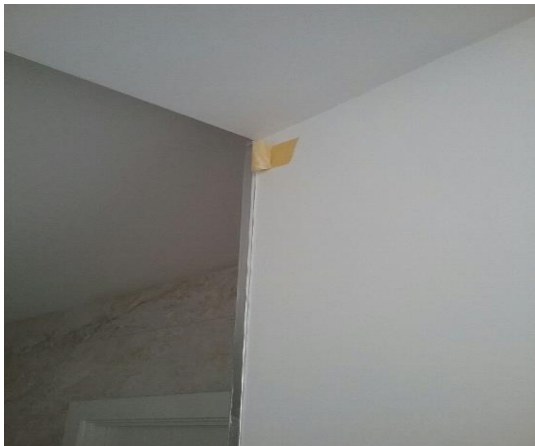
Powder Room- tile trim extrusion proud of wall, make good

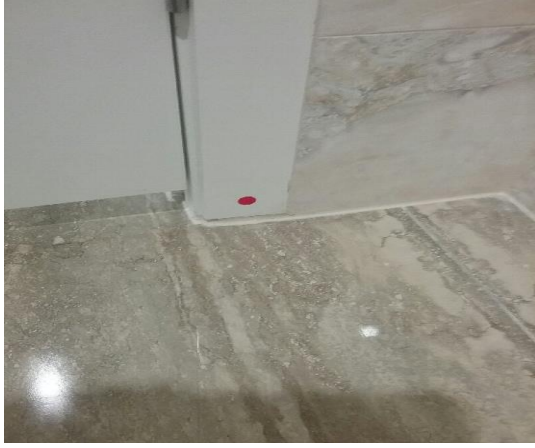
WC- Toilet- make good short architrave

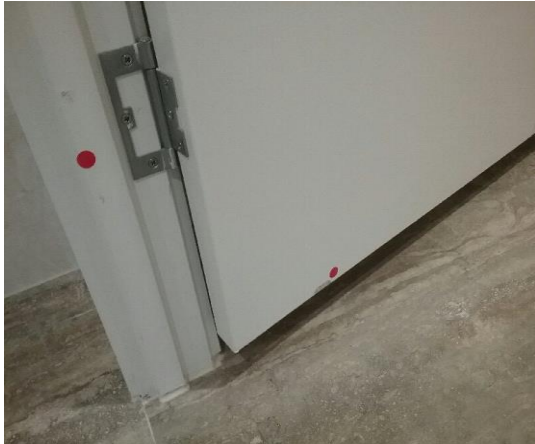
WC- Toilet- excessive gap (>20mm) under door, top and bottom of door not painted and blemishes on face of door and door jamb, make good to all

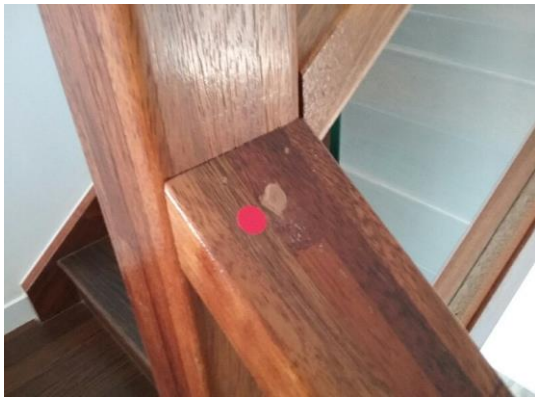
New stairs- make good poor finish and colour of filler on handrails and posts in general

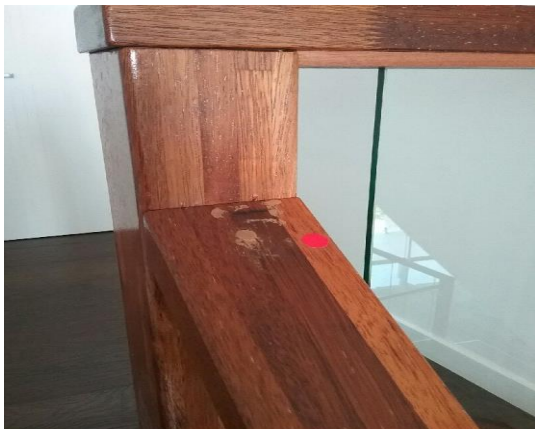
New stairs- make good poor finish and colour of filler on handrails and posts in general

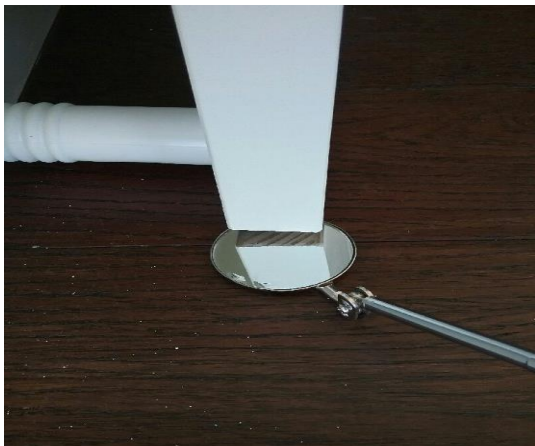
Mezzanine- paint top and bottom of doors as required

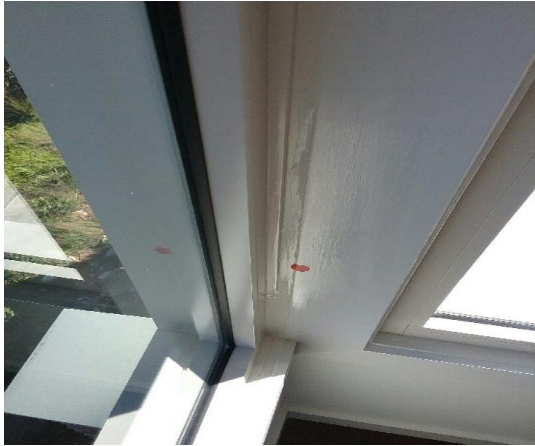
Mezzanine- make good inconsistent finish to timber trim/jamb

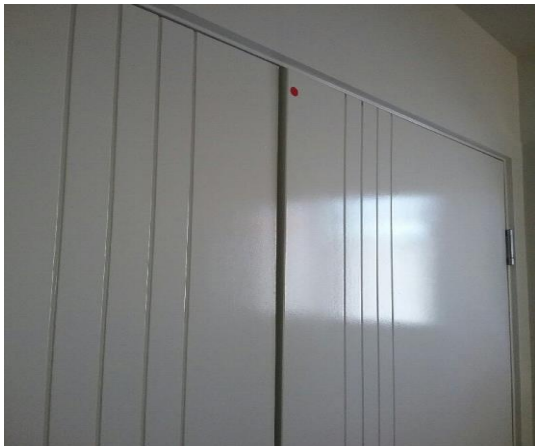
Gallery- make good misaligned doors, reduce gap in centre. Currently greater than 5mm

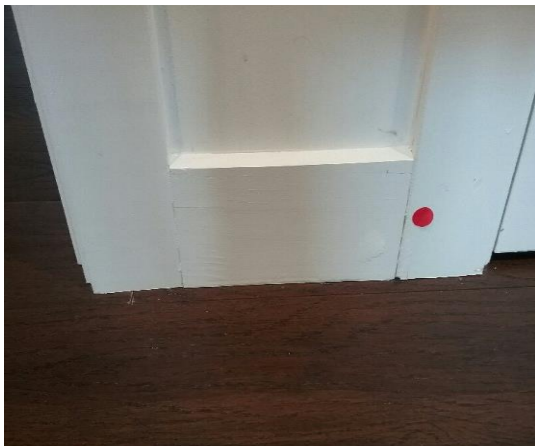
Gallery- make good finish to skirting fill LHS of the pair of doors

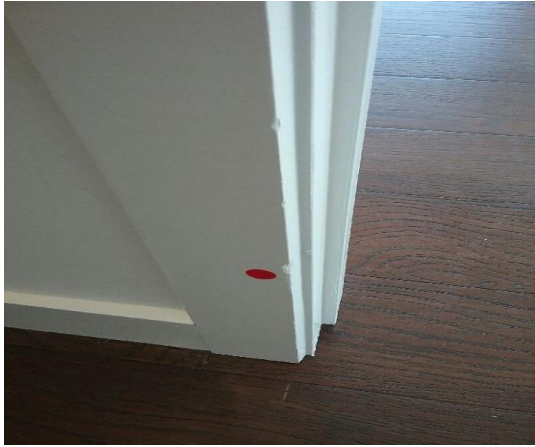
Bed 1- make good blemishes on door frame and architraves

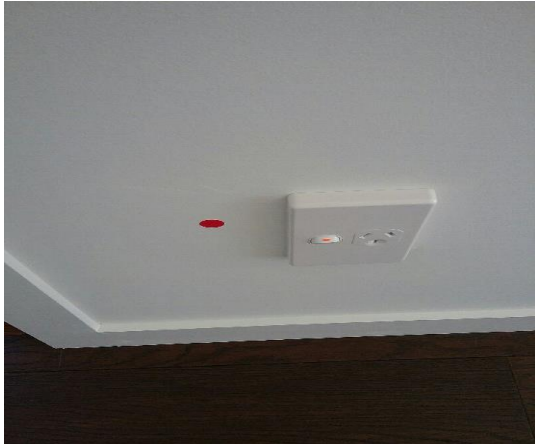
Bed 1- make good poor patch LHS of GPO

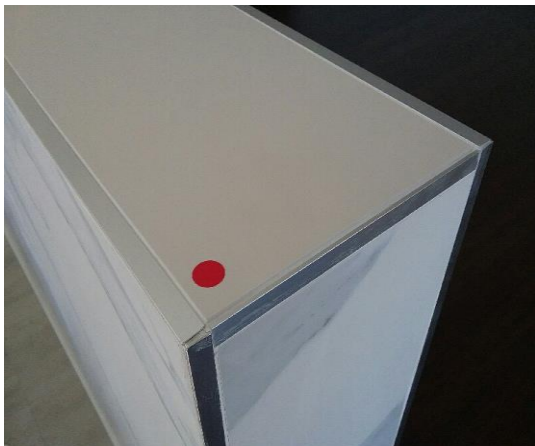
Bed 1- make good chip in door frame reveal

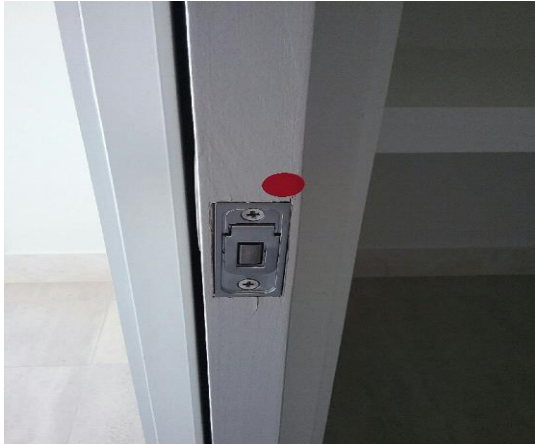
Walk in robe- make good gaps to shelving and end timber trim RHS

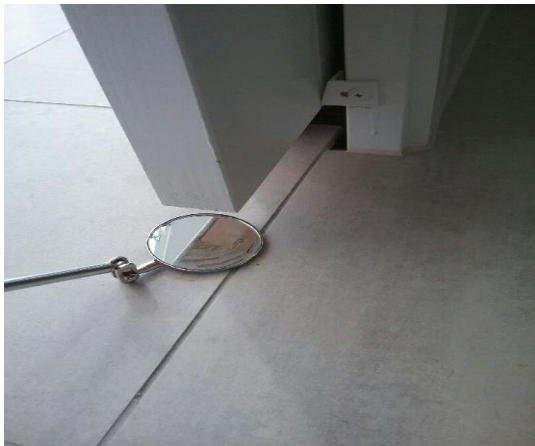
Walk in robe - make good finish around sliding door striker

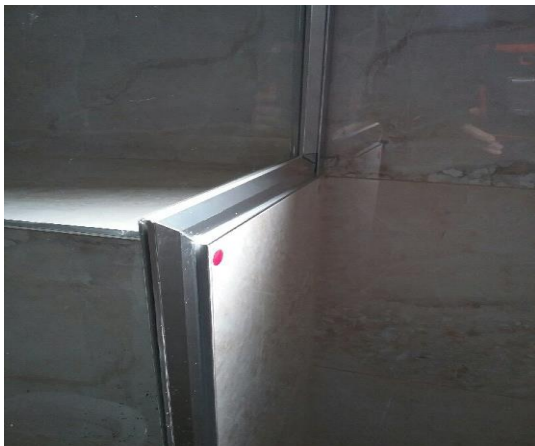
Ensuite- make good blemishes on timber frame

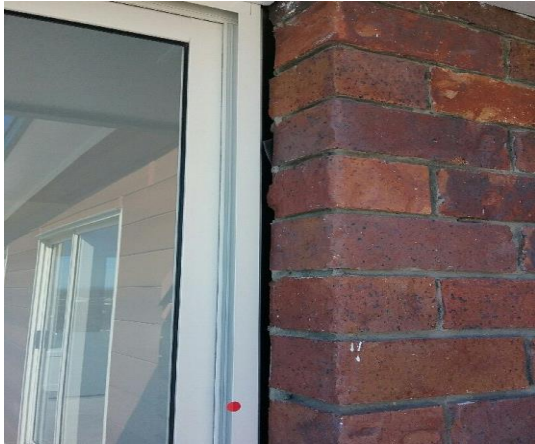
Deck- tile upstand and trim sitting slightly proud of sliding door sill and in my view, appears that it may prevent water escaping freely from door sill. **Consult with Builder/Certifier that all waterproofing has been carried out as per Australian Standards**

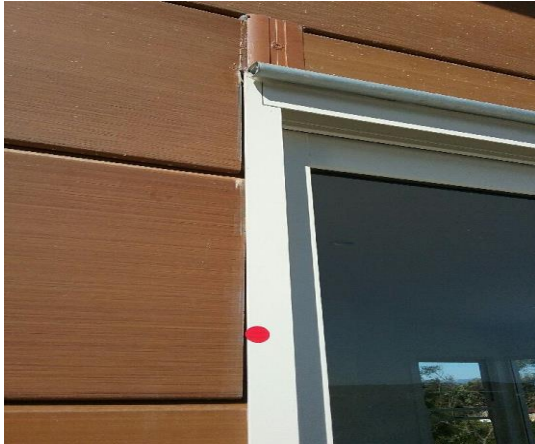
Deck- some panels of the PVC cladding are bowed, make good to all

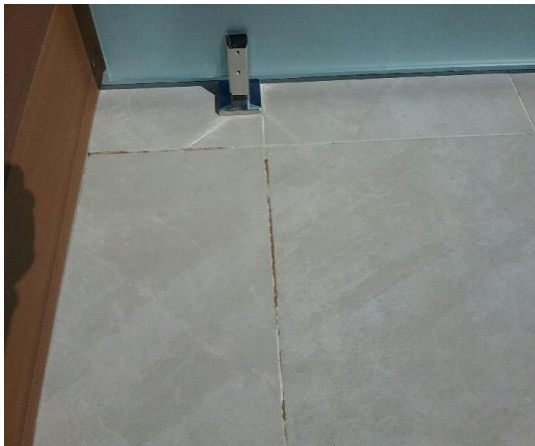
Deck- additional sealant required against PVC cladding & windows/doors, review all and make good to all

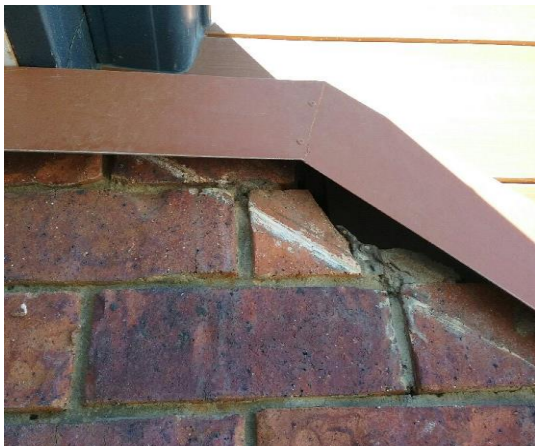
Deck- same as above however in another section of the deck

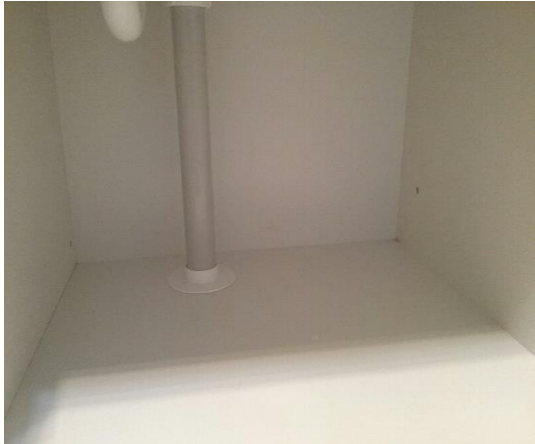
Ensuite 3- make good gaps to sealant at junction of tile/bench top to vanity

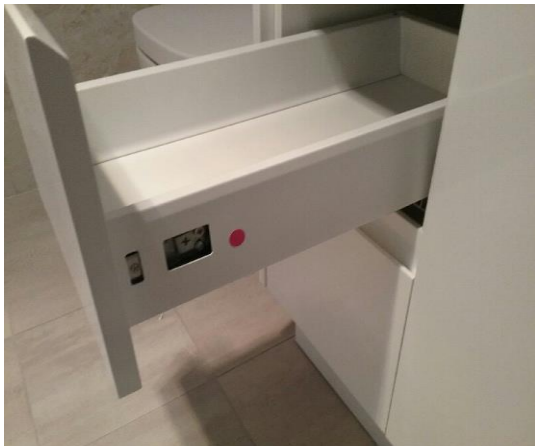
Ensuite 3- install caps to screws in unit

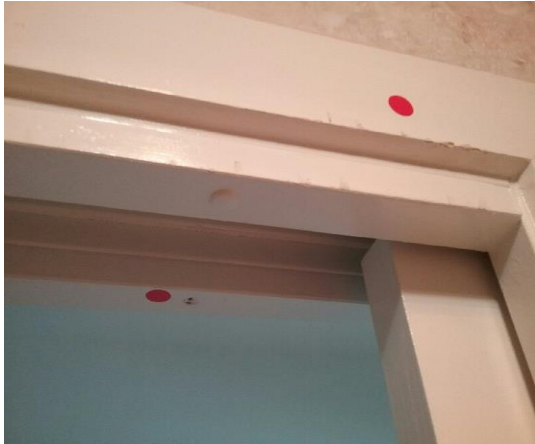
Ensuite 3- make good blemishes to door frame

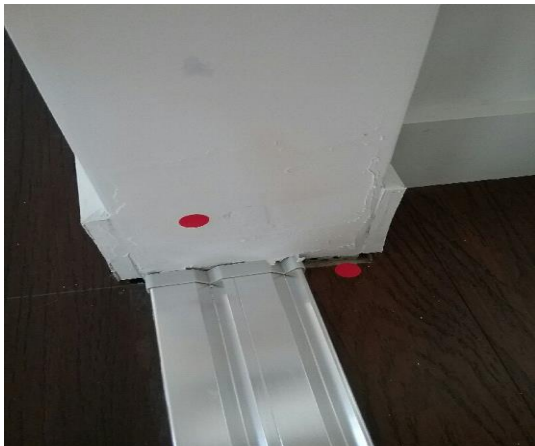
Bed 3- make good poor finish at robe track RHS and blemish on wall

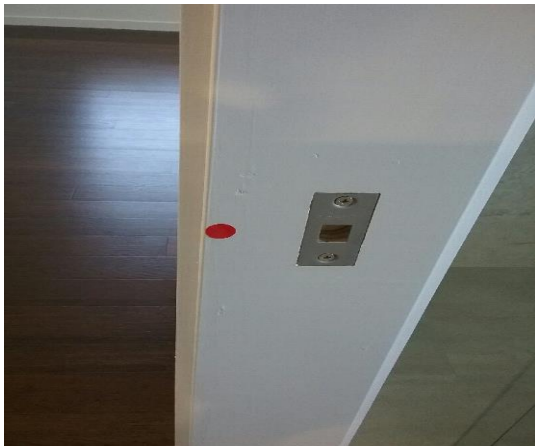
Ensuite 2- make good scratched paint around pelmets caps

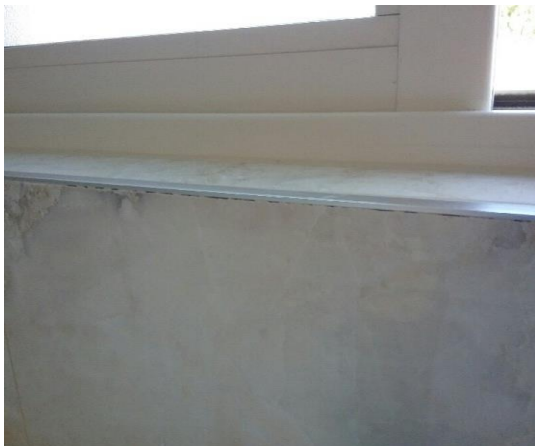
Ensuite 2- make good blemishes on door frame

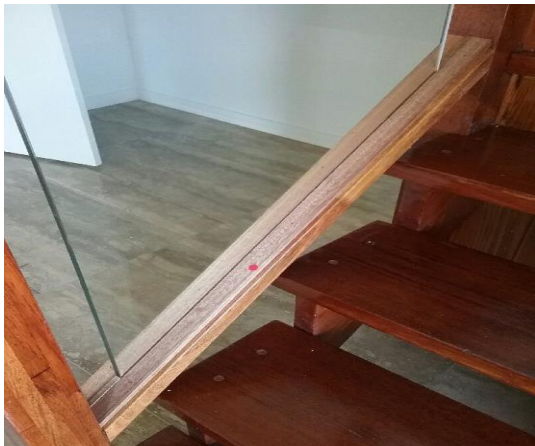
Entry stairs- The riser spacing on the staircase are not compliant to the building code. The riser opening if your staircase is of 'Open Rise Construction' must not allow a 125mm sphere to pass through, Refer BCA Part 3.9.1.3 – Staircase Construction, consult the Builder/Certifier for clarification.

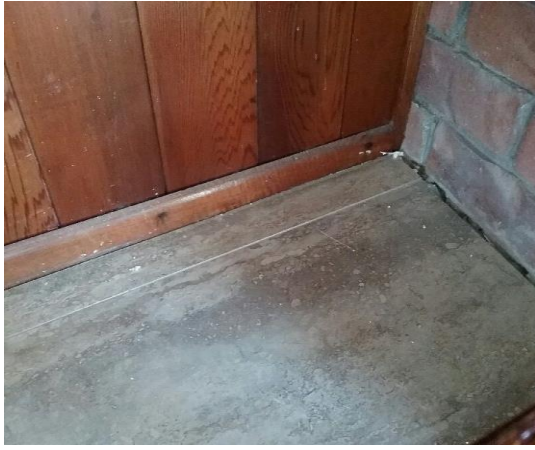
Entry stairs- make good poor or incomplete finish under stairs

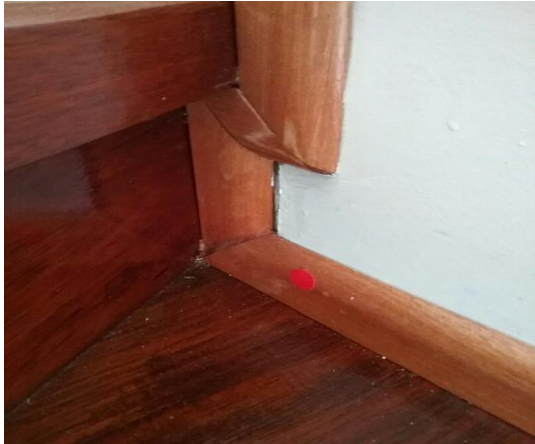
Entry stairs- make good finish to trim/wall just prior to turning corner

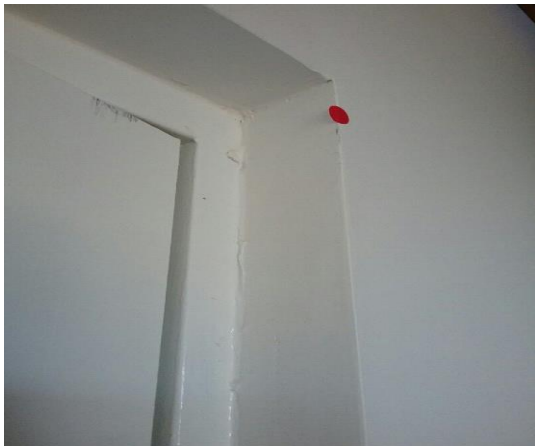
Entry- make good finish around door leading into store room

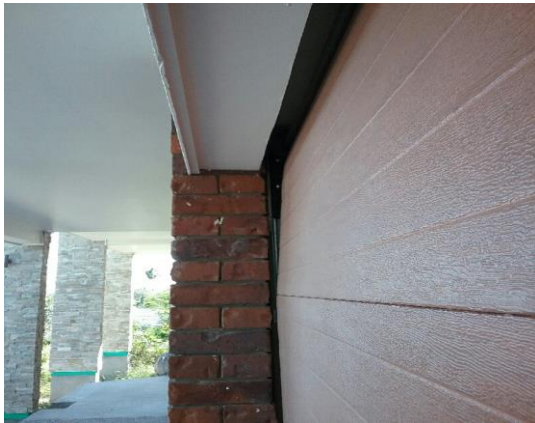
Front elevation- Garage- make good fitment of garage door LHS.

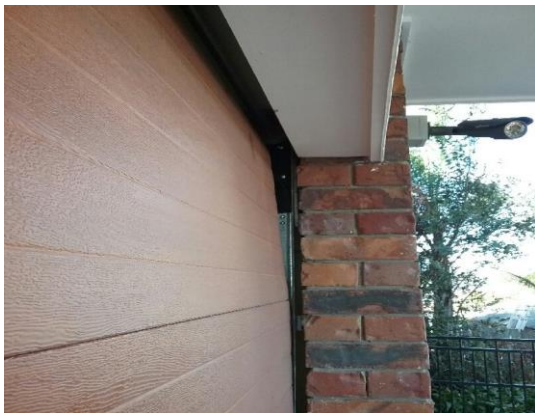
Front elevation- Garage- make good fitment of garage door RHS

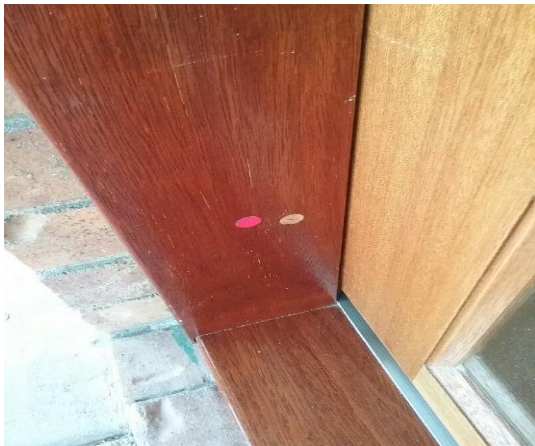
Front elevation- Entry- make good filler colour to match timber and finish. Review all and rectify

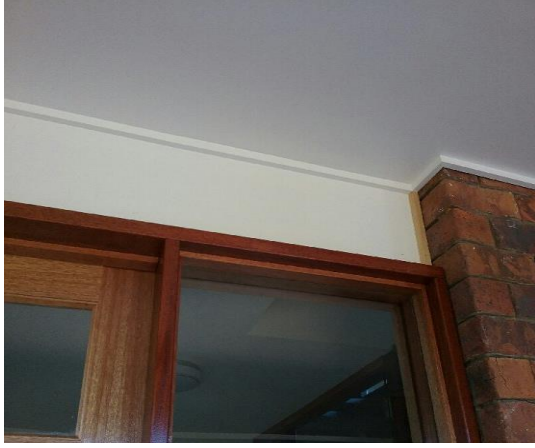
Front elevation- Entry- complete works above entry door

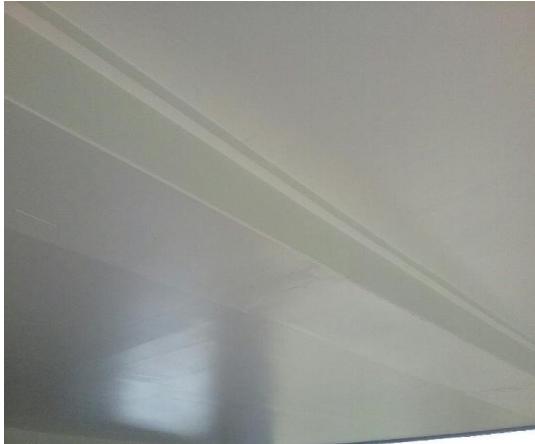
Front elevation- undercroft- finish to ext. bulkheads and ceilings are not finished off in a tradesman like manner. Areas are lumpy and have not been sanded prior to painting. Make good to all
