Handover Inspection Report

Rosedale South, Qld, 4123

Date of Inspection: 19/07/2017

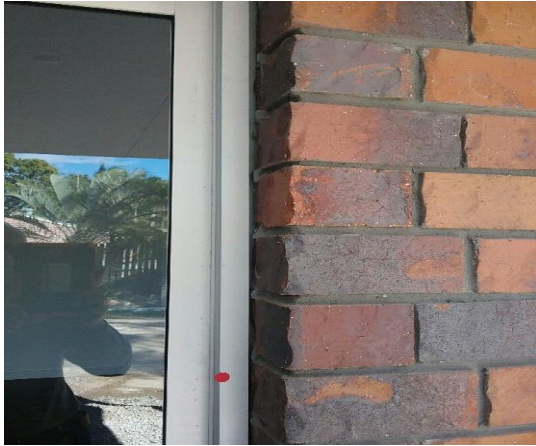
Rear elevation- all around- install same colour trim around sliding door to close gap

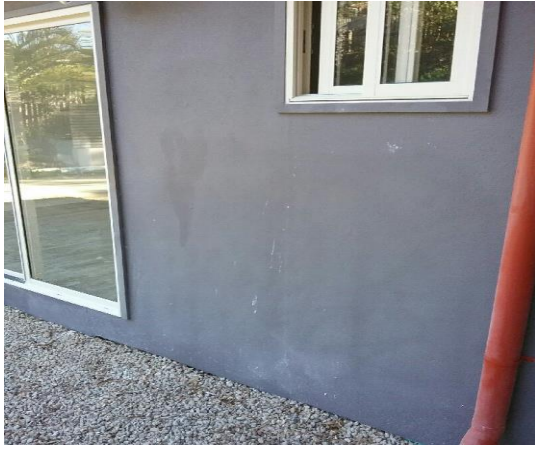
Rear elevation- wash down wall of builder's grime

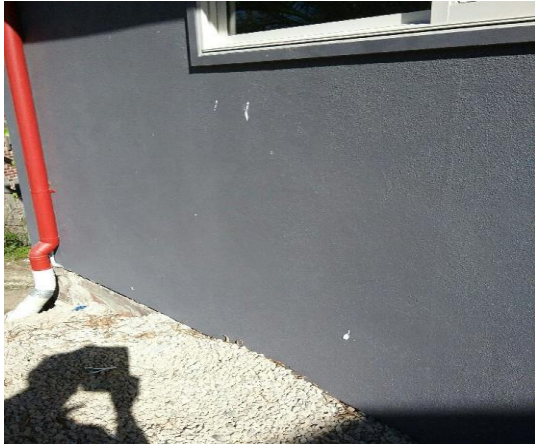
Rear elevation- make good blemishes on wall under window

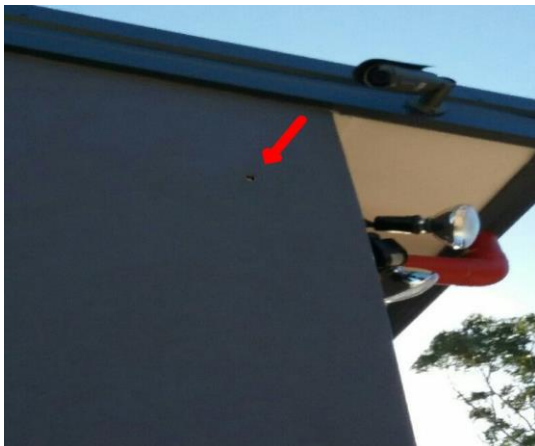
Right elevation- make good hole in wall

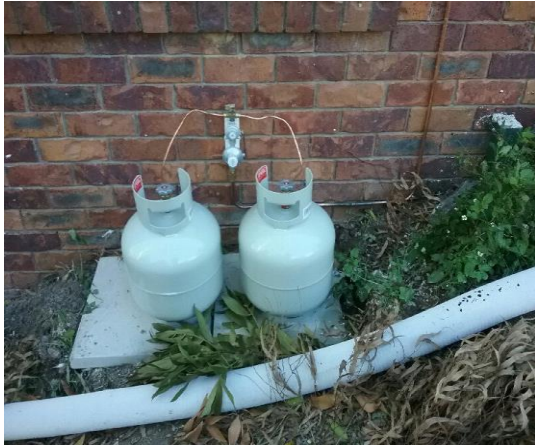
Right elevation- as per AS5601.1 LPG gas cylinders are to be restrained from falling by a chain fixed to the wall, make good and safe
